# Scottish Sanitary Survey Project

Sanitary Survey Report  
Oitir Mhòr Bay  
AB 308  
March 2011

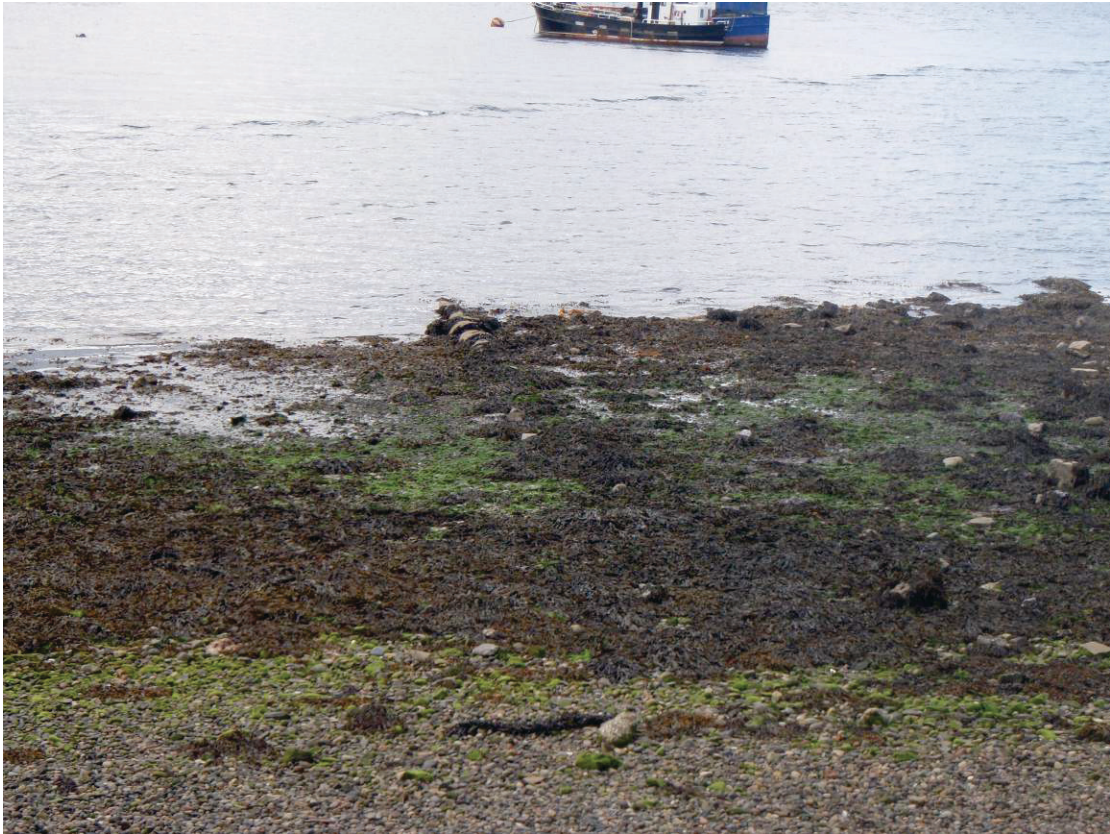
Figure 24. Pipe running across beach which appeared redundant

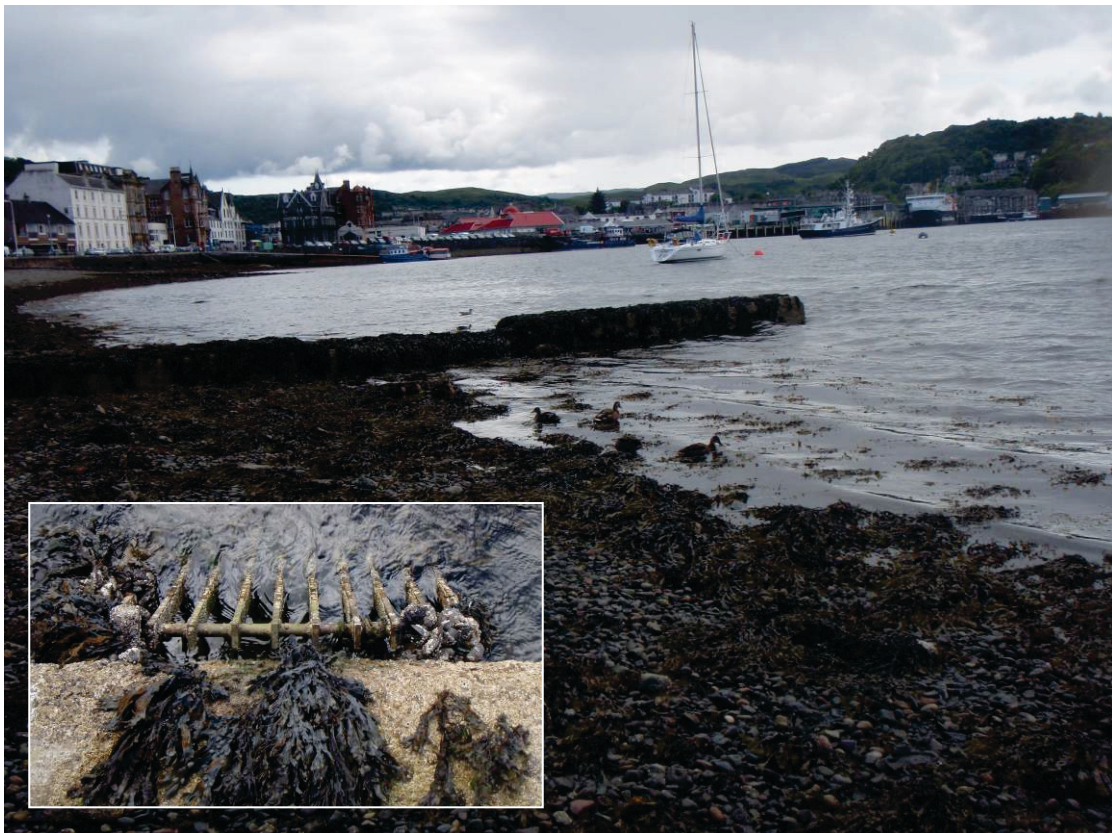
Figure 25. Possible outfall pipe running across beach with grill at the end (inset)

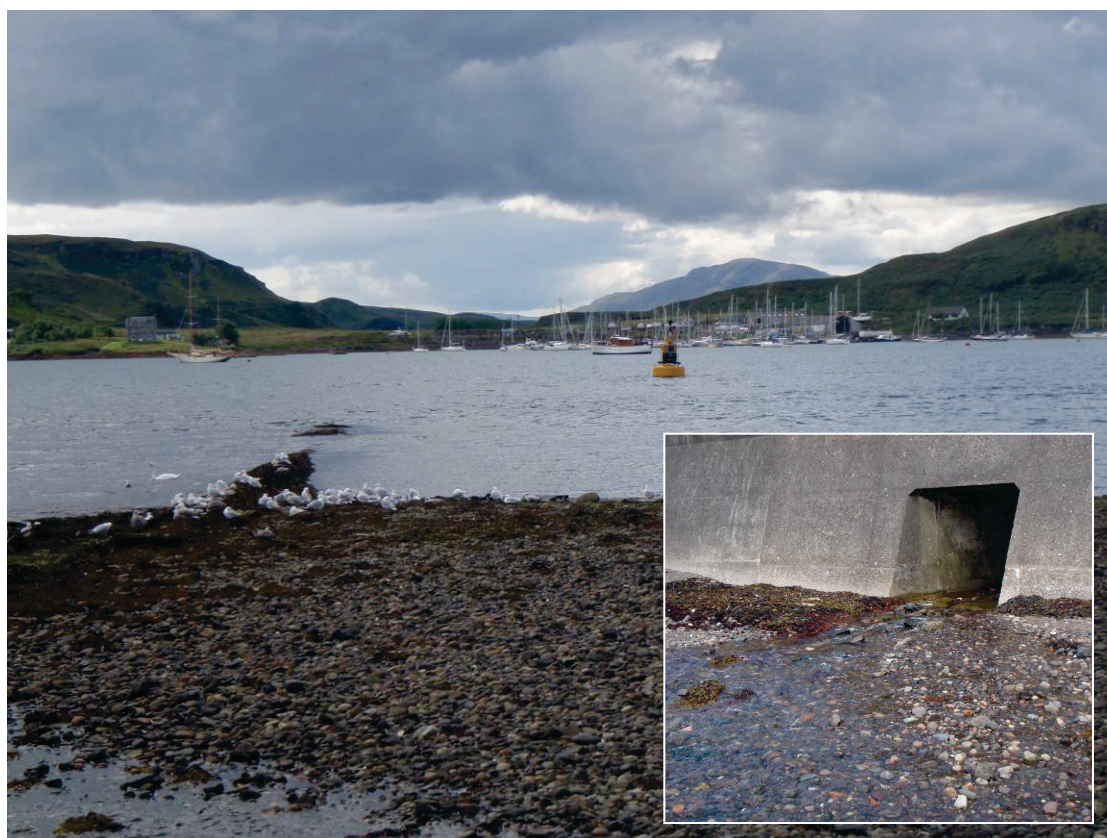
Figure 26. Buoy marking STW outfall in Oban Bay. Inset: Stream running under road and across beach near to buoy, freshwater sample FW06
