Scottish Sanitary Survey Report

Sanitary Survey Report Olna Firth SI 232 August 2013

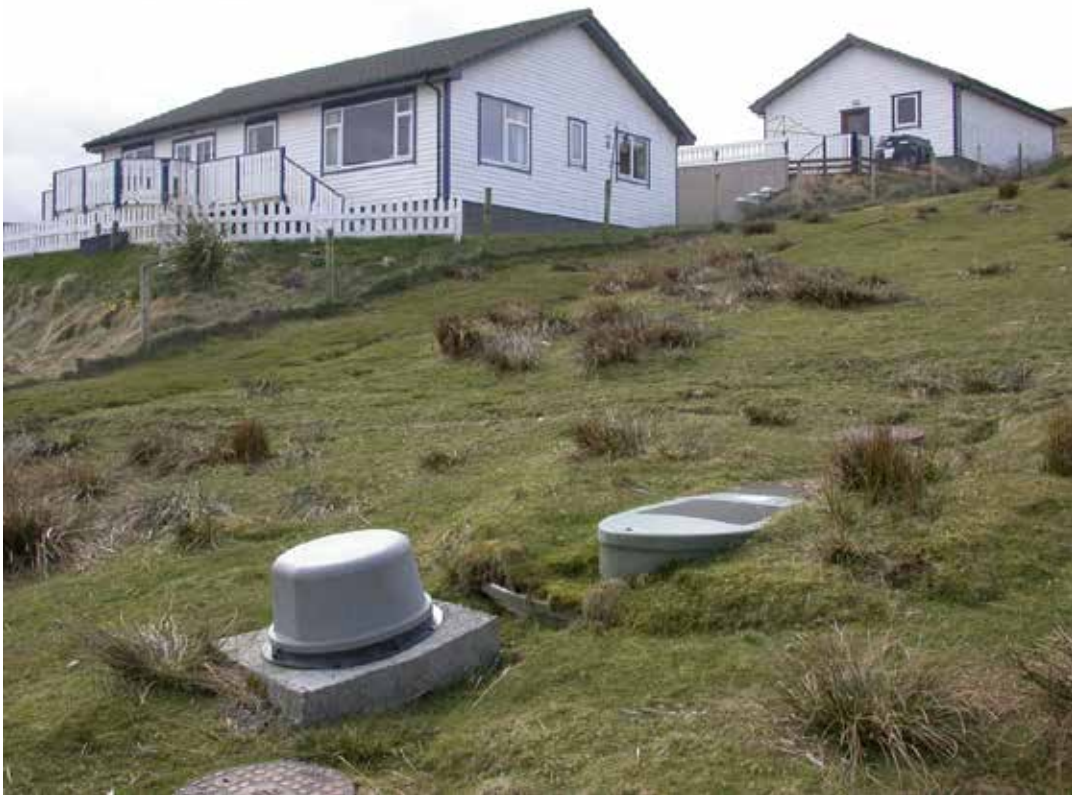
Figure 10 – Septic tank of an occupied property at Hoga, west of Voe.

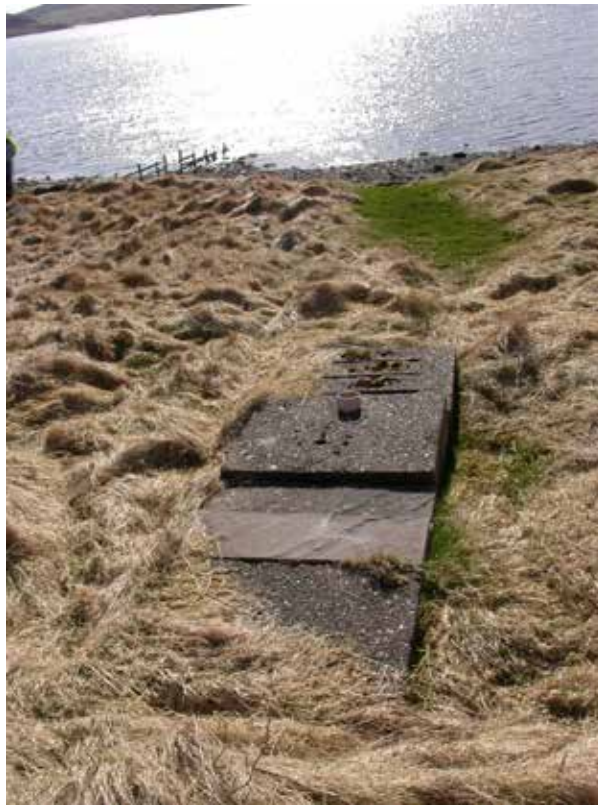
Two discharges were observed with indications of faulty septic tank systems. Observation 2 mentions brown material, assumed to be faecal matter, on the surface of the soakaway. This location plotted <10 m from MHWS. Observation 14, which relates to a septic tank detailed in Table 4.2 (No. 1), states a brown discharge observed from a pipe (see Figure 13 of the shoreline survey report). This is assumed again to be faecal matter.

Figure 12 – Septic tank below an occupied property at Olna.

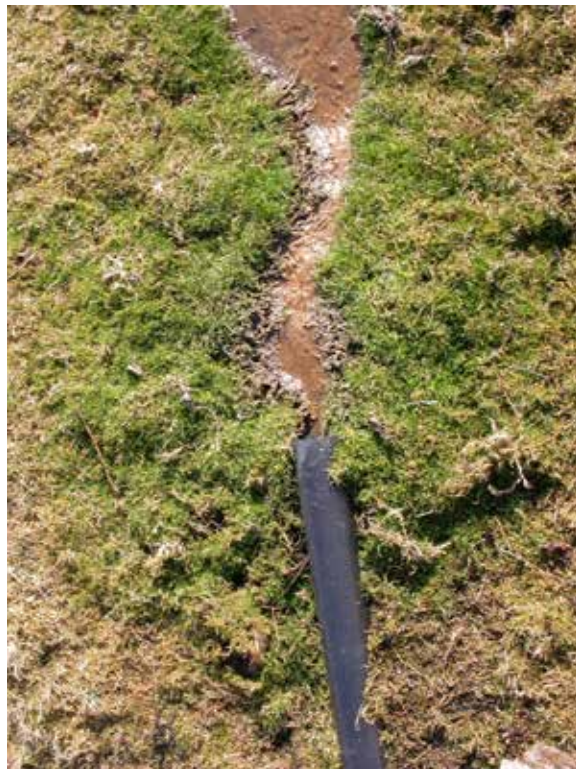
Figure 13 – Overflow pipe of a septic tank discharging to the shore associated with a property east of the Pinchdyke fishery.

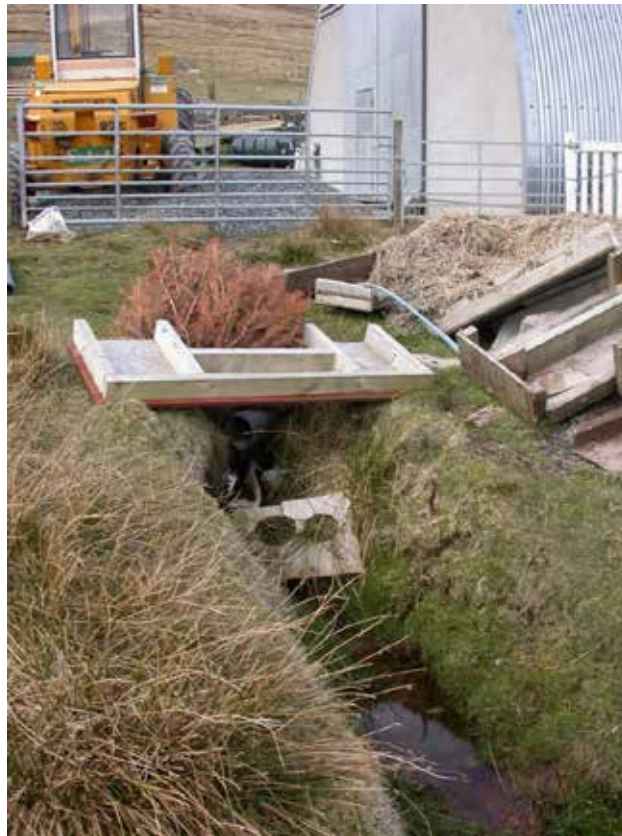
An agricultural shed northwest of the Pinchdyke site had a drain discharging to sea, however this drain also appeared to receive effluent from an adjacent septic tank. On the northern shoreline 117 were observed, with no access to the shoreline. Although no cattle were observed, evidence of these was recorded at the far southwestern shoreline of Olna Firth (hoof prints) and Wethersta on the northern shoreline (hoof prints and faecal matter). These animals would have access to the shore. There was also a small agricultural building close to Wethersta, thought to hold animals although not in use at the time of the shoreline survey. A feeding area for sheep with troughs and animals grazing nearby was also present on the northern coastline.

Figure 14 – Drain leading to the shore from an agricultural building at Hoga.

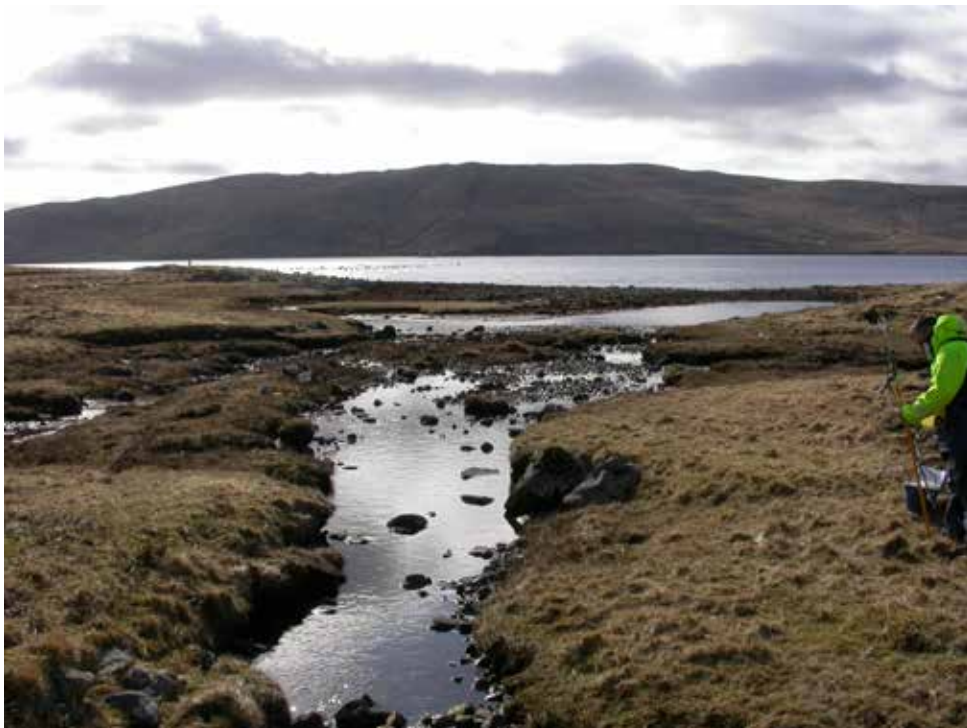
Figure 15 – Freshwater sample and flow rate obtained from a large watercourse below occupied dwellings adjacent to the Foula Wick fishery.

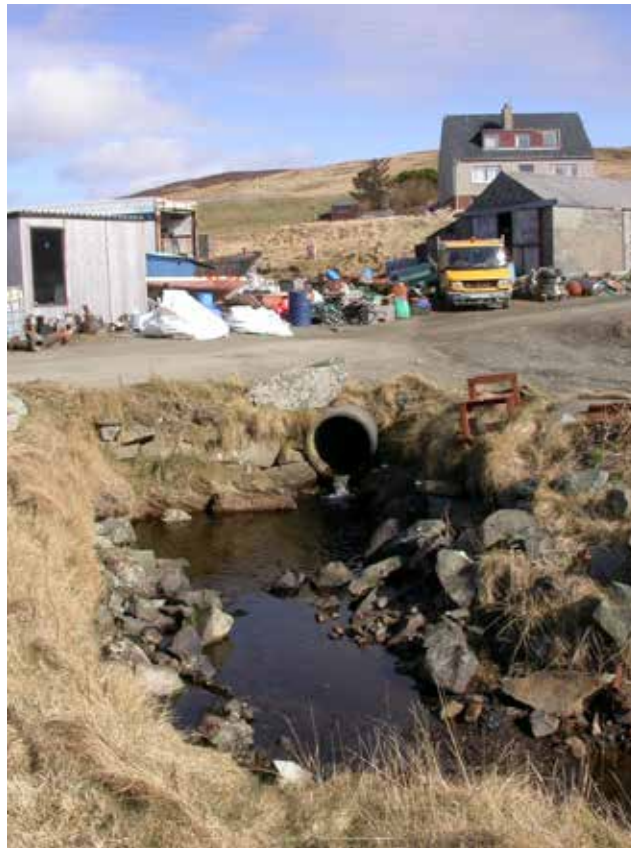
Figure 16 – Freshwater sample and flow rate obtained from a watercourse below occupied dwellings at Olna.

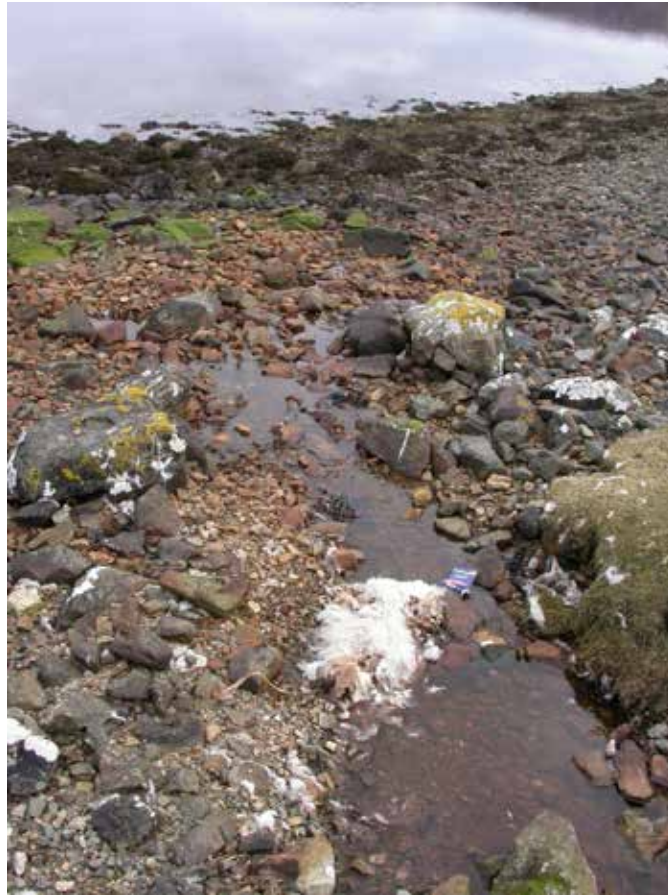
Figure 20 – Small watercourse sampled west of the Outer fishery with a sheep carcass present.

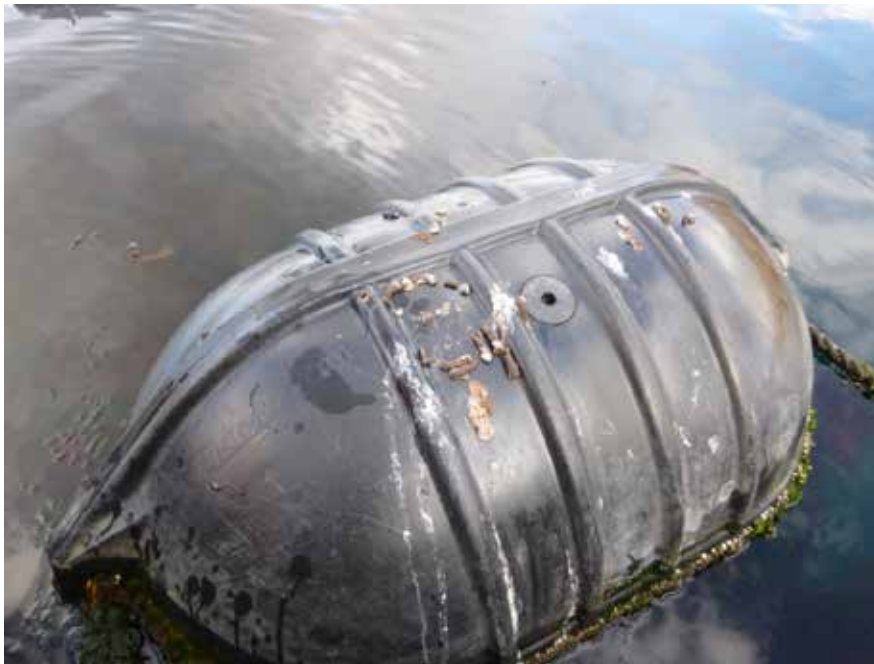
Bird droppings were observed on the mussel floats, which suggests a direct source of faecal loading to the mussel lines. Furthermore, there was evidence of birds feeding with urchin tests and mussel shells found in several areas along the shoreline at Olna Firth (Waypoints 5, 6, 15, 17 and 29). These areas suggest birds are using the surrounding areas to rest and feed, which may also suggest a concentration of faecal contamination.

Figure 21 – Bird faecal matter on a mussel float at the Inner fishery.

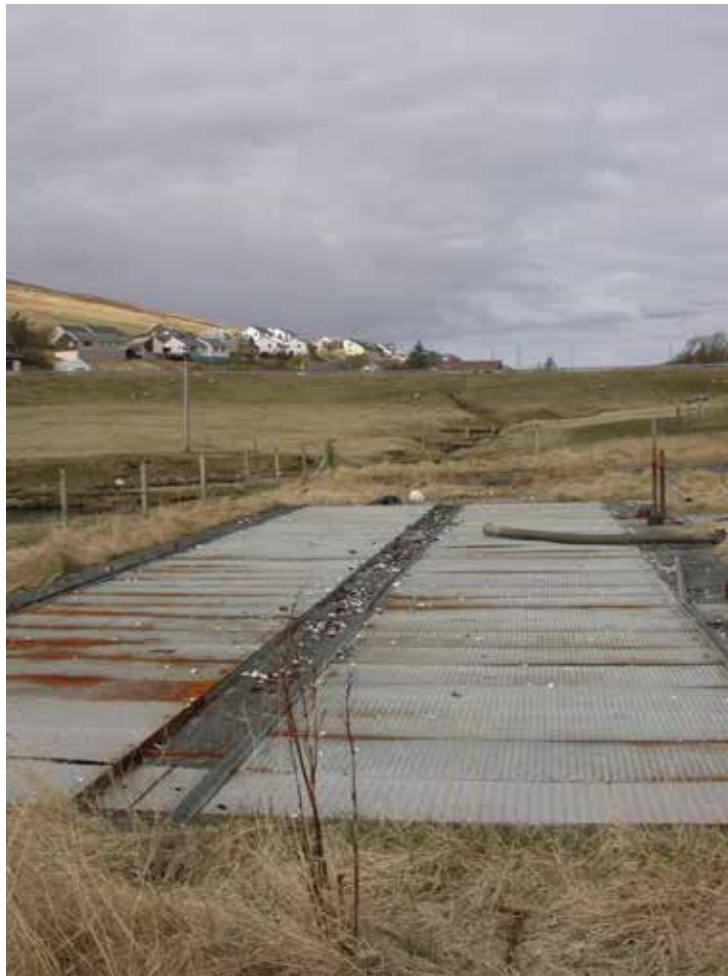
Figure 22 – Voe community septic tank with shell debris, potentially used as a feeding area for birds.
