Scottish Sanitary Survey Project

Restricted Sanitary Survey Report Saddell Bay AB 512 February 2010

Saddell Bay AB 512

Restricted Sanitary Survey

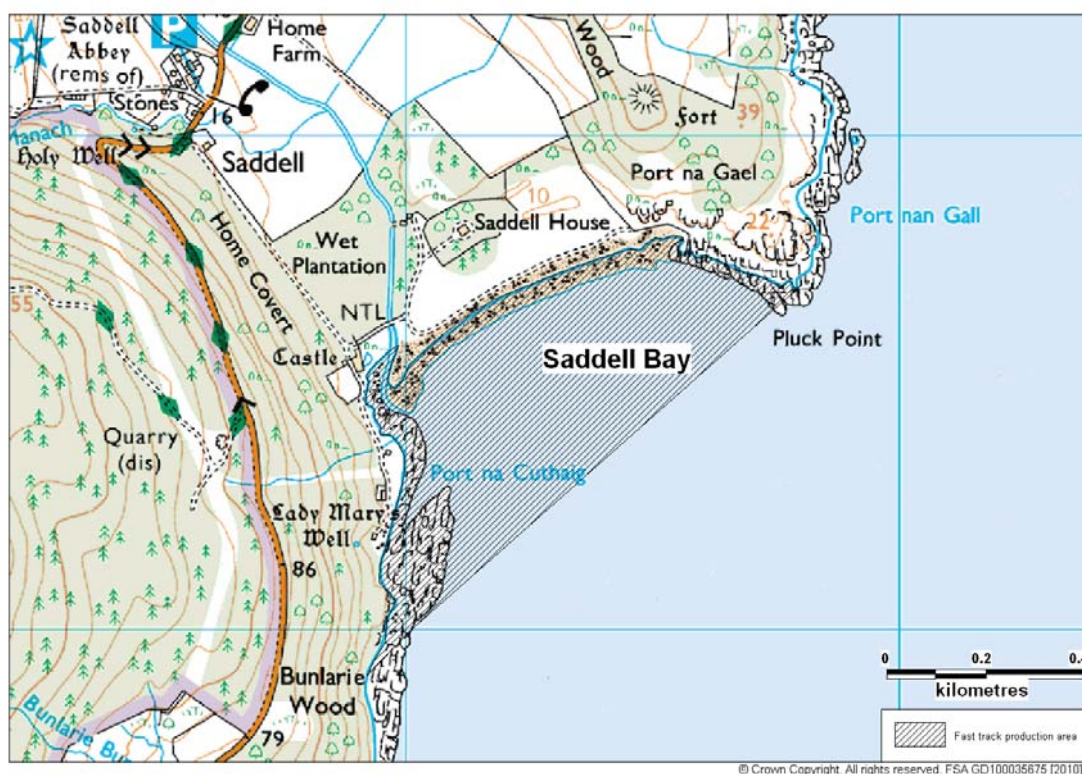
Figure 2.1 Saddell Bay fishery

The razor clam bed lies within the fast track production area boundaries, although the exact boundaries are not known (see Figure 2.1). Harvesting of razor clams is planned to take place throughout the year.

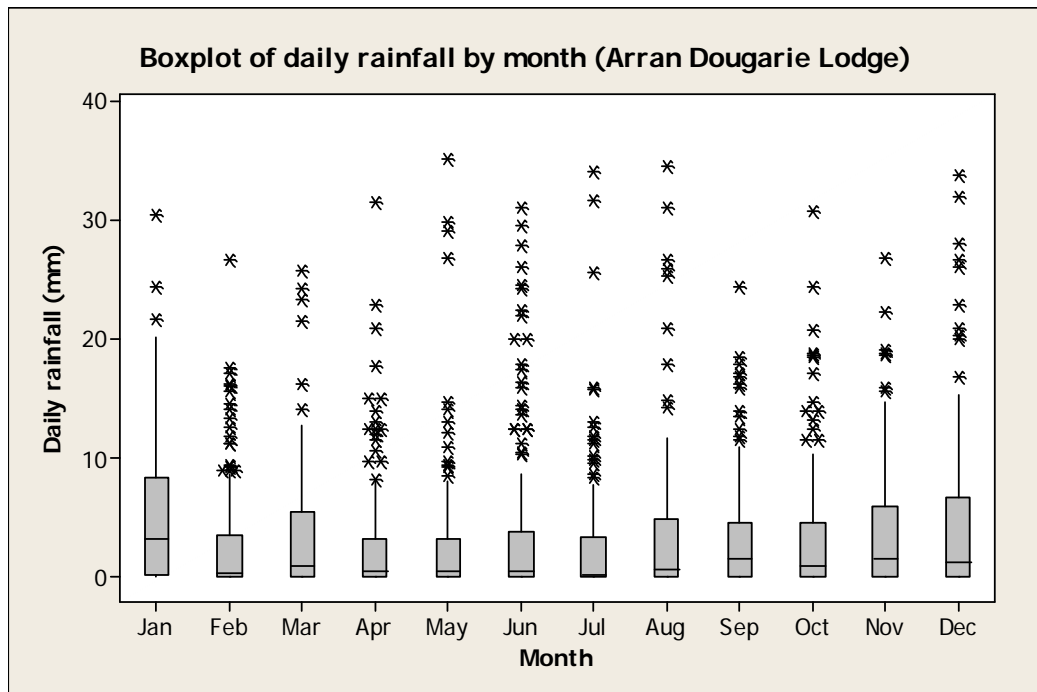
Figure 5.2 Boxplot of daily rainfall values at Arran Dougarie Lodge by month

The wettest months were December and January. For the period considered here (2003 – 2008), 35% of days for which records were available experienced no rainfall while 52% of days experienced rainfall of 1mm or less. Though mean rainfall was less than 10 mm per day, maximum daily rainfall on certain day was recorded at levels greater than 30 mm. The highest daily rainfall recorded here fell in May, one of the driest months. Overall, relatively high rainfall events occurred through the year and in all years.

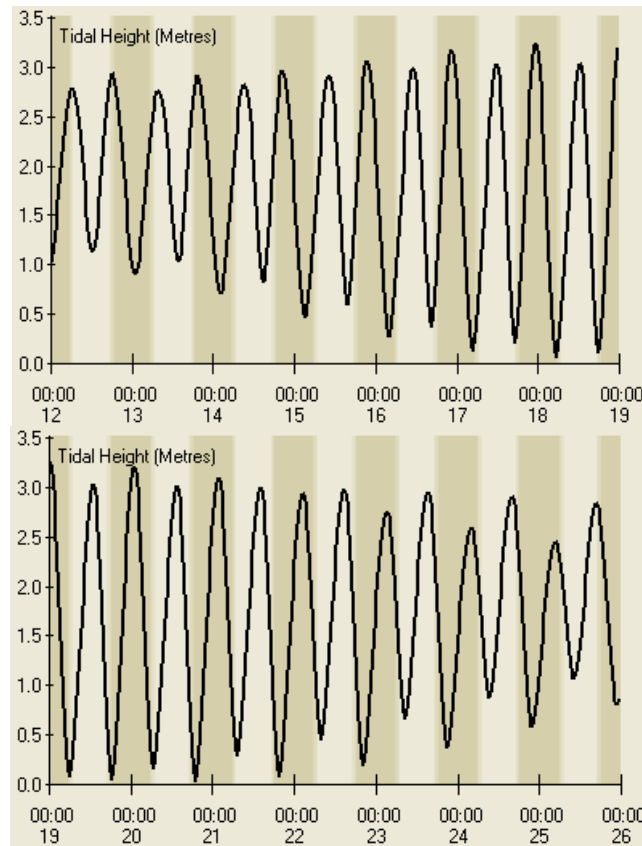
Figure 8.3 Tidal curves for Carradale

The two tidal curves below are for the port of Carradale, the nearest secondary port (5.5 km north of Saddell Bay). These have been output from UKHO TotalTide. The first is for seven days beginning 00.00 GMT on 12th October 2009. The second

is for seven days beginning 00.00 GMT on 19th October 2009. Together they show the predicted tidal heights over high/low water for the full neap/spring tidal cycle during which the shoreline survey was undertaken.

Predicted heights are in metres above chart datum. The tidal range at spring tide is therefore approximately 2.7 m and at neap tide 1.5 m.

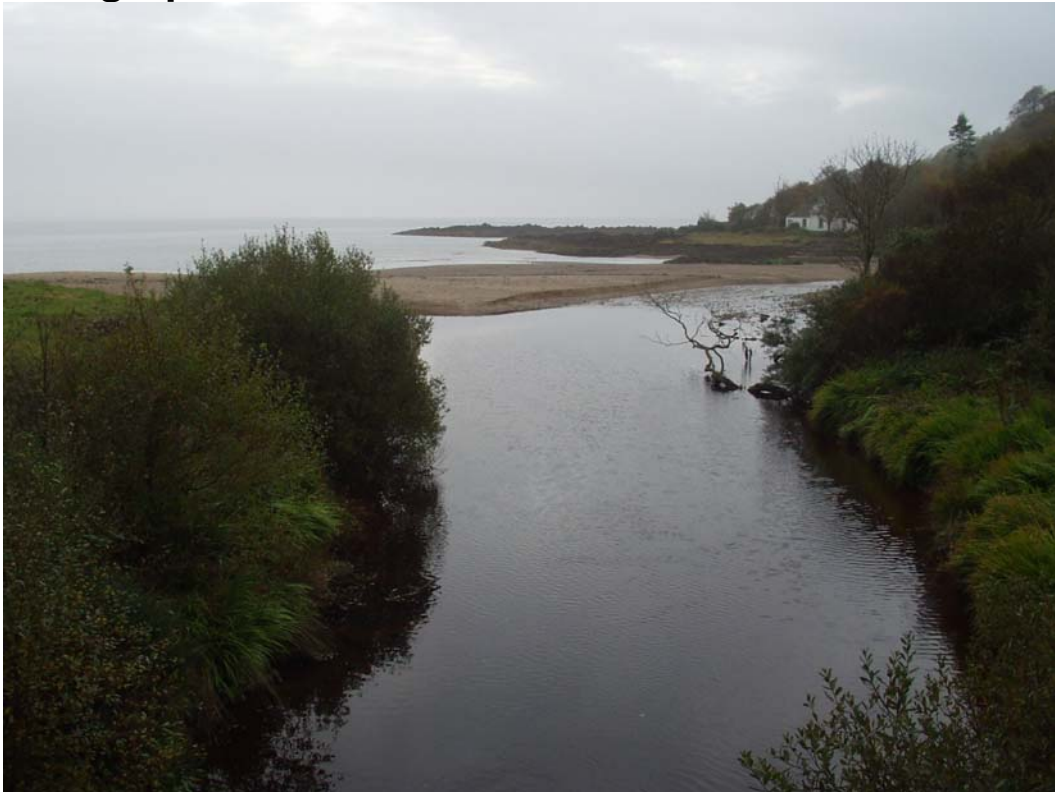
Figure 4. Allt nam Manach river, location of water sample 1 (SADDELL FW10)

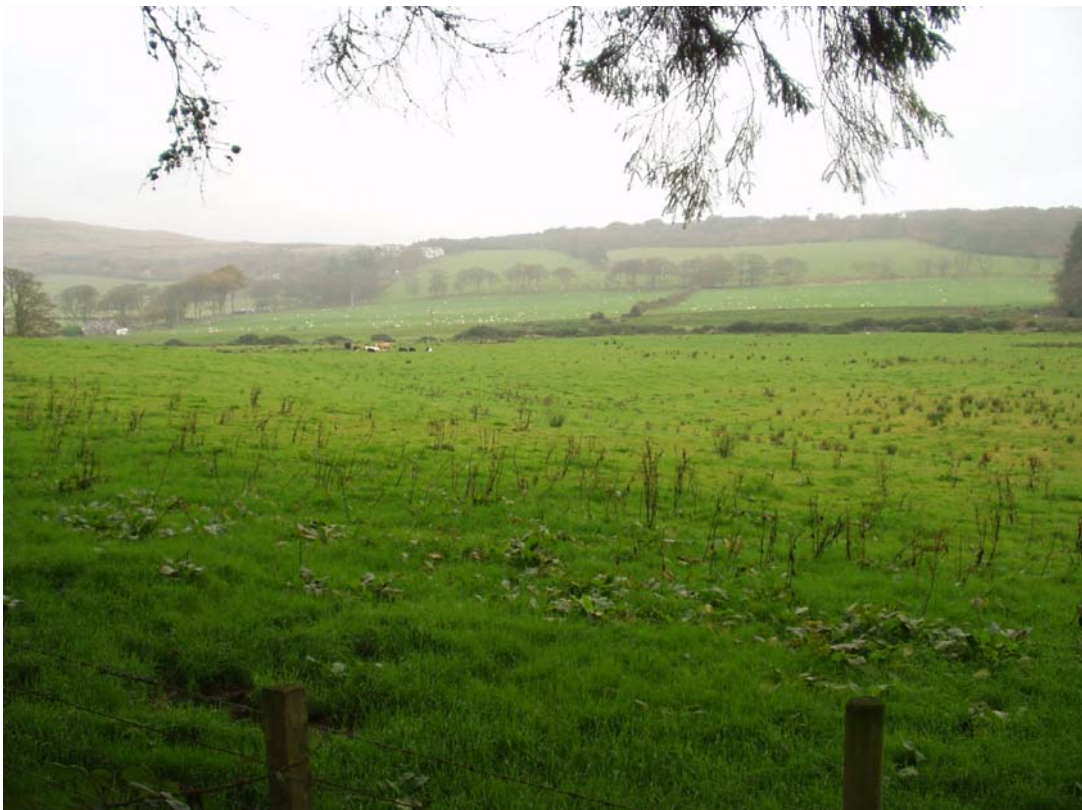
Figure 7. 10 cattle, 300 sheep (where the Allt nam Manach river runs through the field left to right)

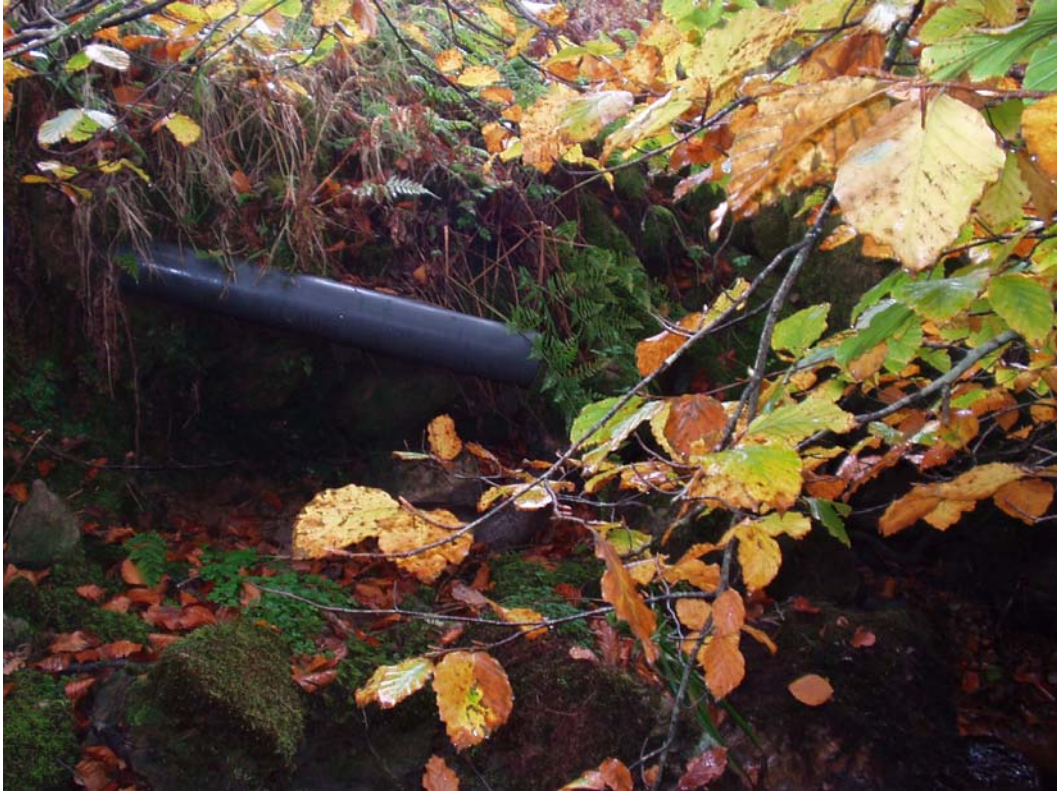
A single possible outfall pipe was observed discharging into Bunlarie Burn, 0.5 km south of Saddell Bay.

Figure 8. Grey pipe going into stream at Bunlarie
