# Scottish Sanitary Survey Programme

## Sanitary Survey Review

Sandsound Voe

SI 261

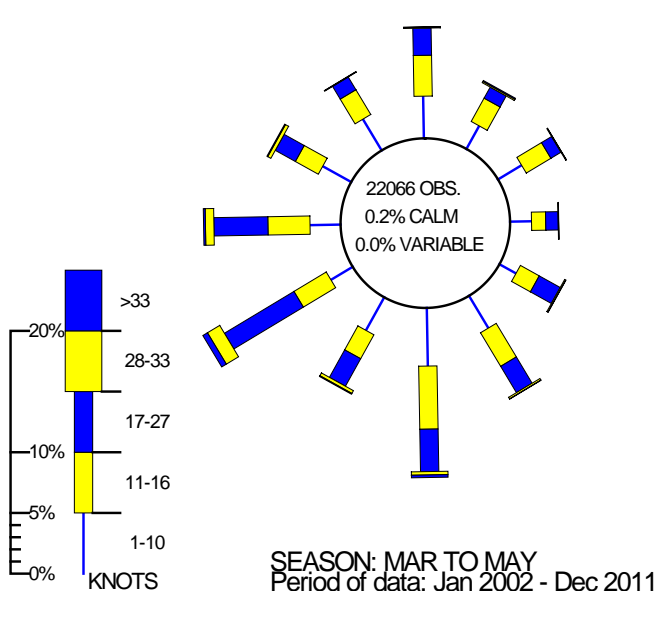
**Figure 8.3 Seasonal wind roses for Lerwick (2002-2011)**

Prevailing winds throughout all four seasons appears to be between south-south westerly particularly in autumn and winter when they are the highest winds. However, strong north easterly and north westerly winds also occur in summer, whilst spring winds were highest to the south-west. There are slight variations between years and seasons, but this trend was seen in both datasets.

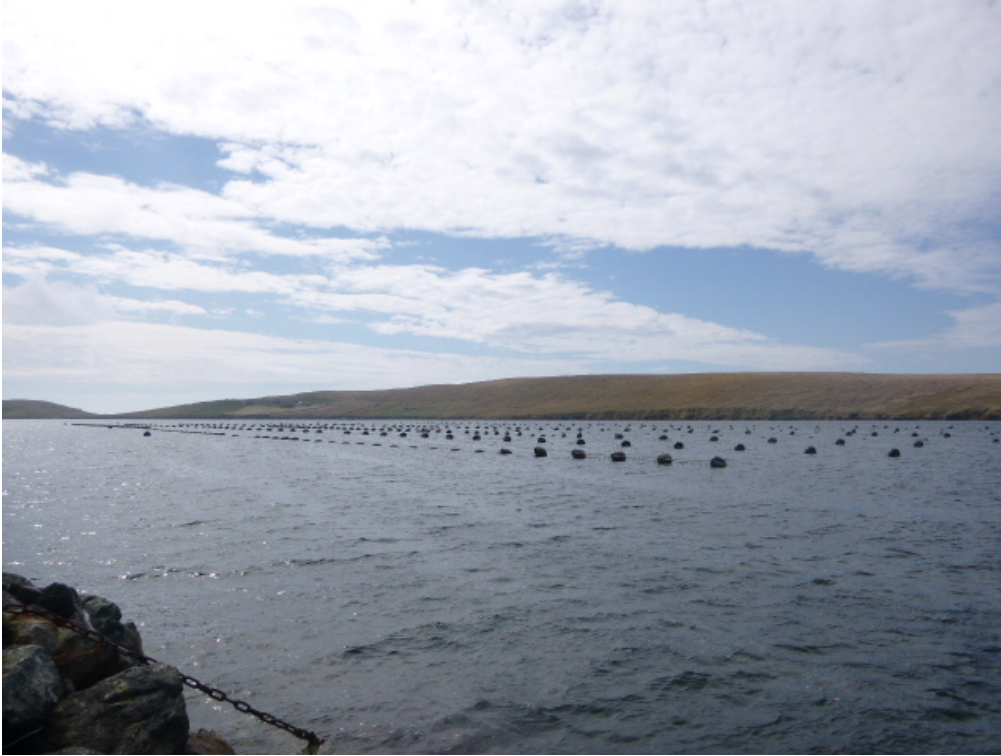
The fishery consisted of nine mussel lines running parallel to the shoreline (Figure 4). All lines were double headed long lines with 8-9 metre droppers. Two mussel samples were collected from the north west corner of the site from the line furthest from the eastern shore, taken from the top and bottom of a mussel line. Two mussel samples were also collected from the south east corner of the site from the line nearest the eastern shore, taken from the top and bottom of a mussel line.

**Figure 4 – Mussel lines at the Sandsound Voe fishery looking west.**

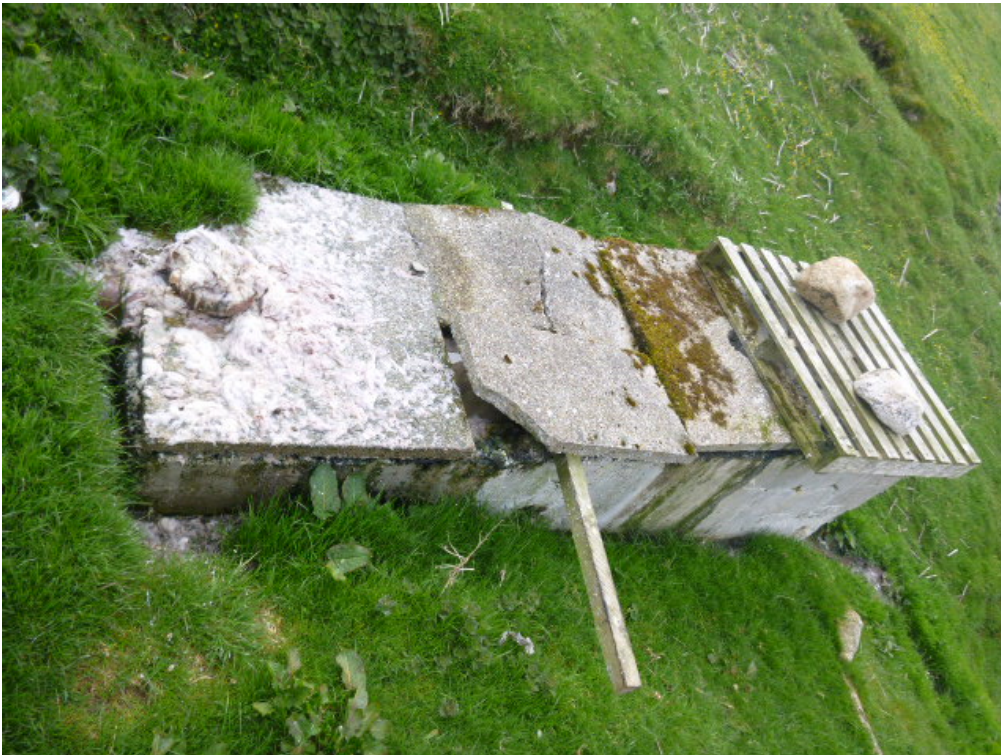
**Figure 5 – Overflowing septic tank at the south end of Sandsound Voe.**

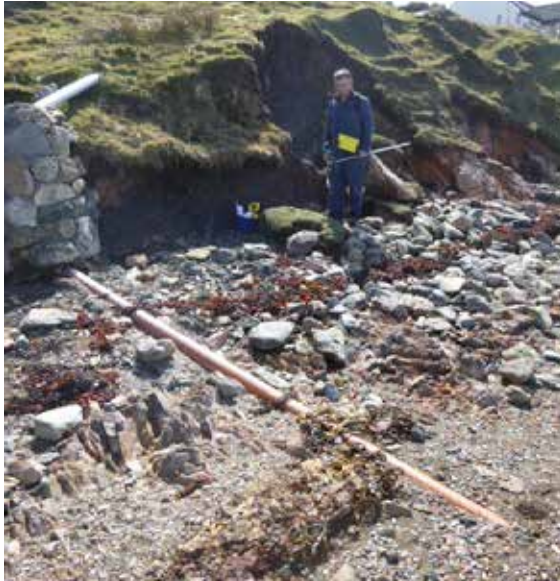
**Figure 6 – Bed and Breakfast property pipe from the septic tank entering the water south of the Sandsound Voe fishery.**

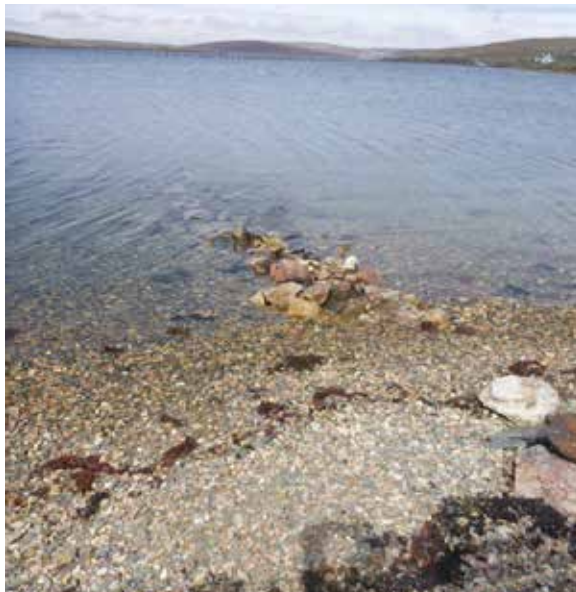
pipe from the septic tank. Again the end of the pipe could not be seen as the built up area extended into the water (Figure 7). Three pipes associated with land drainage were observed coming under the road and discharging to the field below. One of these pipes created a small watercourse which lead to the shore which returned a high *E.coli* count but this was most likely due to faecal matter being present in the watercourse (Figure 8). A small overflow pipe entered the watercourse which was assumed to be associated with the septic tank adjacent but no discharge was coming from the pipe. A small drainage pipe discharging clear water to the shore was present below a house, assumed to be land drainage. At the beginning of the shoreline walk an overflow pipe was noted below a septic tank however no discharge was present from the pipe. An open septic tank was present in the field next to a property to the east of the Sandsound Voe fishery which had two pipes extruding vertically from the ground most likely used for venting.

**Figure 7 – Built up area which may be covering a pipe coming from a septic tank, south of the Sandsound Voe fishery.**

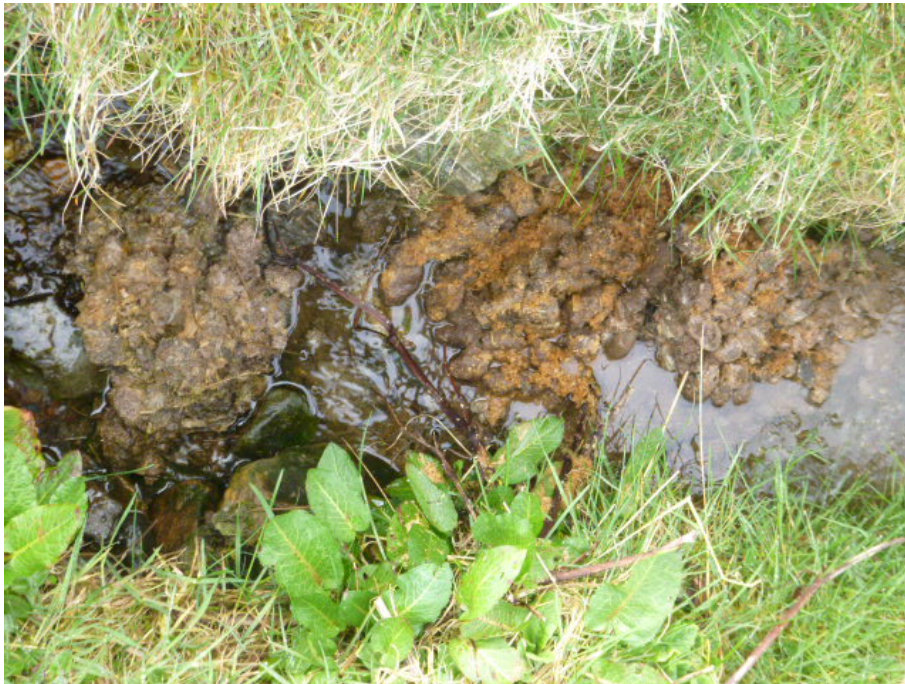
**Figure 8 – Suspected discarded faecal matter in a small watercourse at the south end of Sandsound Voe.**

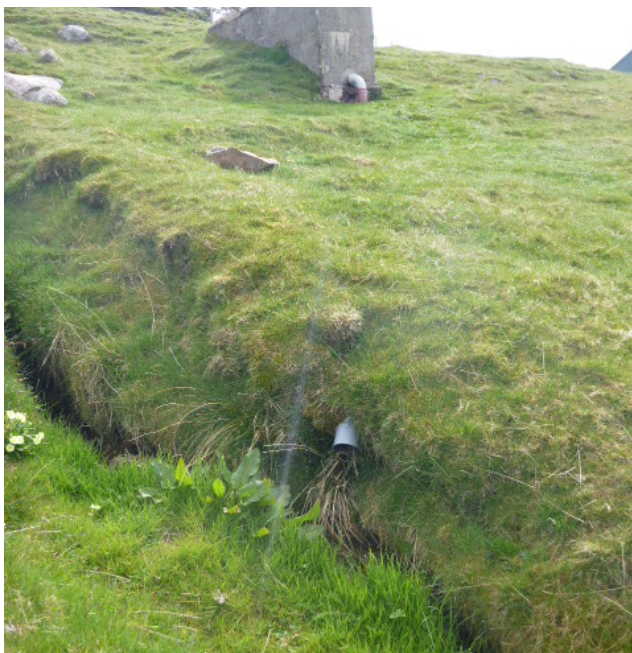
**Figure 9 – Pipe assumed to be associated with a septic tank entering a small watercourse leading to the shore at the south end of Sandsound Voe.**

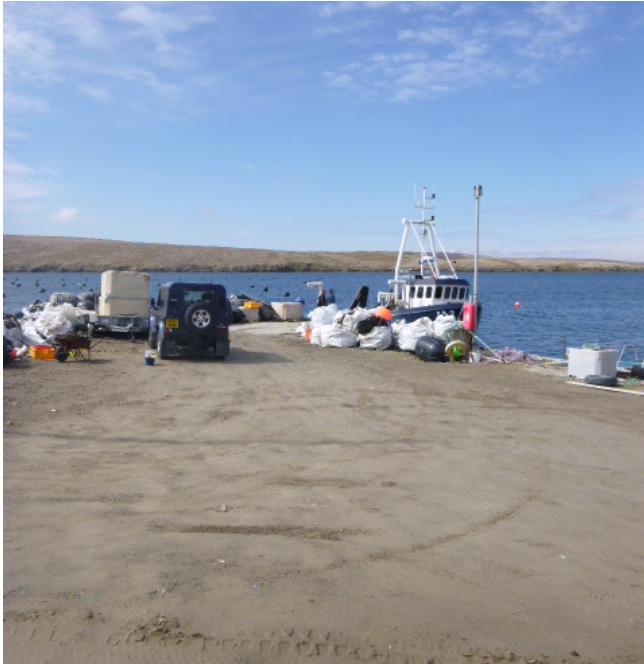
Most boat traffic in the Sandsound Voe area is associated with mussel farming. Sandsound Mussels who own the Sandsound Voe fishery have a shorebase located to the east of the fishery used to service the site (Figure 10). There are two production areas north of Sandsound Voe production area in The Firth. Three mussel fisheries are sited here which are owned by companies who do not have shorebases in the area so can only be accessed by travelling through Sandsound Voe. Sandsound Mussels had one large workboat and one small workboat moored at the shorebase at the time of the survey. Another mussel farming company have been given permission to use this shorebase to carry out weekly sampling for biotoxins and monthly sampling for *E.coli* at sites located out with Sandsound Voe in the surrounding area. However on the day of the shoreline survey the small workboat used for the sampling was not moored at the shorebase. There does seem to be some leisure boating activity in Sandsound Voe with a number of small boats moored on beaches on both the east and west shore. On the eastern shore two

**Figure 10 – Sandsound Mussels shorebase.**

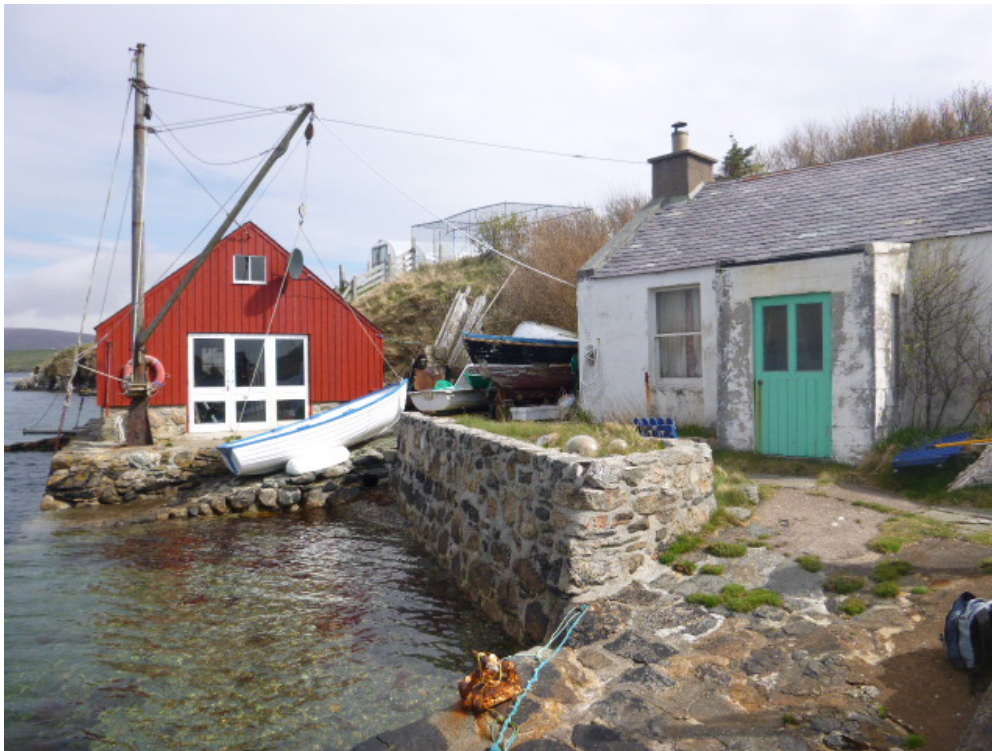
small boats used for leisure purposes were observed on a small stony beach at the south end of the production area. Also at the Omunsgarth jetty there were another four boats ashore next to the house, again most likely used for leisure purposes (Figure 11). On the western shore at the start of the shoreline walk at Innersand, three small boats used for leisure purposes were ashore at the top of a small stony beach.

**Figure 11 – Leisure boats stored at Omunsgarth jetty.**

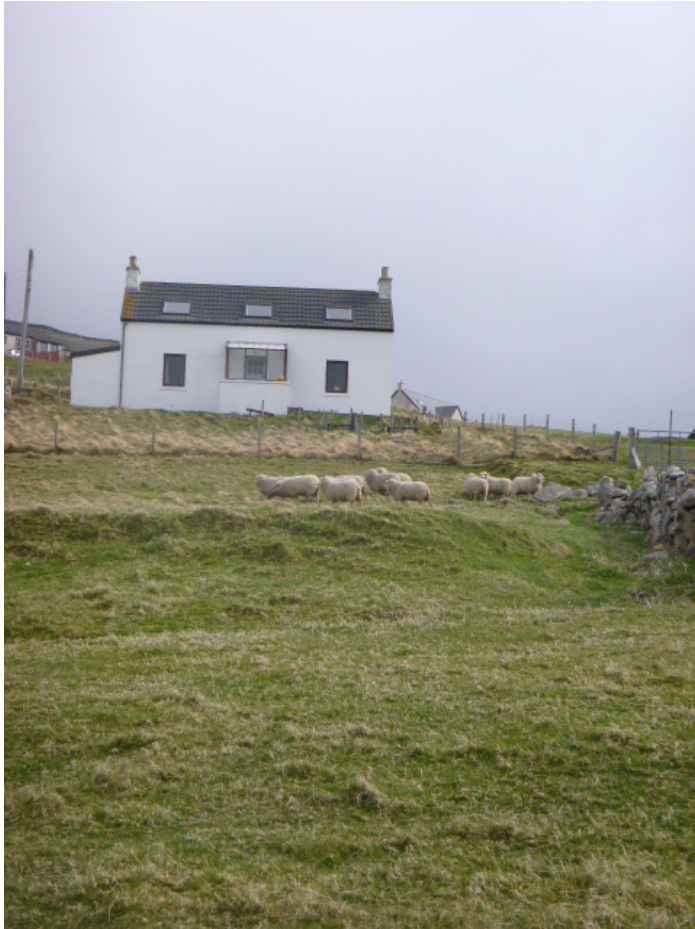
The land on the shoreline survey was largely rough grazing with only one area of improved grazing land present on the eastern shoreline on the east side of Lung Ness. Sheep were frequently observed grazing on both the eastern and western shoreline. On the eastern shoreline sheep were observed on twenty occasions, 325 animals in total with approximately half these animals having access to the shore (Figure 12). On the western shoreline sheep were noted on three occasions but these were large groups of animals, 113 in total, with the majority of these animals having access to the shore, however access may have been difficult in some cases due to the steep escarpments at the shoreline. Sheep faeces were noted in most areas animals were grazing however there were two occasions where sheep faeces were noted but no animals were present.

**Figure 12 – Sheep grazing below a house on the eastern shore.**

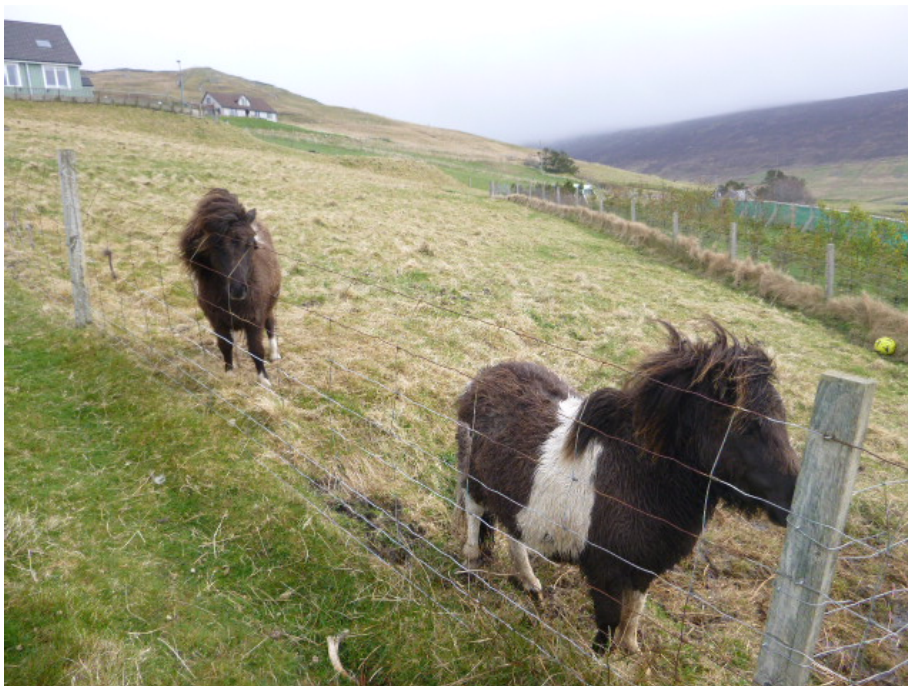
Two Shetland ponies were observed in a field below a house (Figure 13) near the start of the eastern shoreline walk, at the south end of Sandsound Voe. The animals did not have access to the shore.

**Figure 13 – Shetland ponies below a house on the eastern shore.**

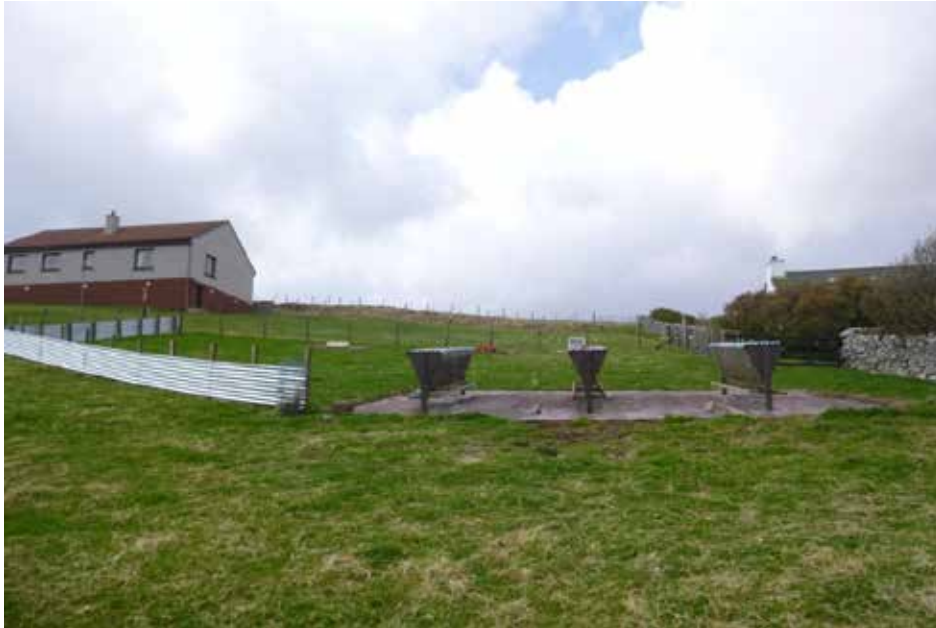
Two agricultural sheds were noted on the eastern shoreline however both were located above the road, some distance from the shore. On the western shoreline three agricultural sheds were observed adjacent to houses near the end of the shoreline walk in the Mayfield area. Also a feeding area for sheep was noted between the two houses in this area (Figure 14).

**Figure 14 – Feeding area for sheep located between two dwellings on the western shore.**
