Scottish Sanitary Survey Review

Seil Point
AB-245
April 2015

Report Title	Seil Point Sanitary Survey Review Assessment
Project Name	Scottish Sanitary Survey
Client/Customer	Food Standards Agency Scotland
Cefas Project Reference	C6316B
Document Number	C6316B_2014_22
Revision	V1.0
Date	10/04/2015

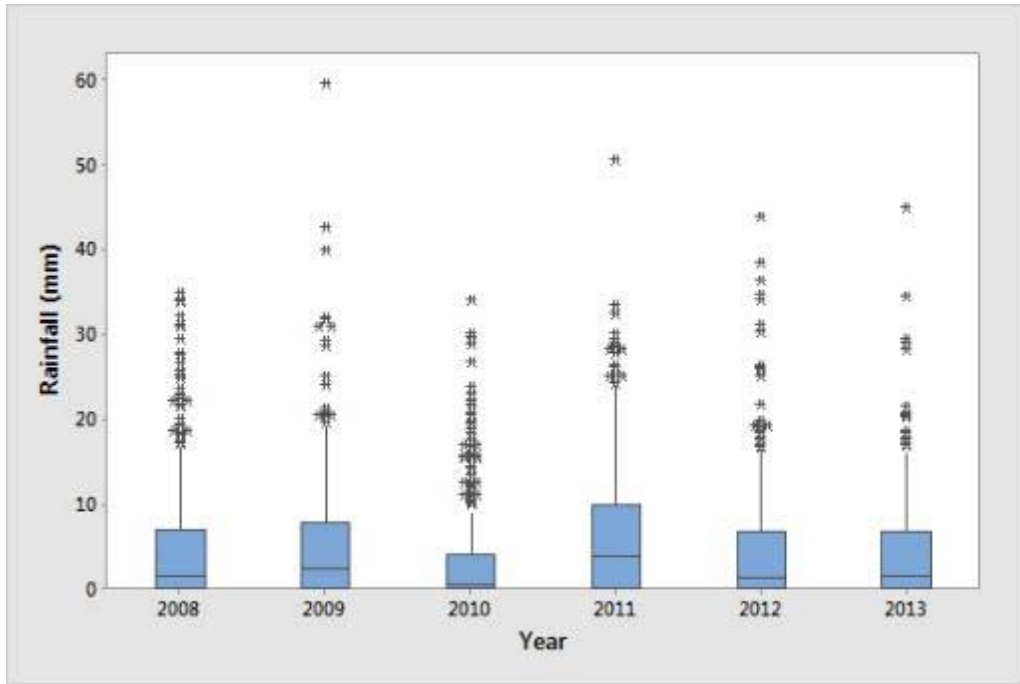
Figure 6.1 Boxplot of daily rainfall at Lismore; Frackersaig Farm (2008-2013)

Daily rainfall totals were mainly below 10 mm per day. Rainfall events of greater than 50 mm/day occurred in 2009 and 2011. Total annual rainfall was highest in 2011 (2354 mm) and lowest in 2010 (1199 mm).

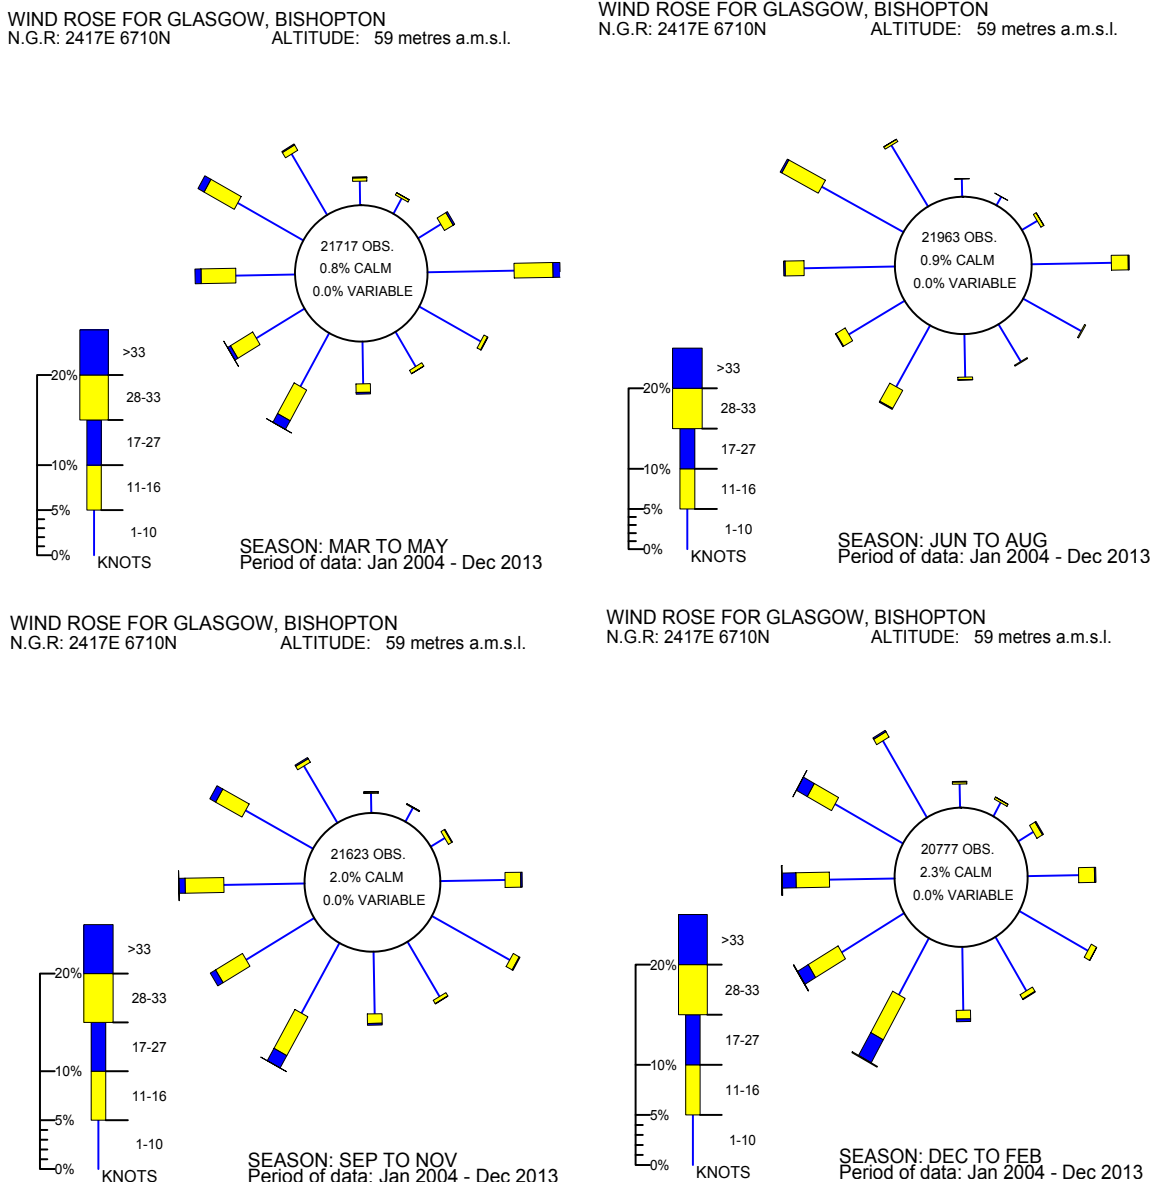
Figure reproduced under license from Meteorological Office. Crown Copyright 2015
Figure 6.3 Seasonal wind roses for Glasgow: Bishopton (2004-2013)

Prevailing winds continue to come from the west (between south-southwest and west-northwest). Winds also arise from an easterly direction, mainly during the spring. Winds are strongest during the winter months and weakest during summer. It should be noted that the wind direction at Glasgow: Bishopton will be affected by the orientation of the Firth of Clyde.

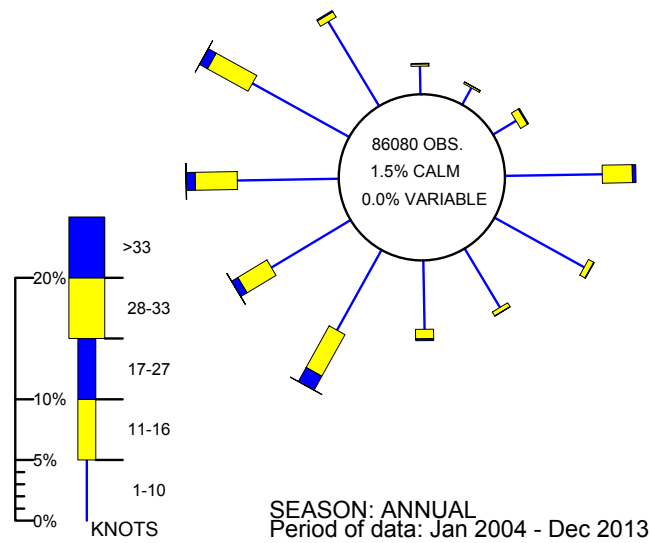
Figure reproduced under license from Meteorological Office. Crown Copyright 2015
Figure 6.4 Annual wind rose for Glasgow: Bishopton (2004-2013)

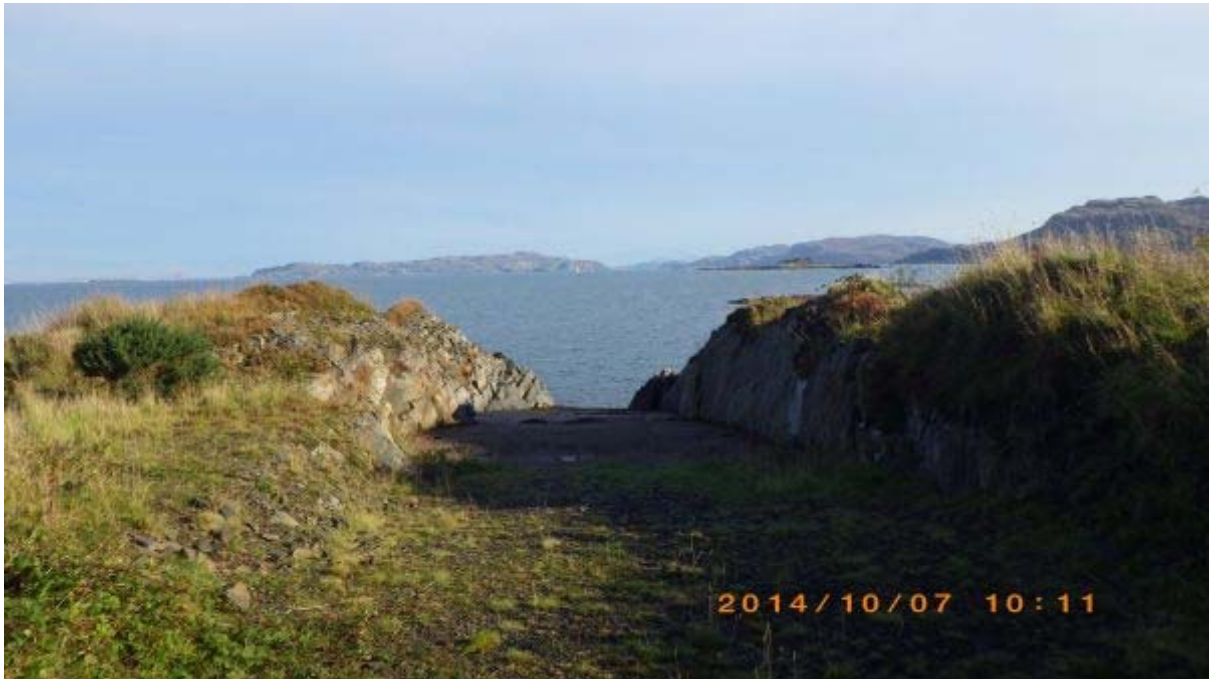
A relatively new, but unused, slipway was observed by the team (Waypoint 5, Fig. 3) and one moored dinghy was seen in Camuslaich (Waypoint 38, Fig. 12) but no other boats were seen on the water or onshore during the survey visit.

Figure 3. Unused slipway. Waypoint 5.

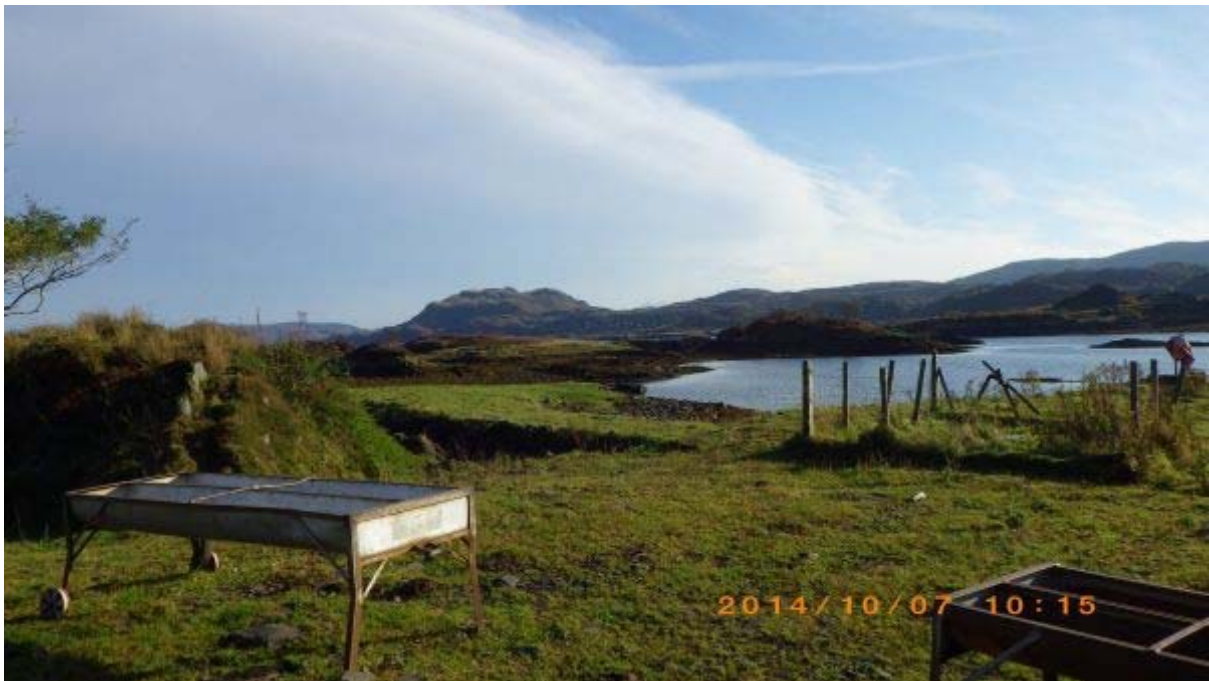
Figure 4. Cattle feeding station, not in use. Waypoint 6.

The cattle feeding station noted to the northwest of the West Bay site is expected to represent a significant contamination source to the western extent of this site when in use. However, the most significant sources remain concentrated around the southern shoreline, where they are expected to continue to have high levels of impacts on contamination levels crossing the Poll a' Bhrochain and former Cadzow sites.

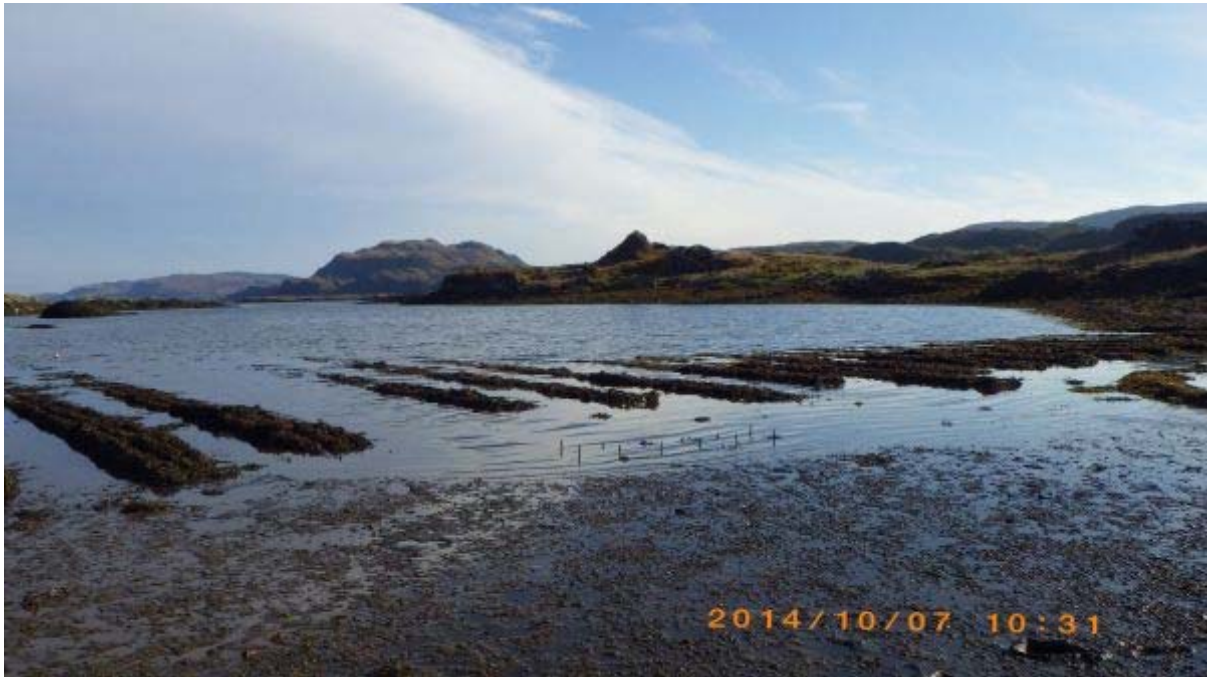
No oyster stock was present at the first site, referred to as 'west bay' by the harvester, but common mussels were found nearby attached to intertidal walling and a sample of these was obtained as a substitute for the two planned oyster samples.

Figure 5. Low oyster trestle array Ardfad Bay ('west bay' Ardencaple-Cyster site). Waypoint 7.

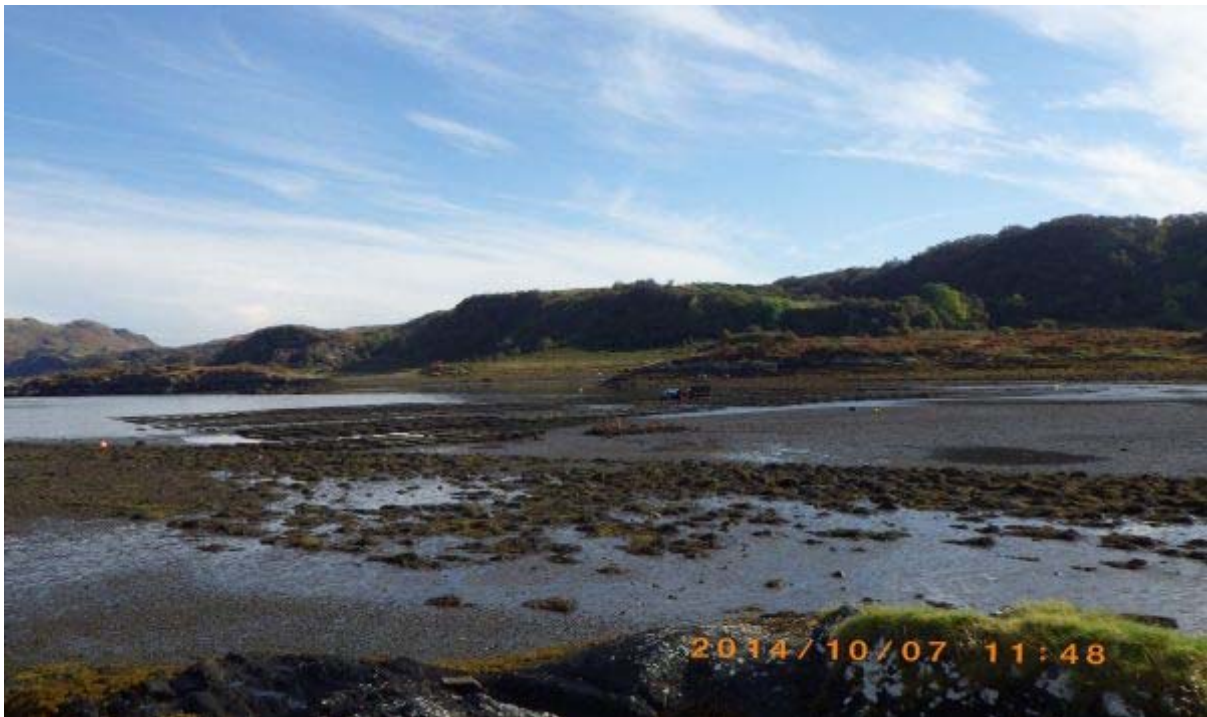
Figure 6. Oyster trestle array at Ardencaple-Cyster site Poll a' Bhrochain. The RMP is the small area of separate trestles in the centre of the photograph. Associated Waypoint 21, centre left (SW corner of trestle array).

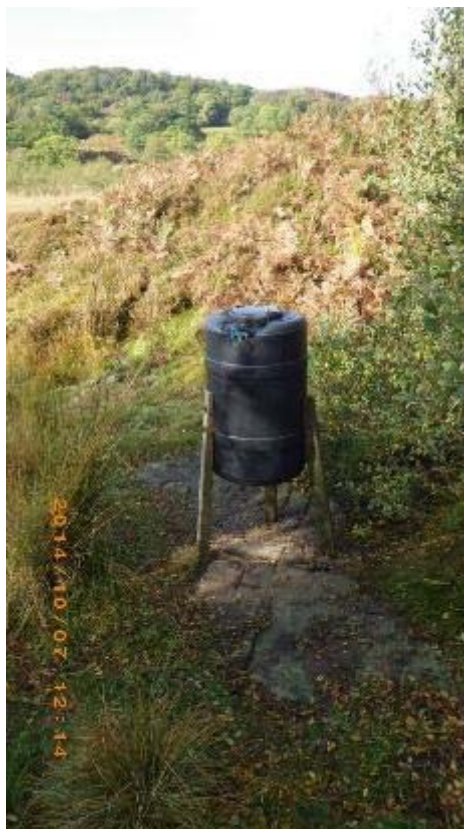
Figure 8. Field grain feeder for pheasants near to Ardencaple oysters shore base. Associated with Waypoint 34.

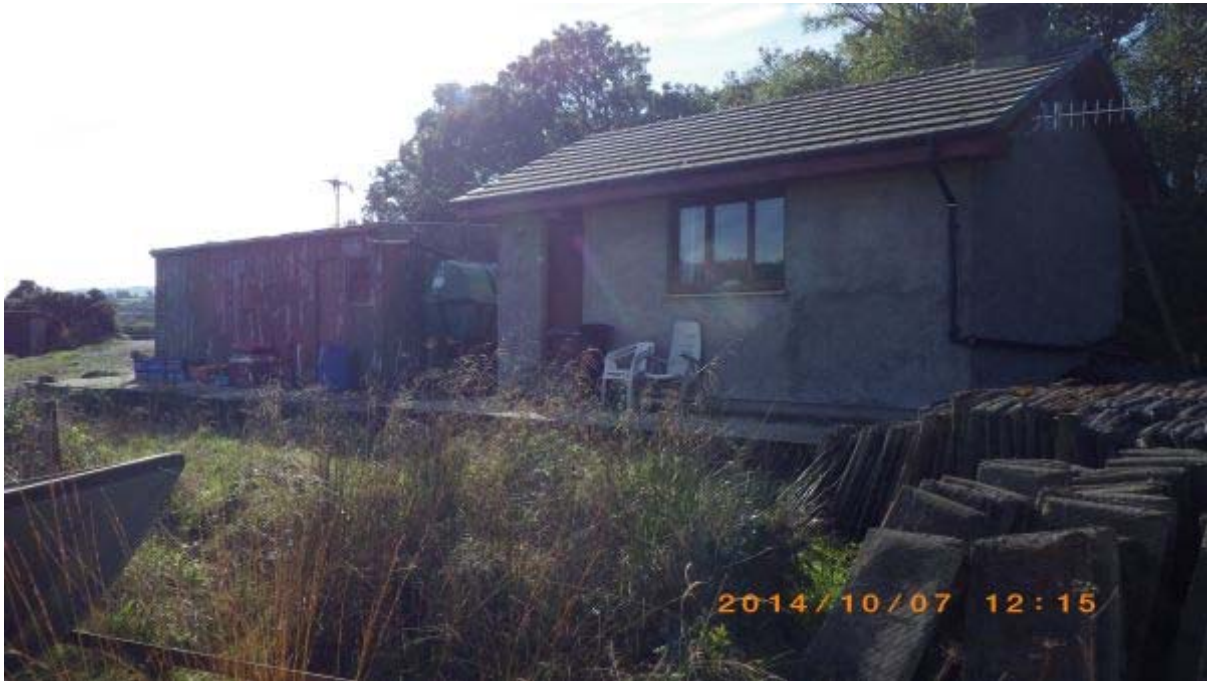
Figure 9. Ardencaple oysters shore base near Loch Caithlim outlet. Waypoint 34.

The Seil Point fishery consists of Pacific oysters cultivated in plastic mesh bags on one metre high steel trestles. There were two sites observed: the Ardencaple-Cyster site consisting of ‘west bay’ (north of Ardfad Castle, Fig. 5) and Poll a’ Bhrochain (Fig. 6) and the Ardencaple – Cadzow site located in a smaller, unnamed bay to the east with the house of Camuslaich at its head (Fig. 12). Currently there is no stock at the west bay or Camuslaich. The Poll a’ Bhrochain array consists of five trestle groups (banks) oriented NW-SE within which the trestles are arranged in parallel rows oriented SW-NE (Fig. 6). There is a shore base beside the Ardencaple road at the head of the bay (Fig. 9) and the site is accessed by tractor at low spring tides.

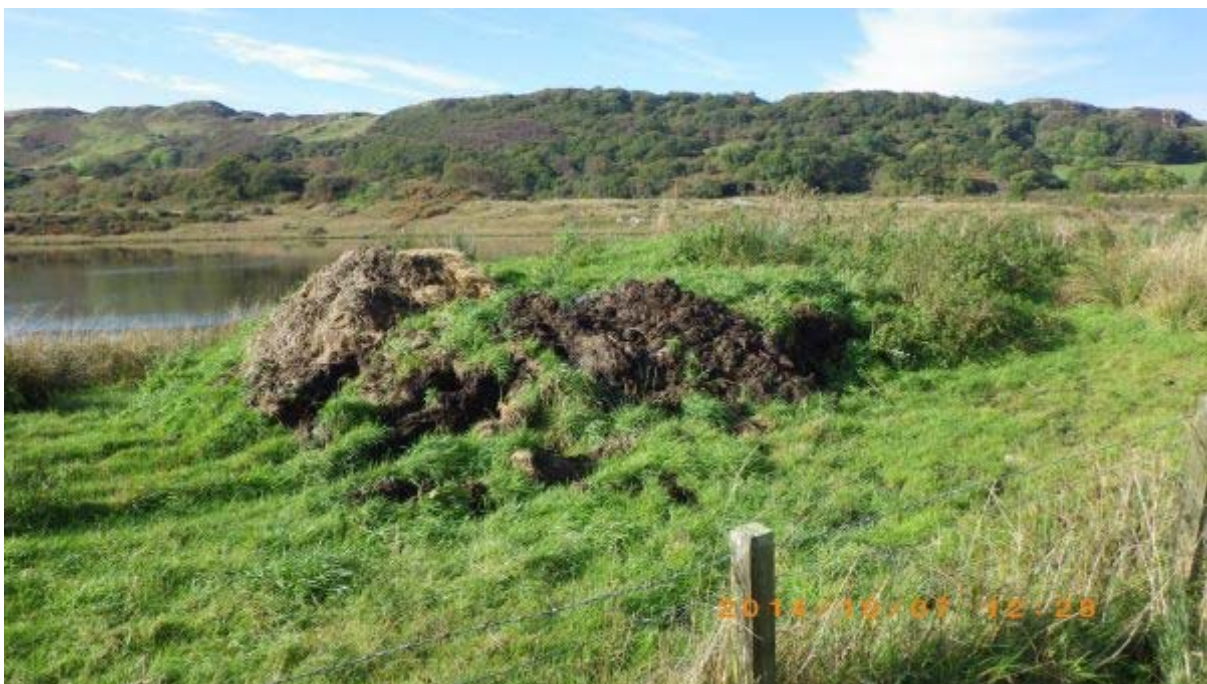
Figure 10. Cattle dung heap overlooking Loch Caithlim. Waypoint 37.

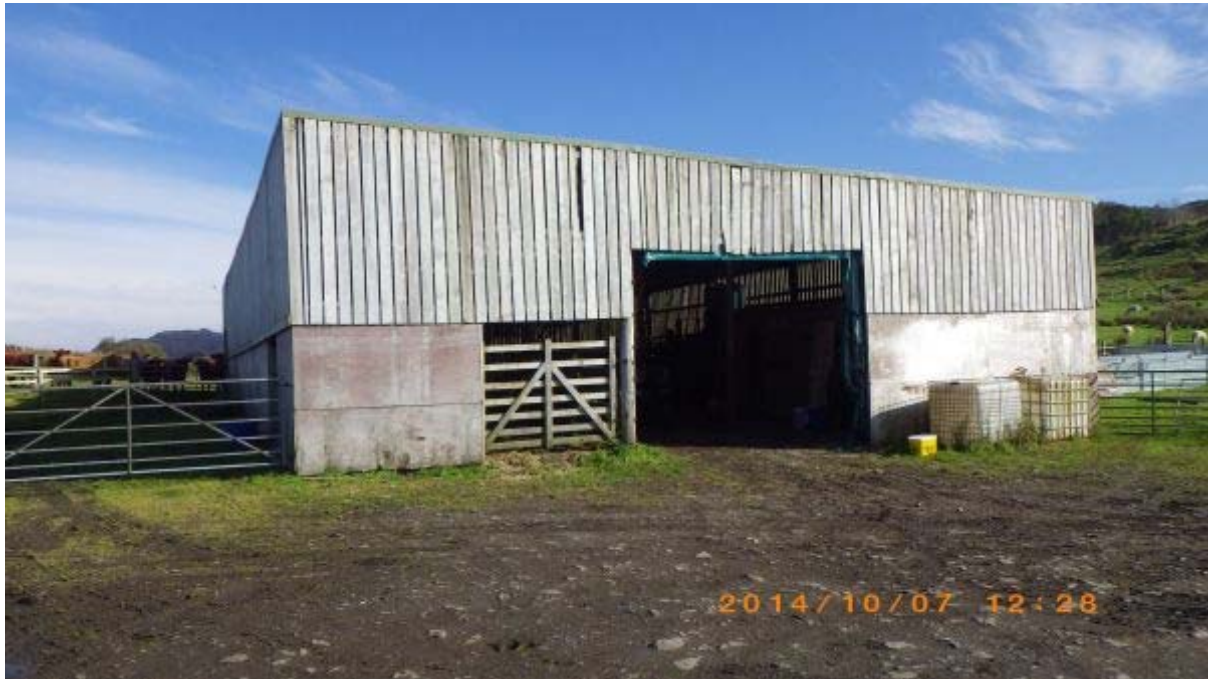
Figure 11. Cattle shed across the road from dung heap in Fig. 10. Waypoint 37.

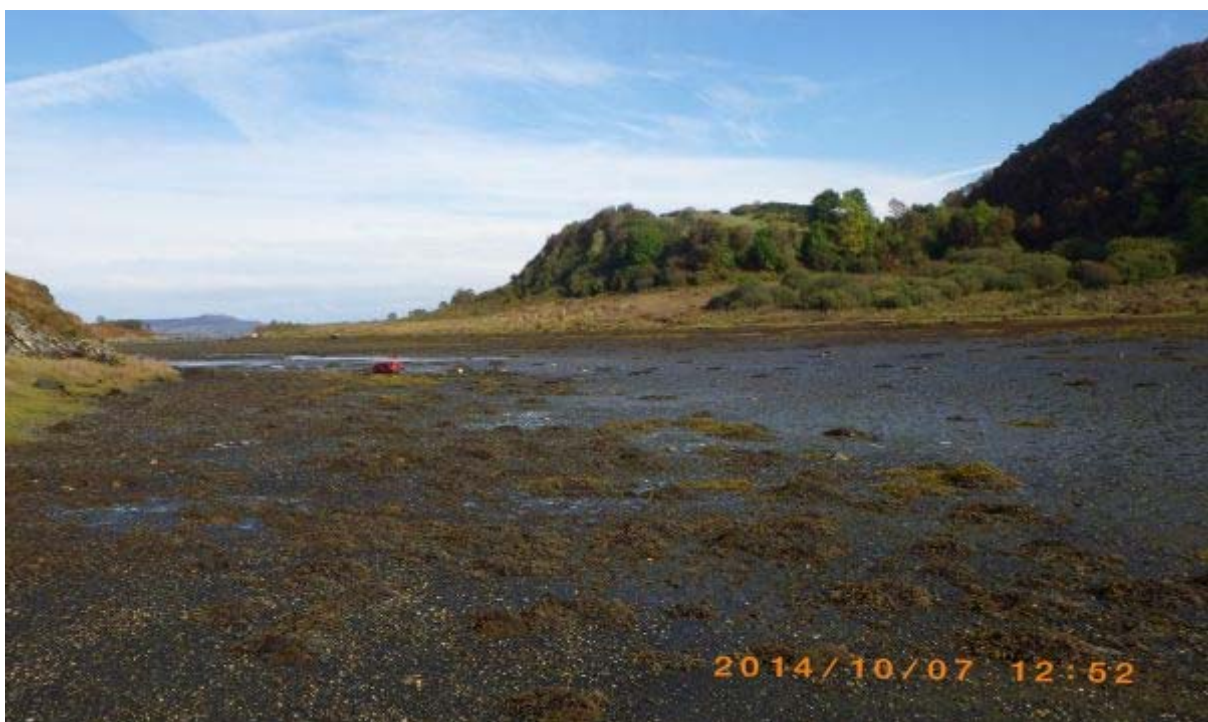
Figure 12. Camuslaich Bay, Ardencaple-Cadzow site. Moored boat in distance (red boat). Disused former Cadzow trestles (Fig. 13) approximately above and slightly left of the red boat, distant. Waypoint 12.

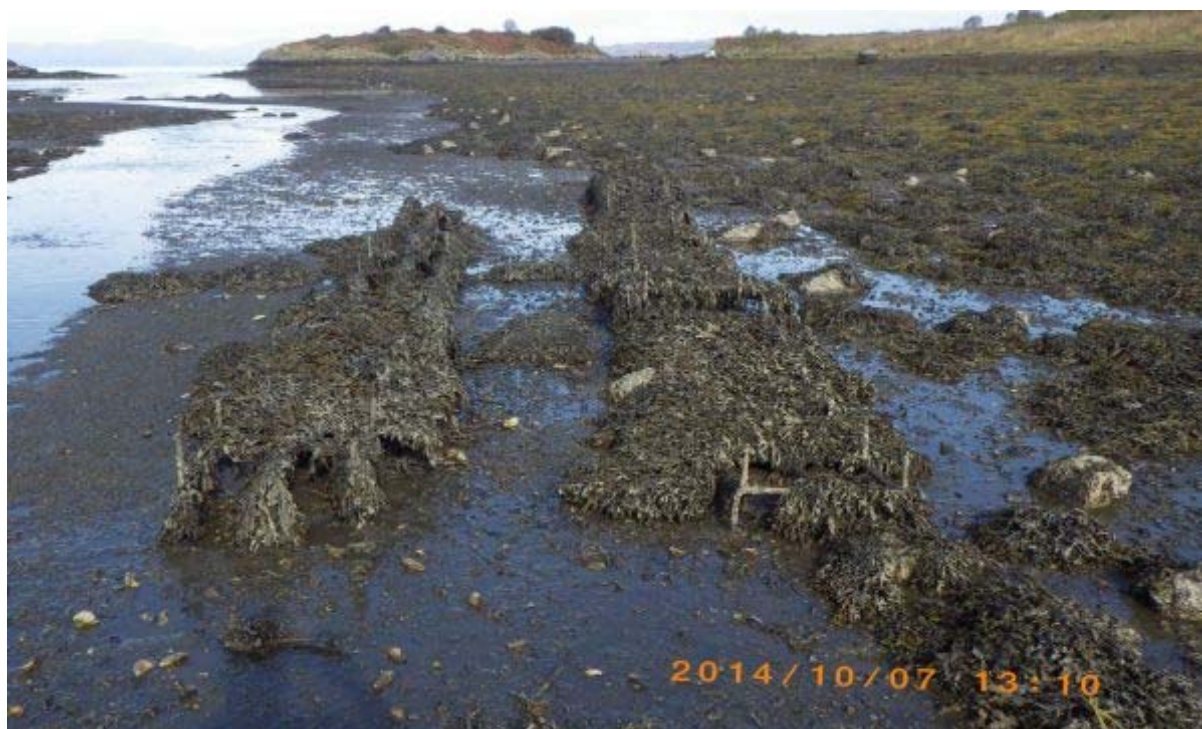
Figure 13. Disused former Ardencaple-Cadzow trestles, Camuslaich Bay. Waypoint 44.
