Scottish Sanitary Survey Project

Sanitary Survey Report
South Voe SI 421
South of Houss Holm SI 261
April 2009

Shoreline Survey Report

South Voe SI 421
and
South of Houss Holm SI 261

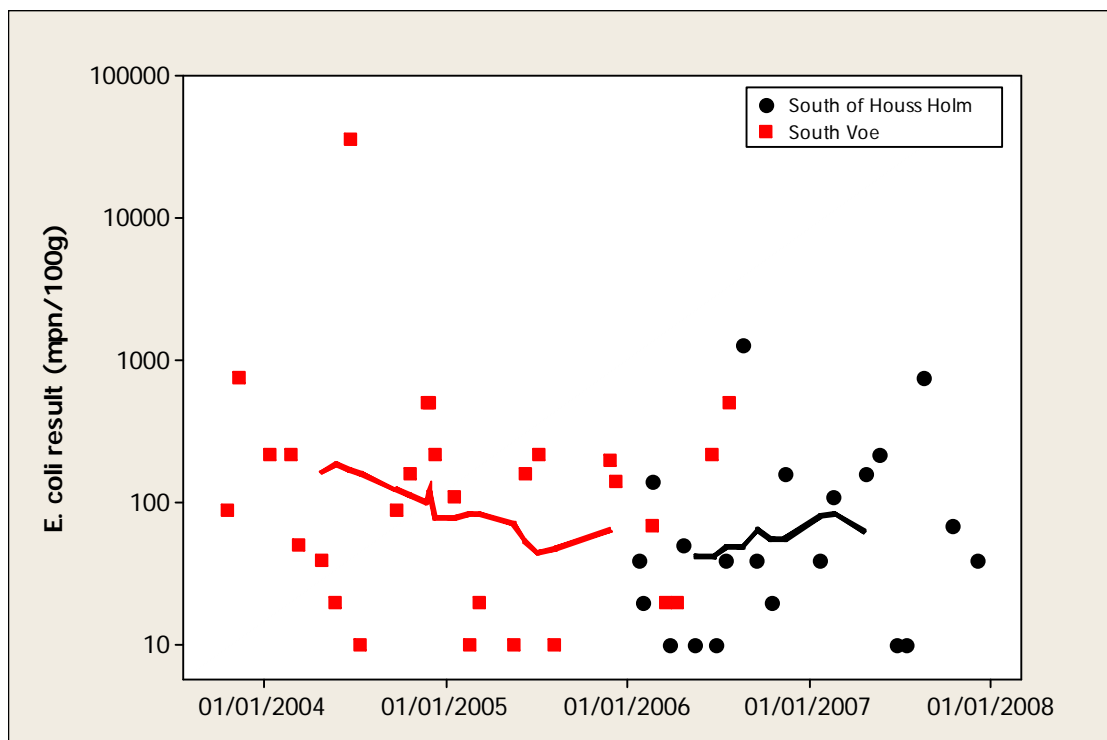
Figure 11.3 Scatterplot of oyster results by production area and by date with rolling geometric mean

No particular trends or cycles are apparent in Figures 11.3 or 11.4.

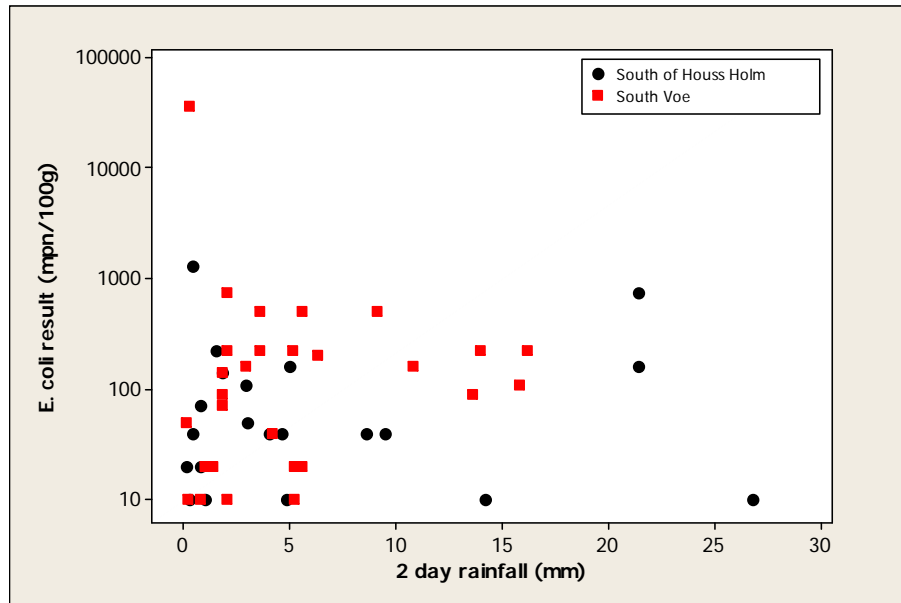
Figure 11.12 Scatterplot of result against rainfall in previous 2 days (oysters)

No correlation was found between the *E. coli* result and the rainfall in the previous two days either for South Voe oysters (Spearman's Rank correlation=0.306, $p=0.113$, Appendix 6) or for South of Houss Holm oysters (Spearman's Rank correlation=0.042, $p=0.857$, Appendix 6).

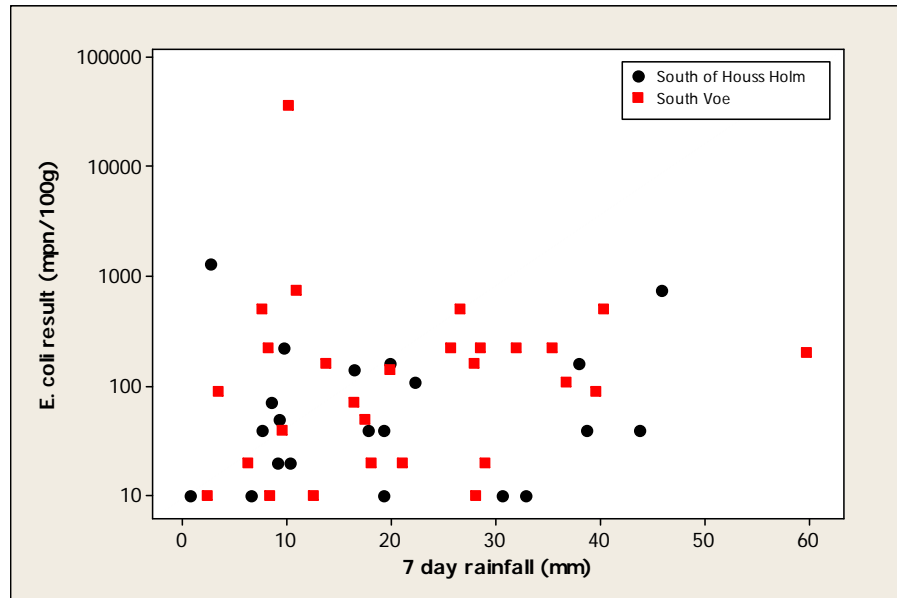
Figure 11.14 Scatterplot of result against rainfall in previous 7 days (oysters)

No correlation was found between the *E. coli* result and the rainfall in the previous seven days either for South Voe oysters (Spearman's Rank correlation=0.217, $p=0.267$, Appendix 6) or for South of Houss Holm oysters (Spearman's Rank correlation=0.114, $p=0.623$, Appendix 6).

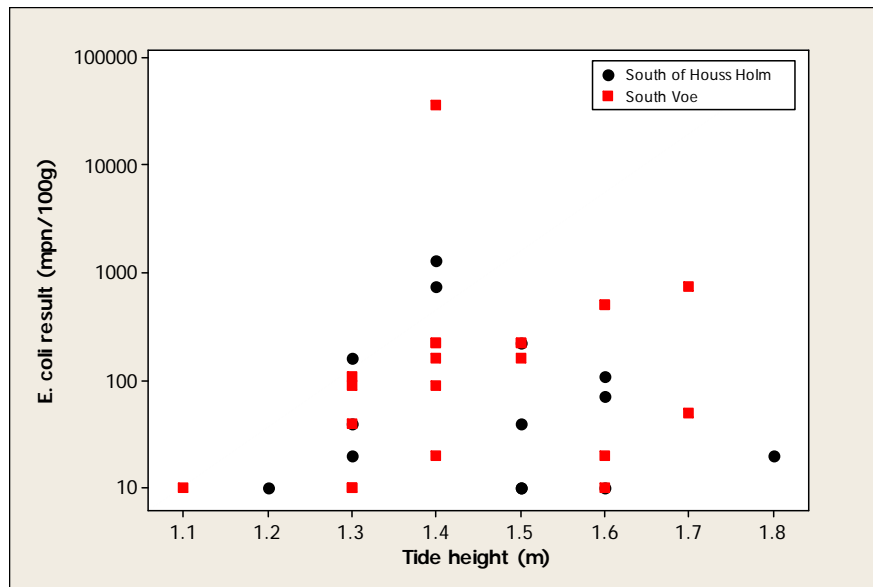
Figure 11.16 Scatterplot of result by tide height (oysters)

The coefficient of determination indicates that there was no relationship between the *E. coli* result and predicted height of the previous tide for oysters at either South Voe (Adjusted R-sq=3.0%, p=0.218, Appendix 6) or South of Houss Holm (Adjusted R-sq=0.0%, p=0.682, Appendix 6).

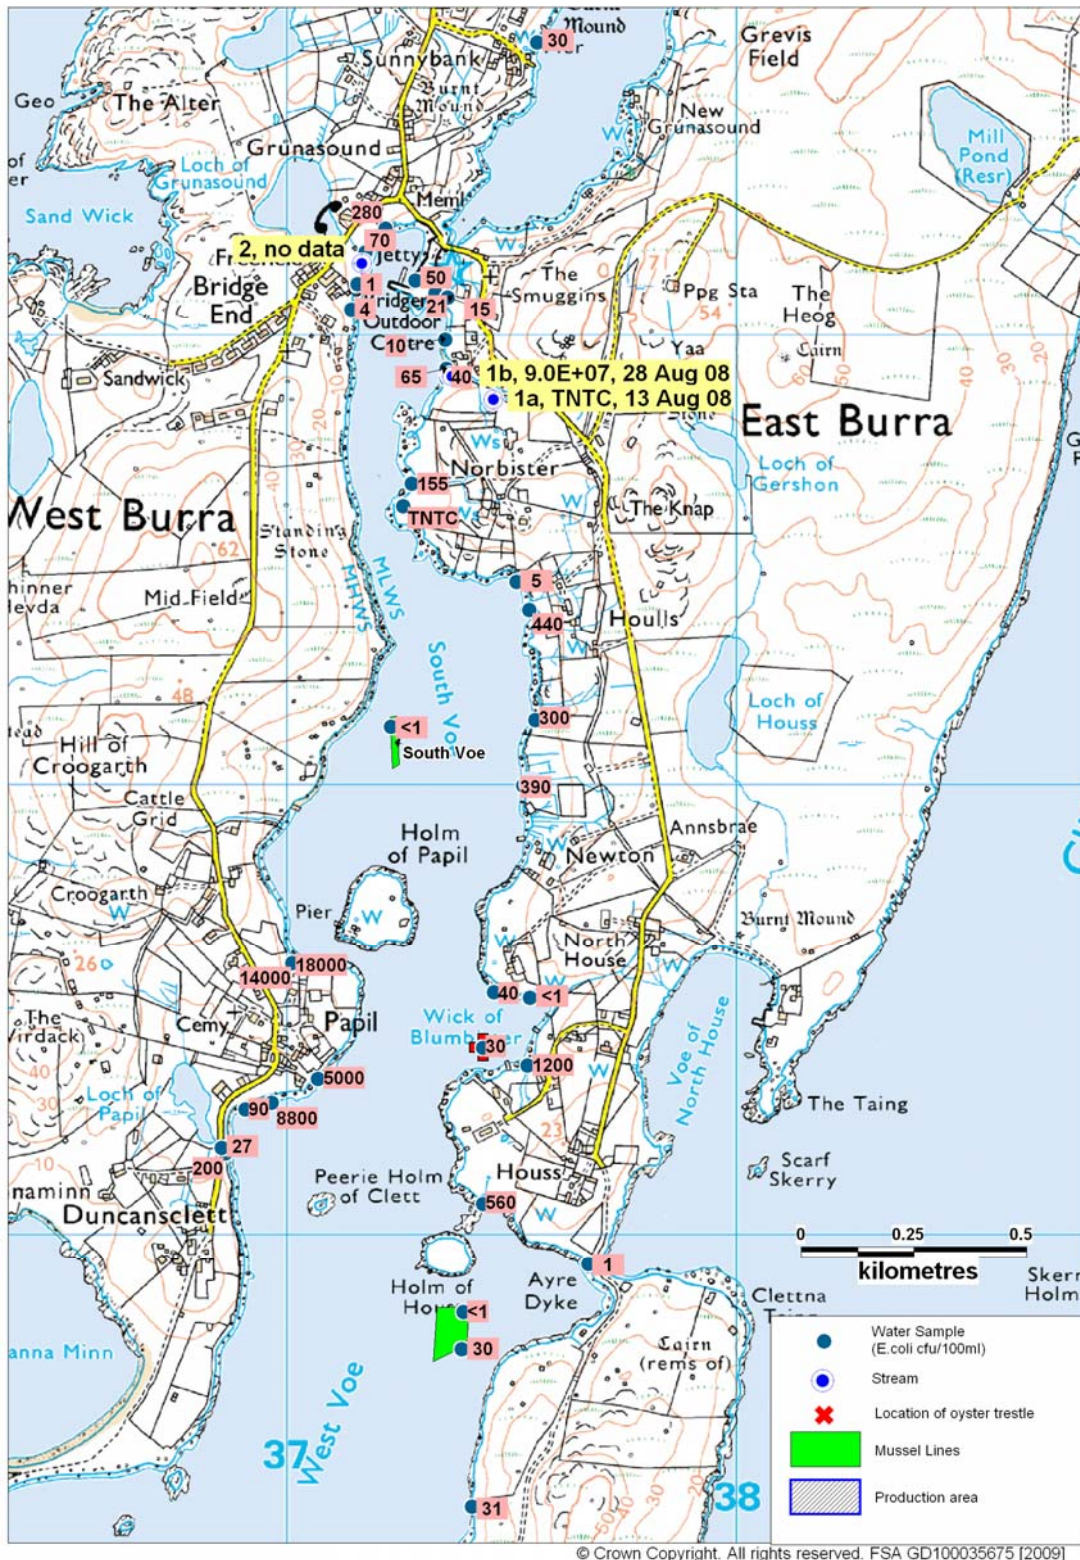
Figure 13.1 Streams and seawater samples at South Voe

Freshwater flow, and hence the amount of contaminated surface runoff, is anticipated to be higher in winter when more rainfall is recorded though episodes of contamination may occur after a heavy rainfall at any time of year.

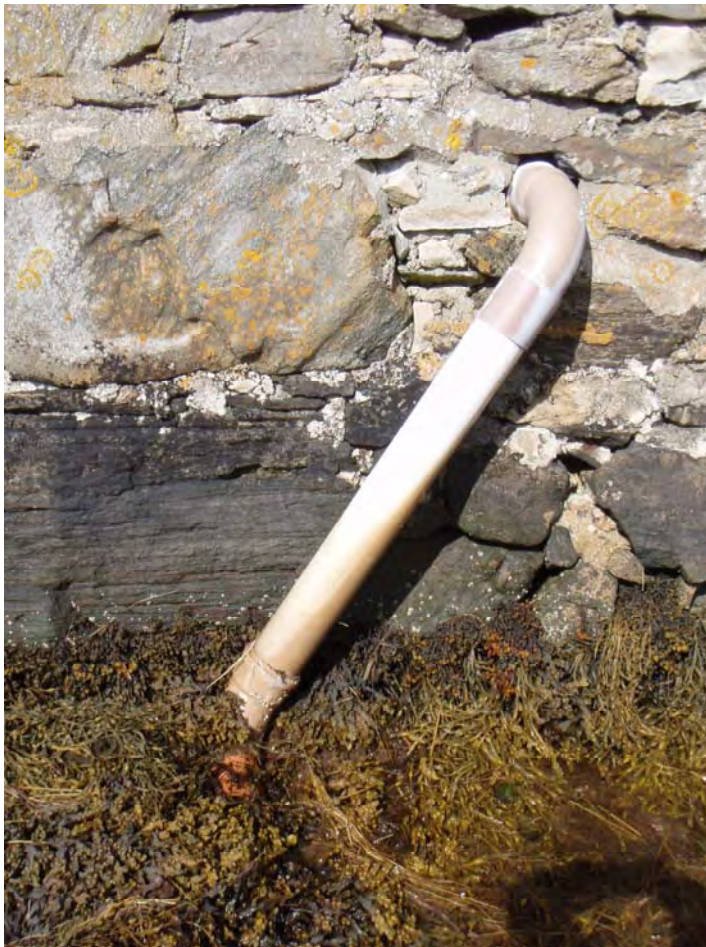
Figure 11. Discharge pipe behind toilet block.

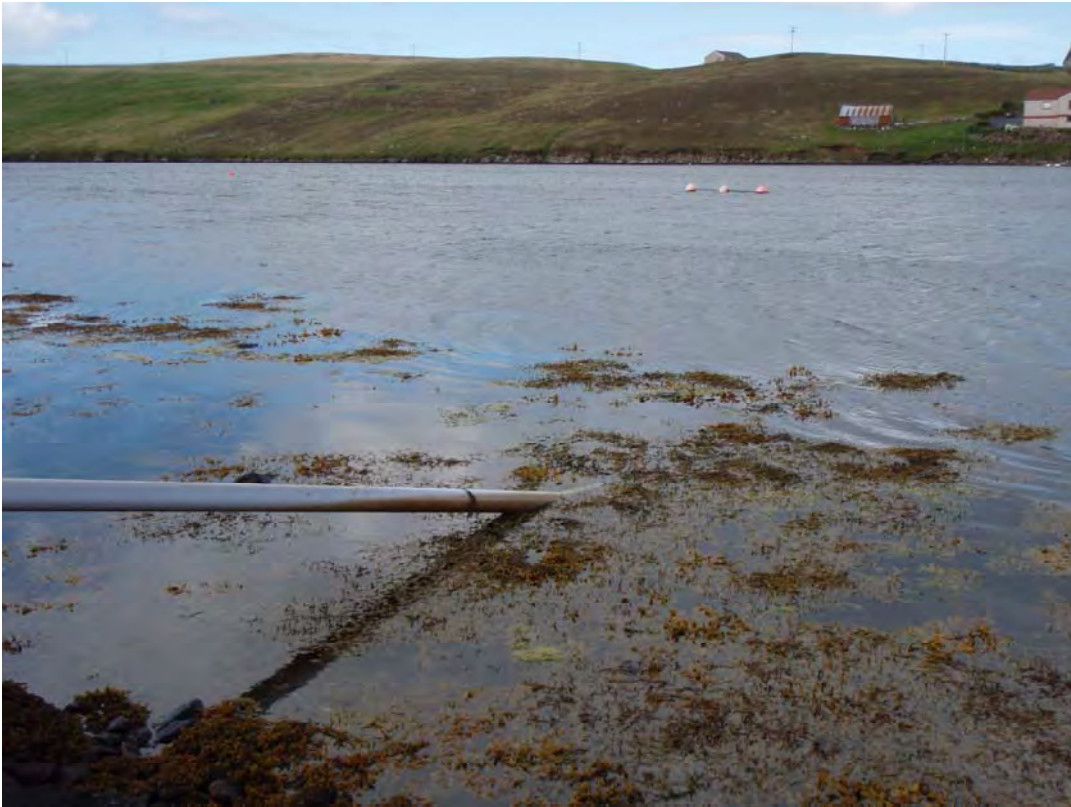
Figure 16. Septic pipe from house, waypoint 37.

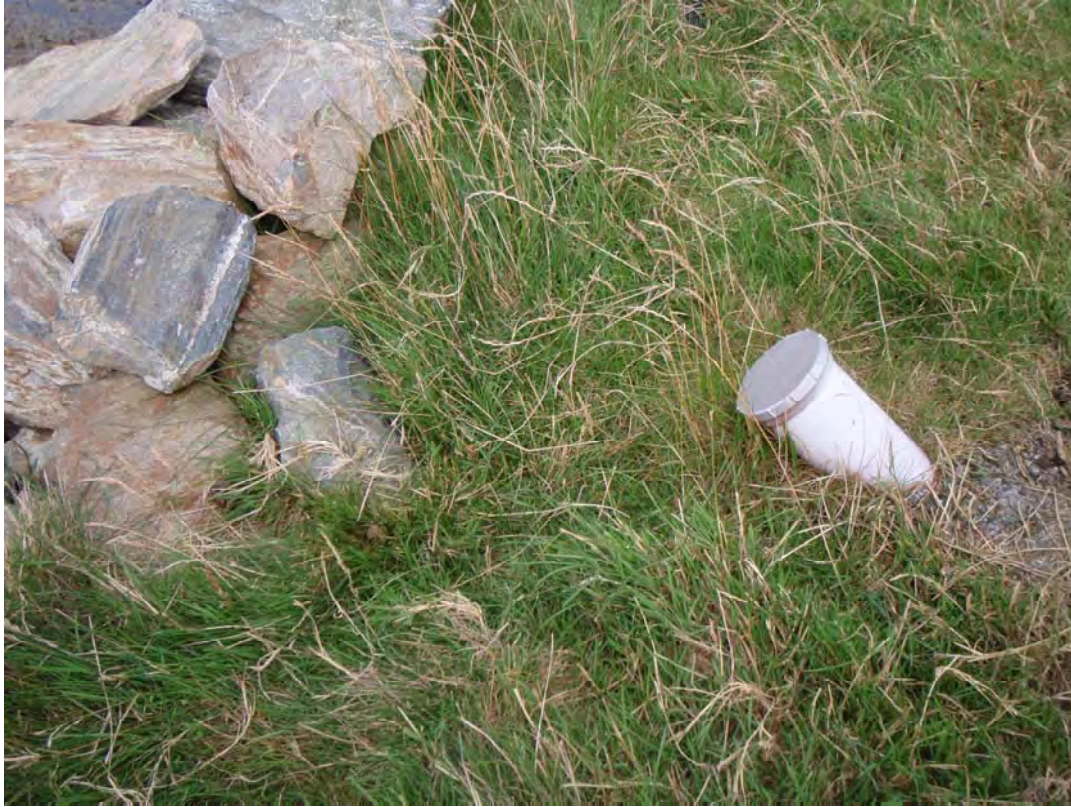
Figure 18. Septic tank inspection pipe.

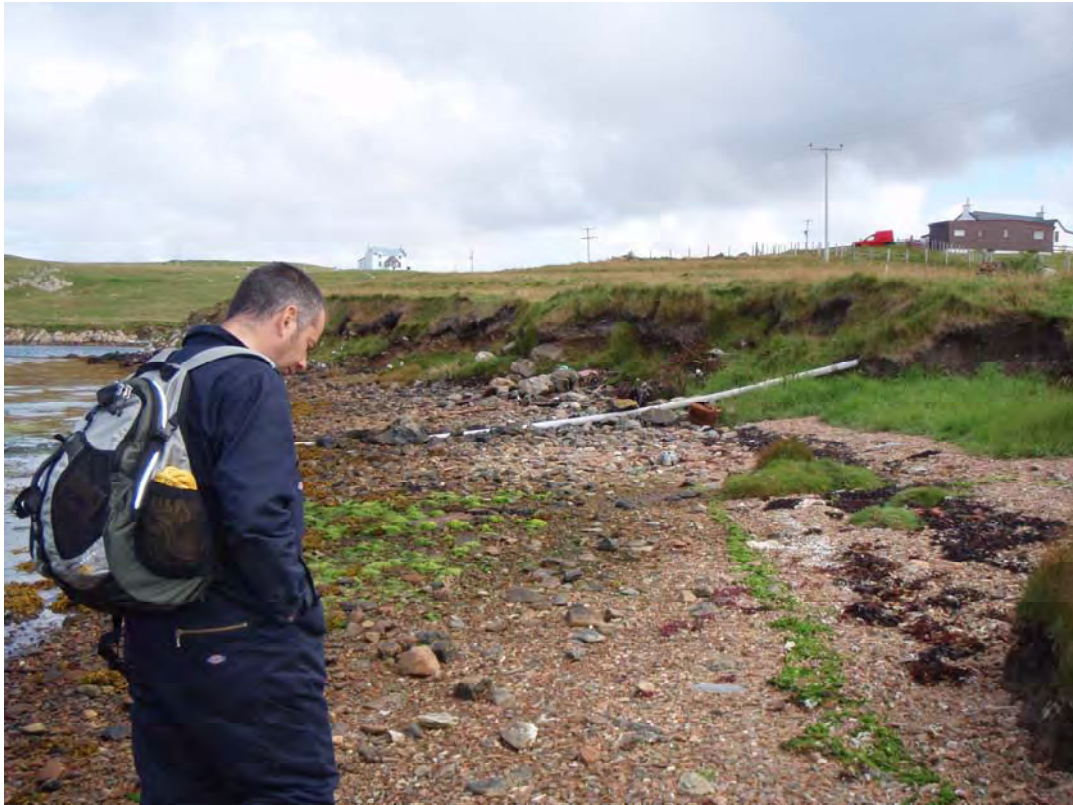
Figure 20. Discharge pipe from home on shore near oyster raft.

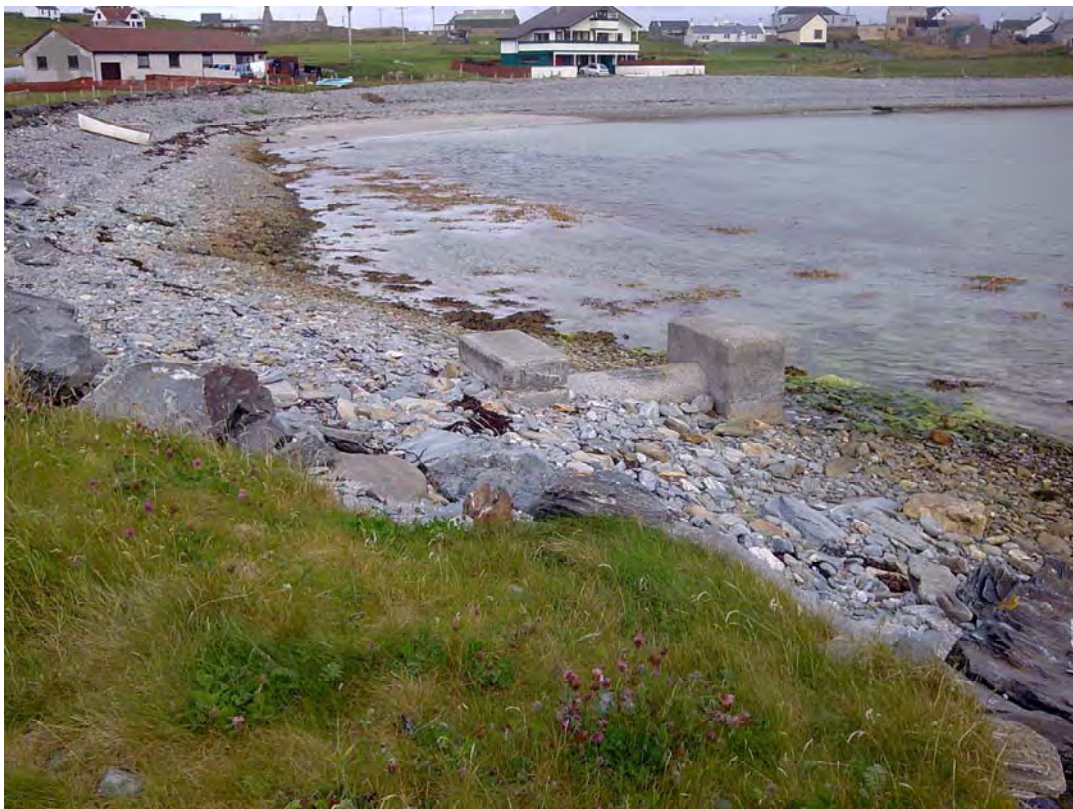
Figure 21. Outfall from freshwater loch, green scum on shoreline.

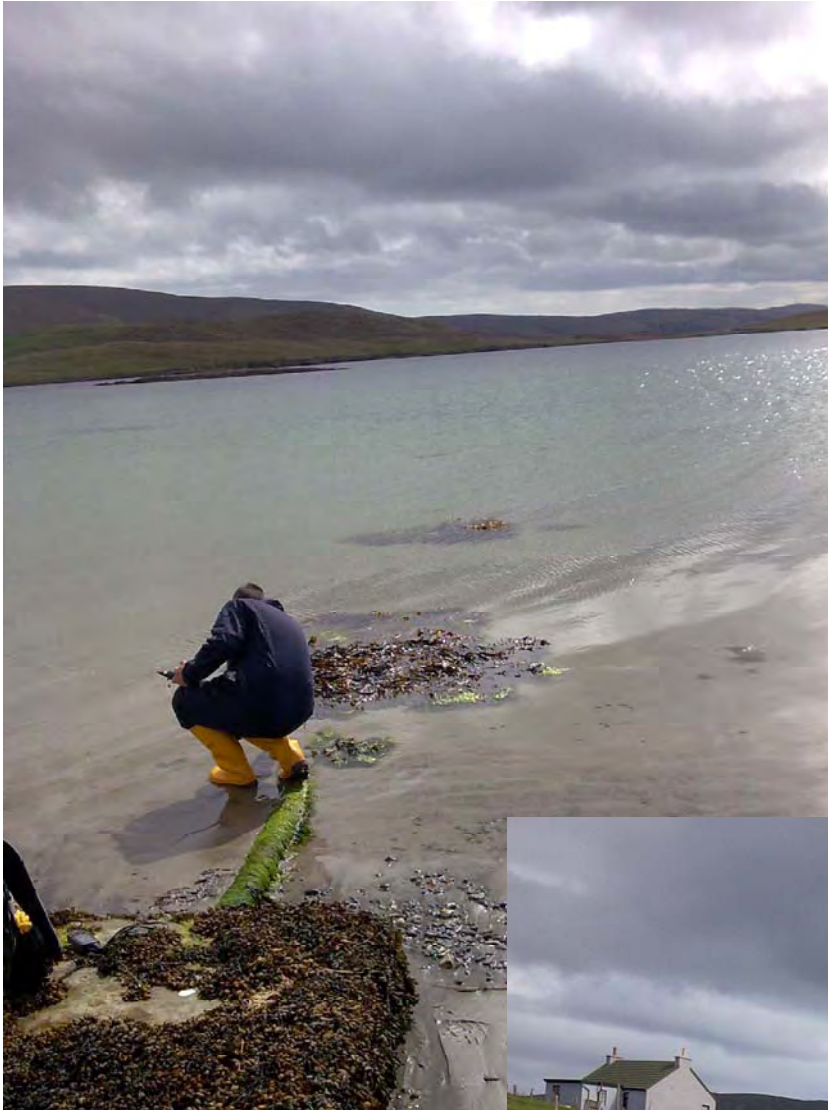
Figure 22. Discharge pipe, waypoint 97.

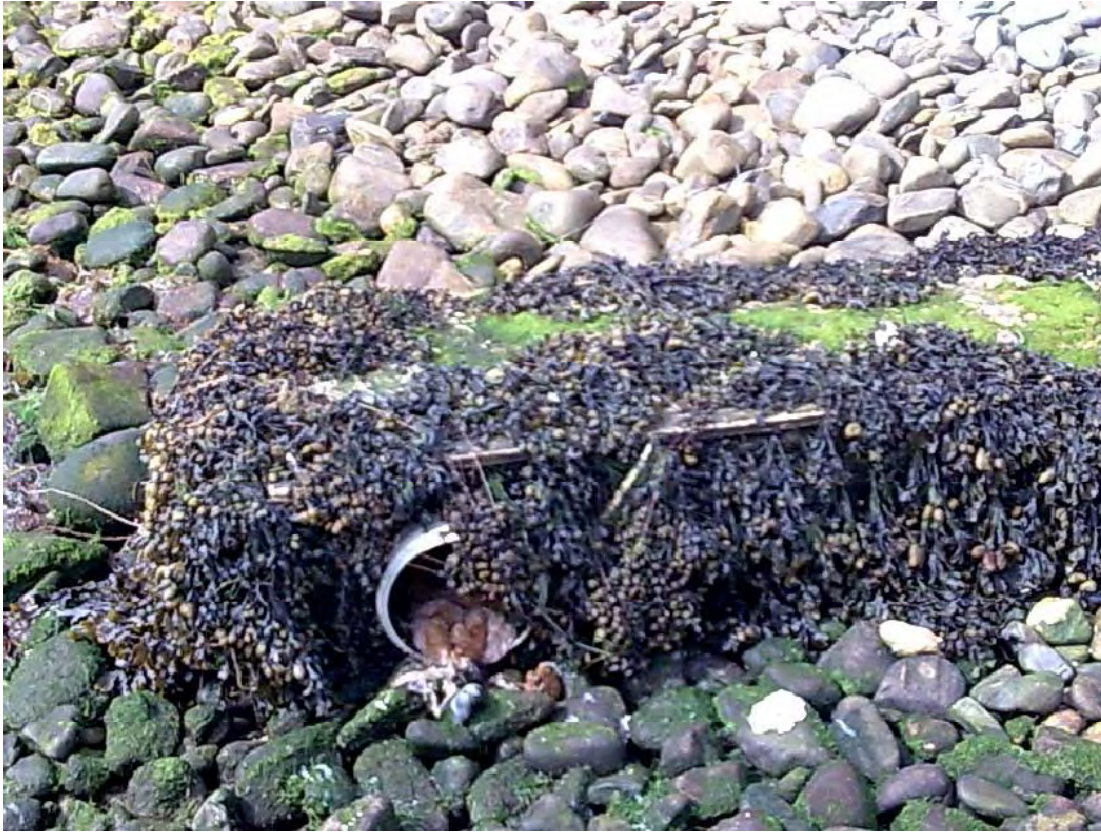
Figure 24. Outfall with solid waste evident, waypoint 99.

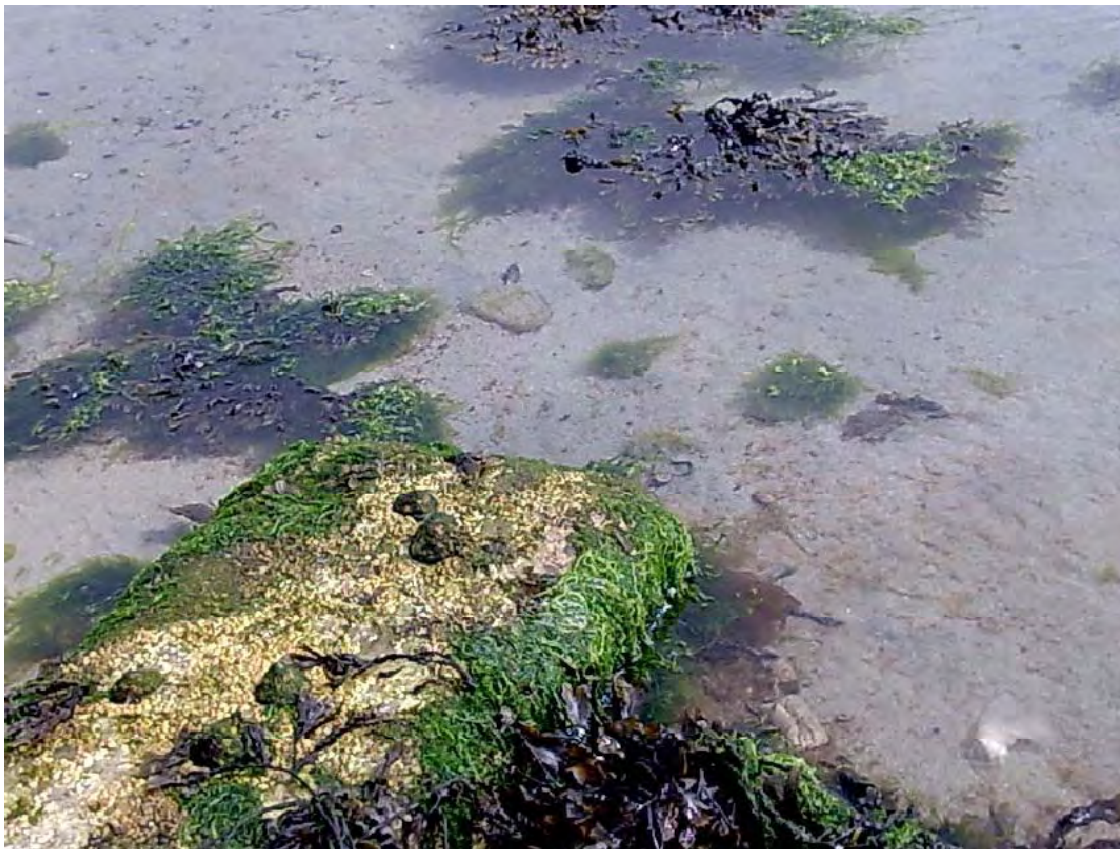
Figure 25. Outfall with grey discharge plume.

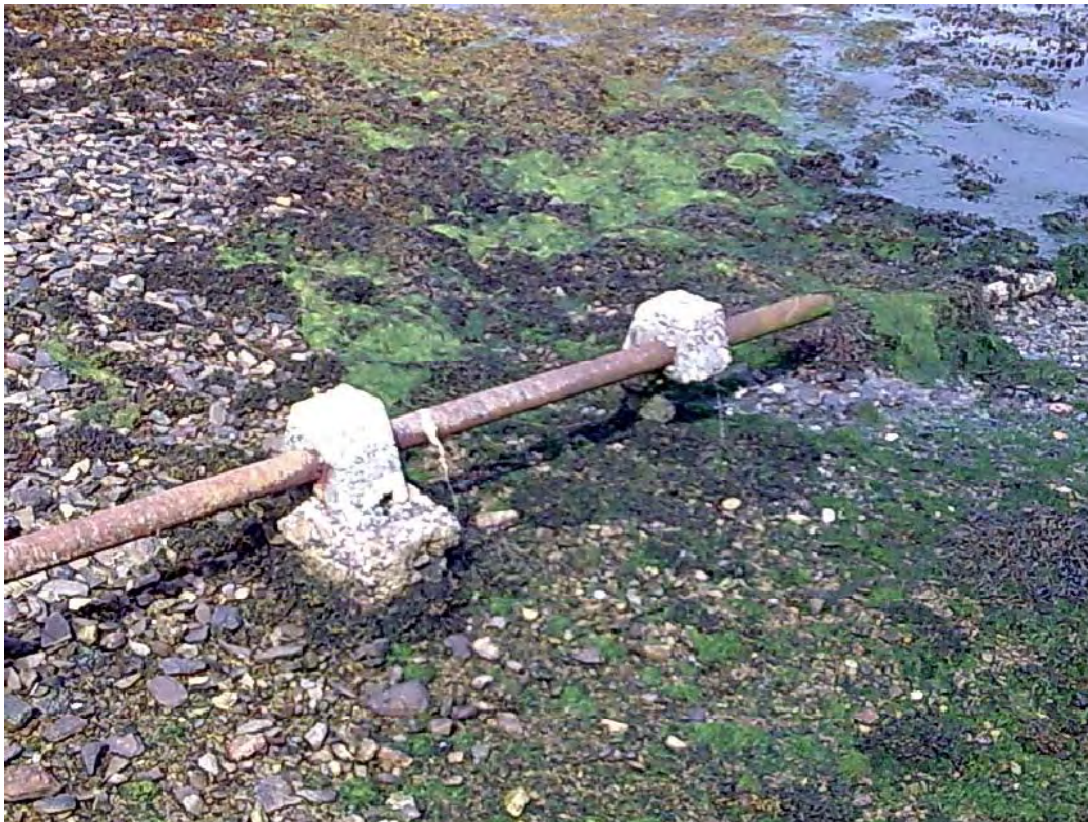
Many properties in the area appeared to have private septic tanks discharging to South Voe and West Voe that were in varying condition. There were raw outfalls noted adjacent to the pier north of Papil.

Figure 27. Discharge pipe adjacent pier, dribbling from end.
