Sanitary Survey Report Stromness Voe SI-273 and New Site November 2013

| Report Title | Stromness Voe Sanitary Survey Report |
| Project Name | Scottish Sanitary Survey |
| Document Number | C5792C_2013_11 |

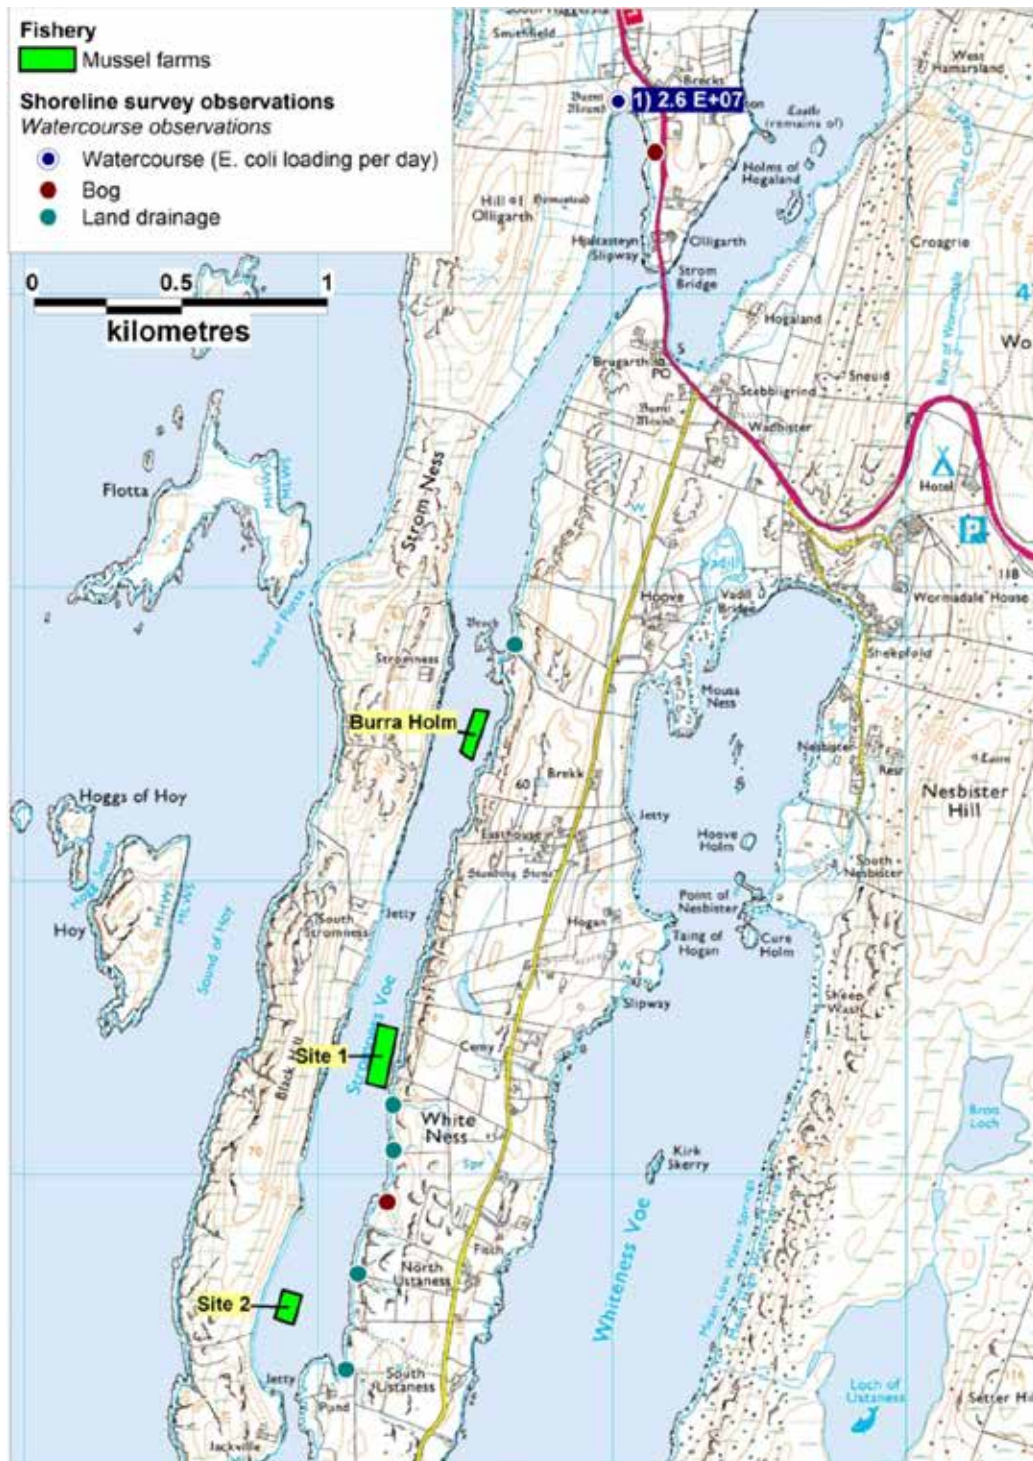
Figure 8.1 Map of watercourse loadings at Stromness Voe

The shoreline survey was conducted on the 5th August 2013 under mainly dry weather conditions, though some light showers were recorded in the 24 hr prior to the survey. Only one watercourse could be measured and sampled during the survey. Details of this watercourse are shown below in Table 8.1. The remaining five observed watercourses had insufficient flow to measure and therefore are not included in the table. Two areas of bog were also recorded. The above features are shown in the map in Figure 8.1.

The majority of the land drainage areas were observed to the southern end of Stromness Voe. These are closer to the Sites 1 and 2, with two areas noted < 250 m south of Site 1 and two areas within < 250 m of Site 2. One area of land drainage was also noted < 250 m north of the Burra Holm site. Two bogs were also noted, one at the head of Stromness Voe, and the other to the south close to Sites 1 and 2.

Overall, it is not expected that freshwater sources will have a significant impact on the extent of contamination of the mussel fisheries at Stromness Voe. Due to the dry weather that was experienced prior to and on the day of survey, it is expected that during or following periods of higher rainfall, the areas of land drainage that were observed during the survey will enter into the voe and may represent additional potential sources of faecal contamination. Freshwater contamination is expected to be greatest at Site 1, where one of the potential sources is close to the southeast end of the mussel farm. Inputs to the Loch of Strom have not been considered due to the distance from the mussel farms.

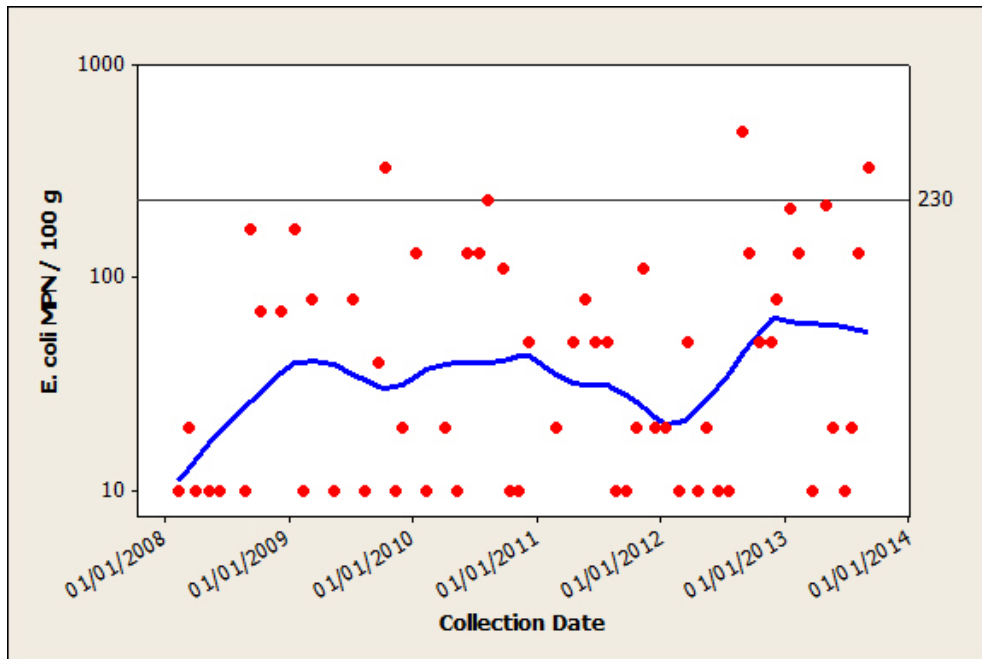
Figure 11.2 Scatterplot of *E. coli* results by collection date at Stromness Voe, fitted with a lowess line

A scatterplot of *E. coli* results against date for Stromness Voe is presented in Figure 11.2. The dataset is fitted with a lowess trend line. Lowess trendlines allow for locally weighted regression scatter plot smoothing. At each point in the dataset an estimated value is fitted to a subset of the data, using weighted least squares. The approach gives more weight to points near to the x-value where the estimate is being made and less weight to points further away. In terms of the monitoring data, this means that any point on the lowess line is influenced more by the data close to it (in time) and less by the data further away. A trend line helps to highlight any apparent underlying trends or cycles.

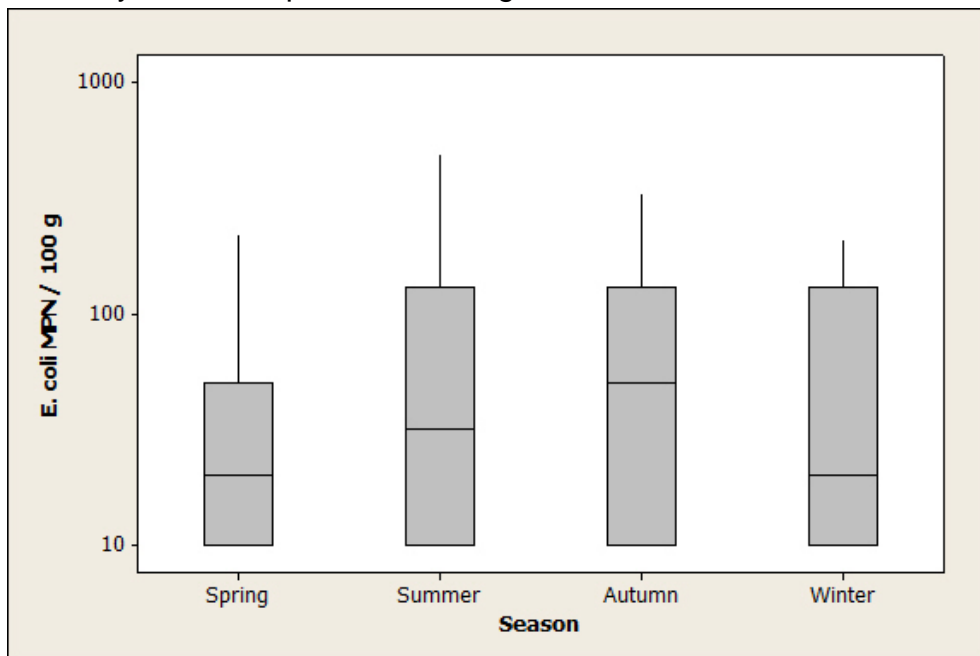
Figure 11.4 Boxplot of *E. coli* results by season at Stromness Voe

No significant difference was found between *E. coli* results by season (one-way ANOVA, $p = 0.410$, Appendix 4).

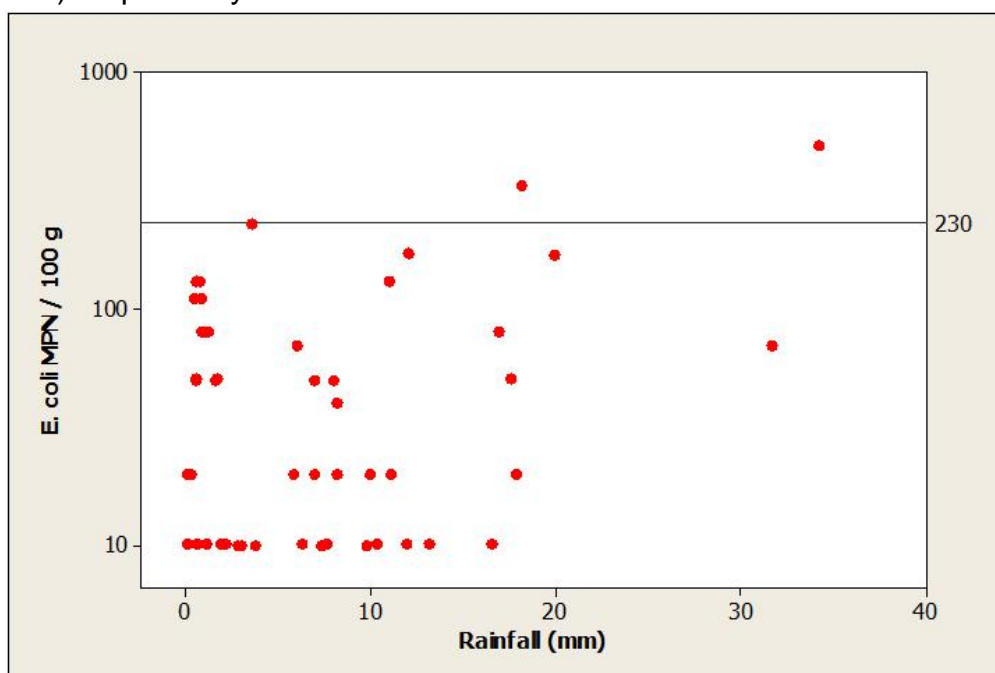
Figure 11.5 Scatterplot of *E. coli* results against rainfall in the previous two days at Stromness Voe

No significant correlation was found between *E. coli* results and the previous two day rainfall (Spearman's rank correlation $r = 0.099$, $p = 0.487$), though the highest result of 490 *E. coli* MPN / 100 g taken at the highest rainfall value.

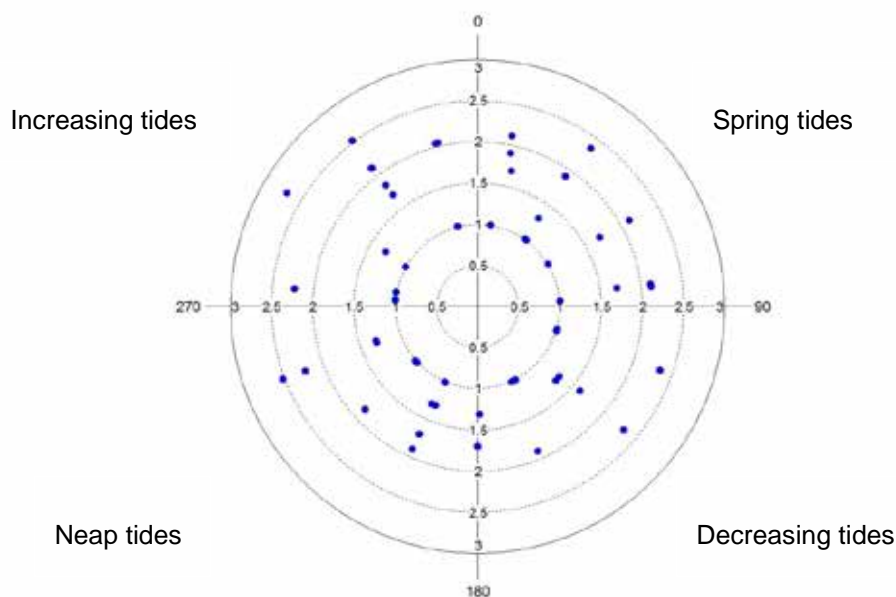
Figure 11.7 Polar plots of Log_{10} *E. coli* results on the spring/neap tidal cycle at Stromness Voe

A significant correlation was found between log_{10} *E. coli* results and the spring/neap tidal cycle (circular-linear correlation $r = 0.267$, $p = 0.016$), highest results were taken on increasing tides.

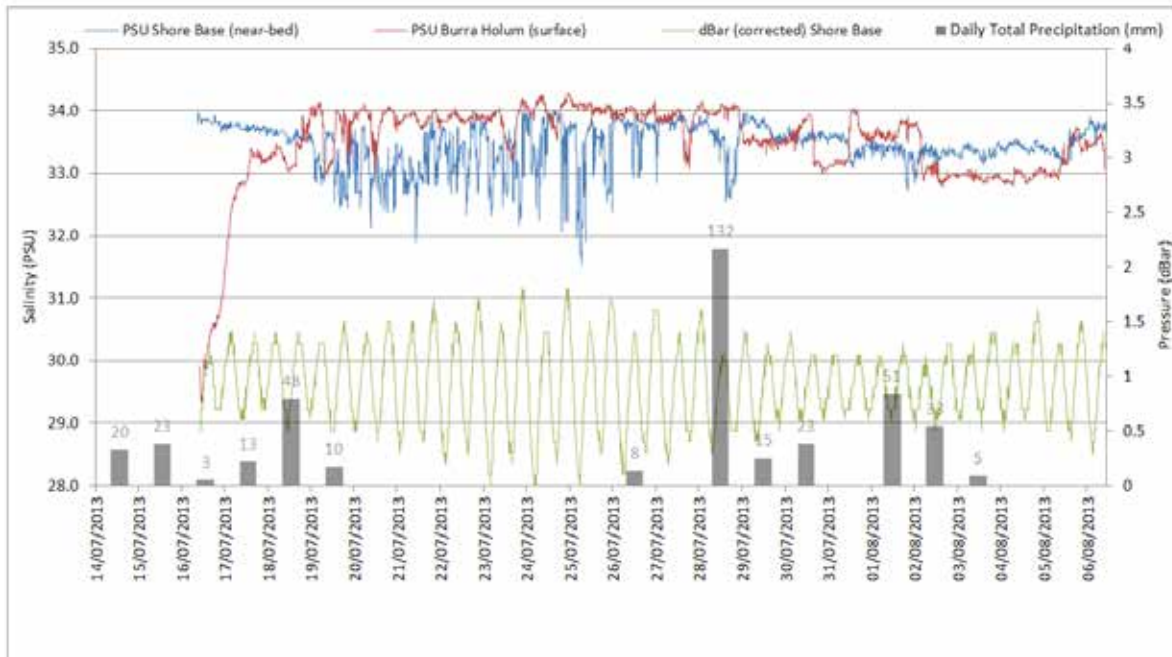
Two Star-Oddi DST CDT loggers (accuracy ± 1 psu) were deployed in Stromness Voe for the 21 days prior to the shoreline survey, one at the seabed at the shore base close to the entrance to the voe to characterise the tidal cycle and variation in salinity close to the seabed and the second attached to the lines at the Burra Holm fishery at 1 metre below the sea surface to characterise near surface salinity patterns (Figure 13.6). When the accuracy of the instrument is considered the values must be reported to zero decimal places. While the actual salinity may be within ± 1 psu of the value recorded by the instrument, as both instruments were calibrated prior to the initiation of data collection it remains possible to have confidence that the spatial and temporal patterns evident in the raw data correspond to actual patterns in the voe.

Figure 13.6 Salinity readings at the Stromness Voe shore base and Burra Holm fisheries relative to tide height, including total daily precipitation at Gulberwick.

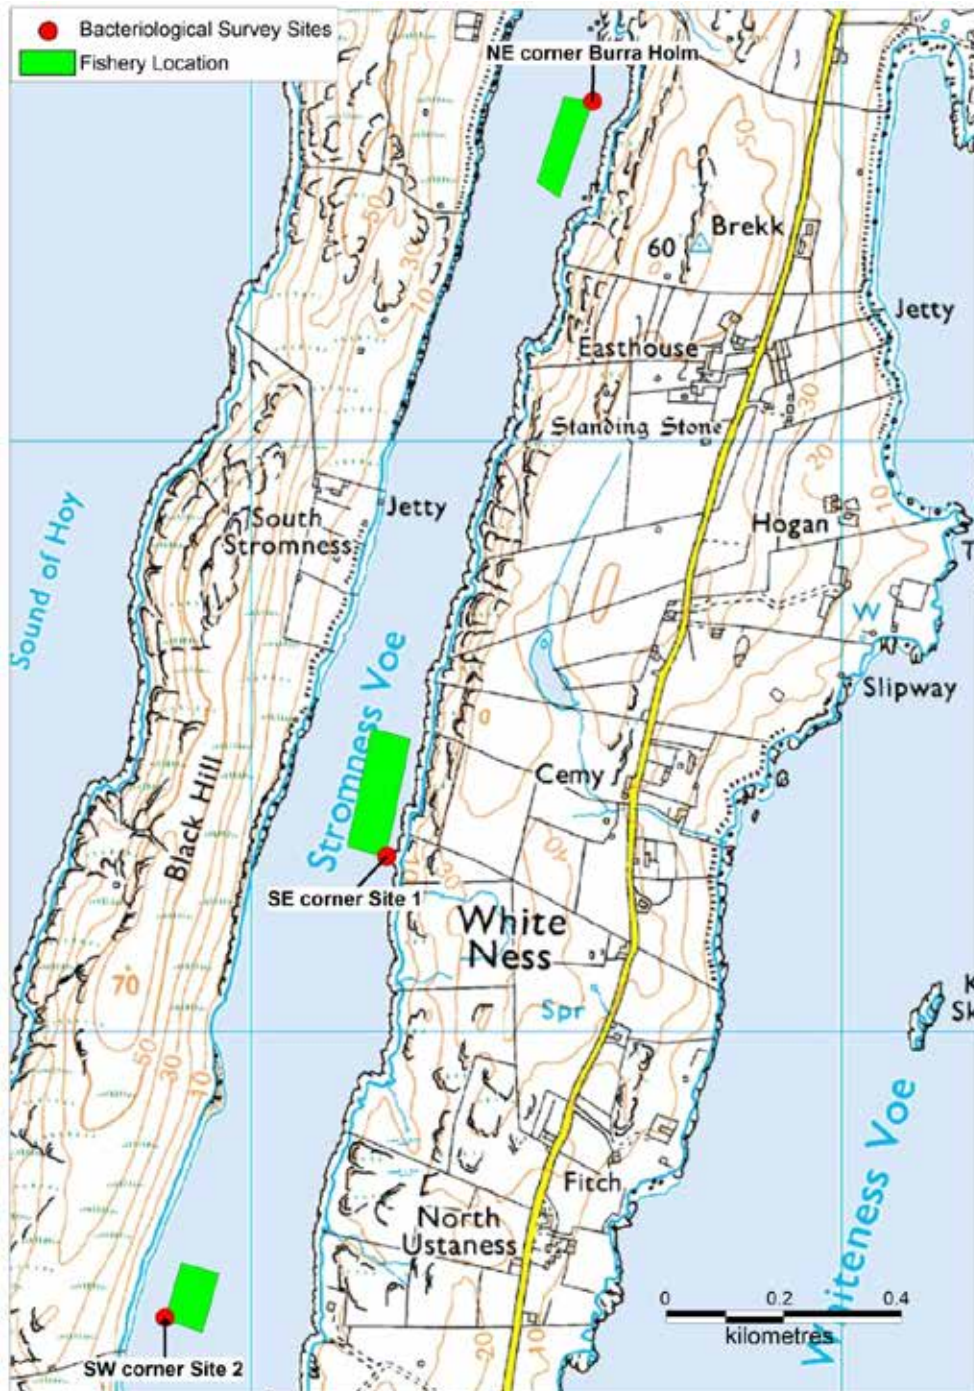
Figure 14.1 Bacteriological Survey Site Locations

Due to the limited spatial distribution of historic *E. coli* samples, it was decided a bacterial survey would be undertaken. Three locations were sampled at two different depths. The locations are shown in Figure 14.1 and the results are shown in Table 14.1. A summary of the data is presented in Table 14.2.

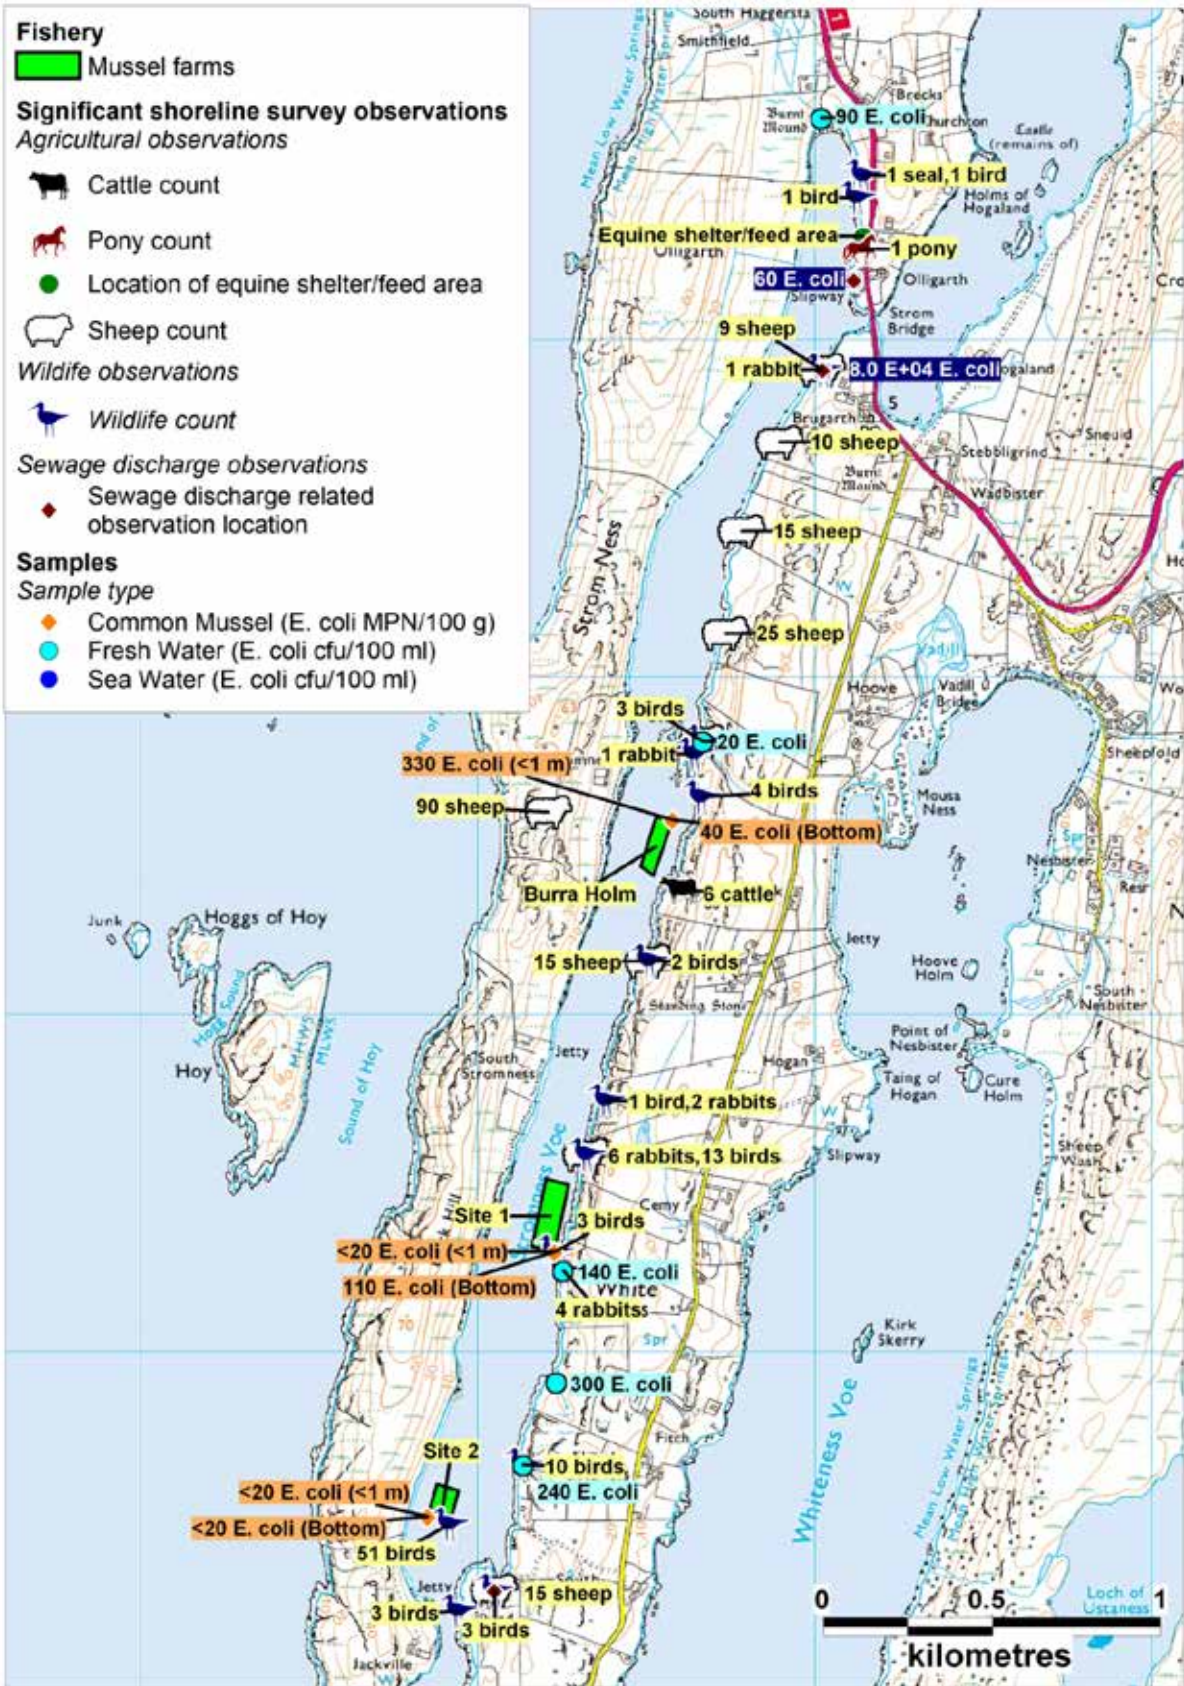
Figure 15.1 Principal shoreline survey observations at Stromness Voe

Birds were the most common wildlife species observed, and included curlew, a great skua, Arctic terns, gulls, collared doves and starlings. The majority were seen in flight, with some noted in the water. A cormorant was also seen on the buoys and ropes at Site 2, where a large amount of bird faeces was observed. Bird faeces were also present on buoys at Site 1 and Burra Holm farms. Fourteen rabbits were observed along the eastern shore, south of Strom Bridge, with rabbit holes noted in the hill just south of the Bridge. One seal was observed in the water at the head of the Voe.

Observations and results of samples from the shoreline survey are presented in figure 15.1 below.

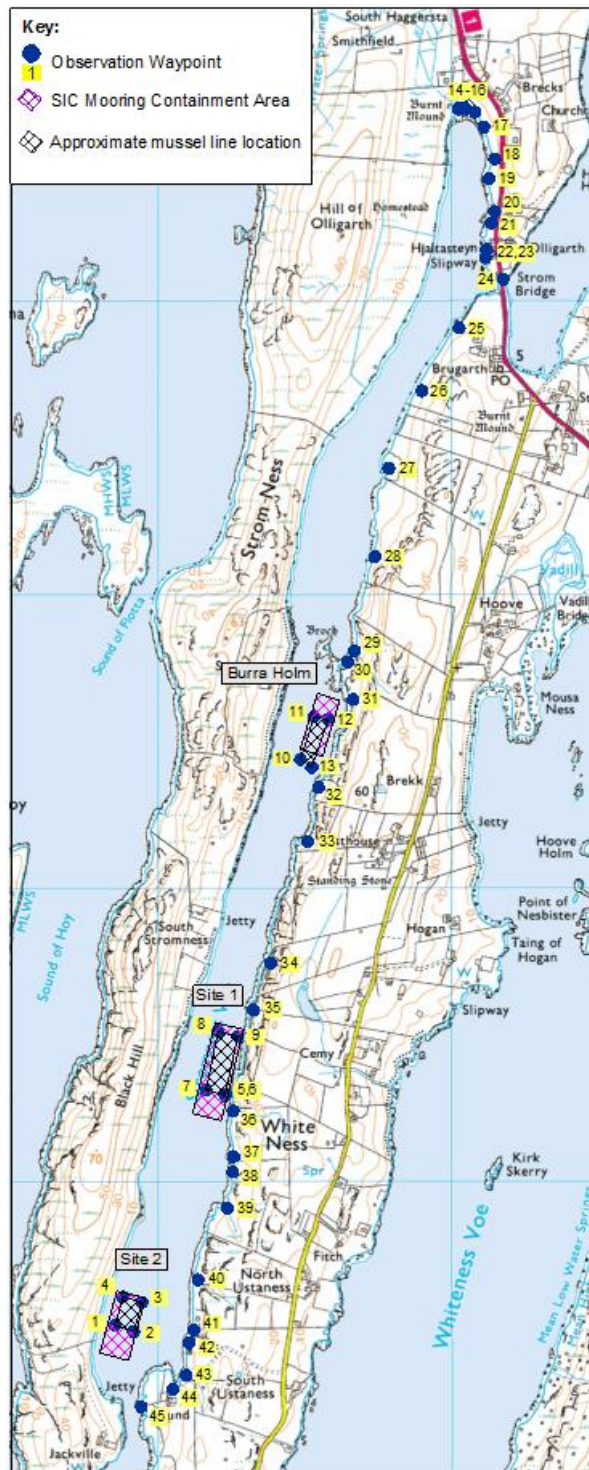
Figure 1 Map of shoreline observations

The location of the Burra Holm, Site 1 and Site 2 mussel lines are mapped in Figure 1. All fisheries had stocked mussel lines on site at the time of the survey. Harvesting was not occurring at any of the fisheries at this time.

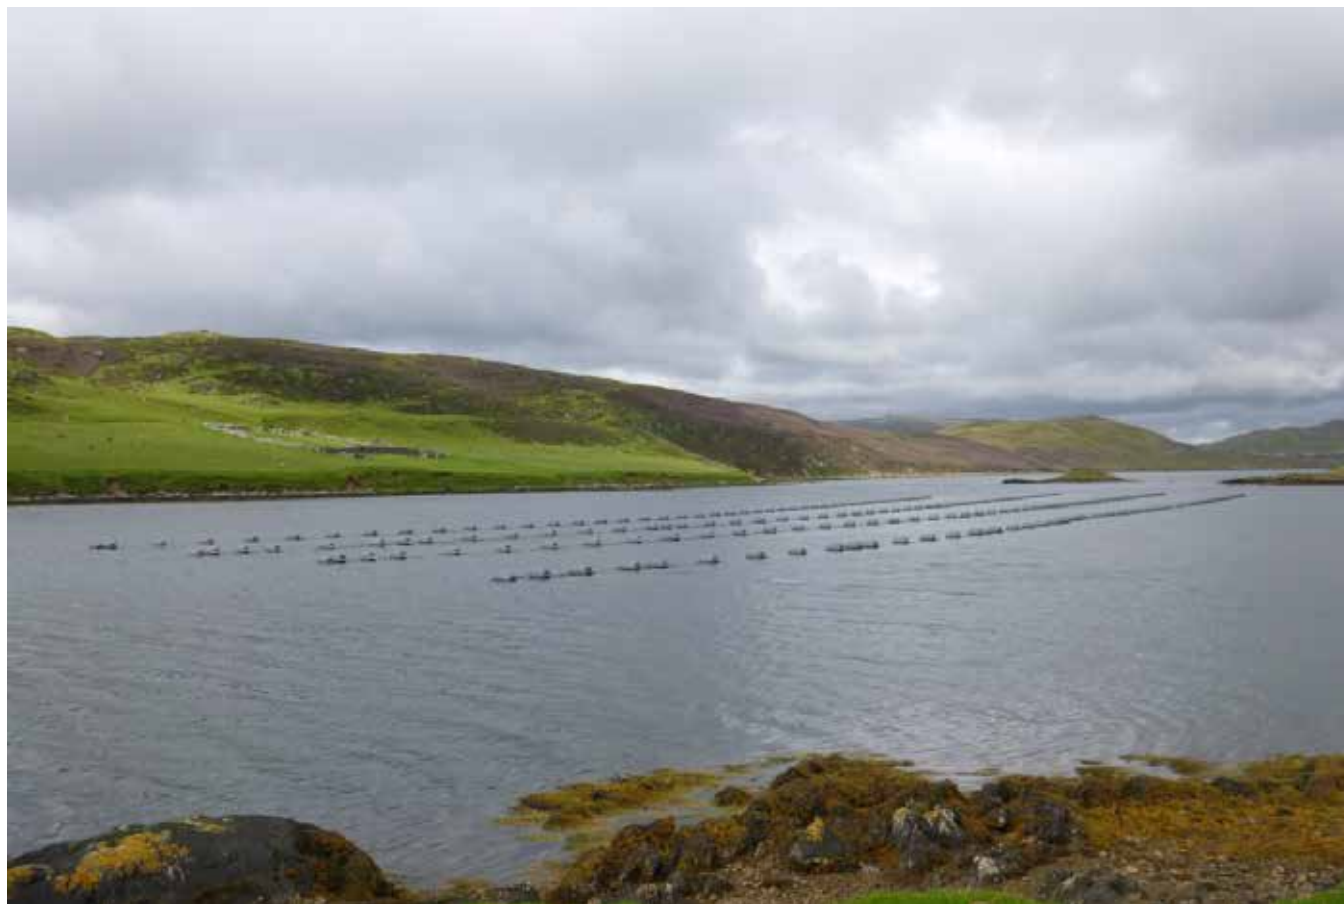
The Burra Holm fishery consisted of four mussel lines running parallel to the shoreline (Figure 4). All lines were double headed long lines with 4 metre droppers. Two mussel samples were collected from the north east corner of the site from the line closest to the shore taken from the top and bottom of a mussel line. The site is licenced for four 150 metre twin-headline longlines.

Figure 4 – Mussel lines at the Burra Holm fishery looking north.

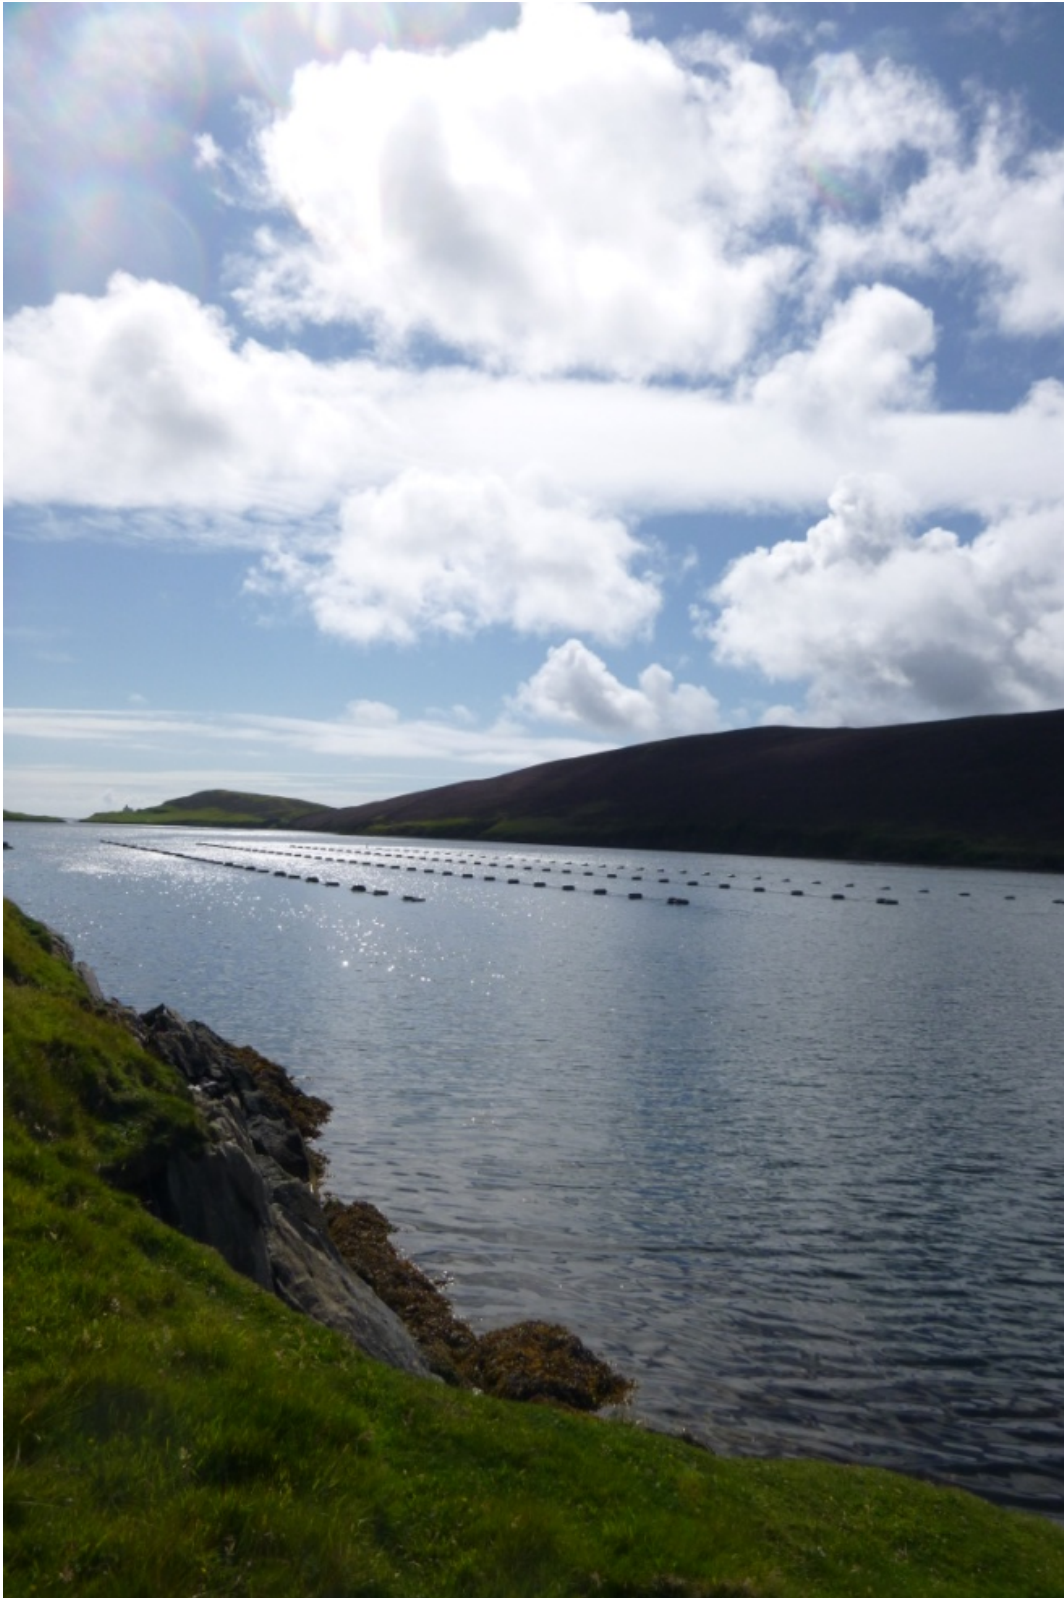
The Site 1 fishery consisted of four mussel lines running parallel to the shoreline (Figure 5). All lines were double headed long lines with 10 metre droppers. Two mussel samples were collected just north of the south east corner of the site from the line nearest the shore taken from the top and bottom of a mussel line. The site is licenced for four 200 metre twin-headline longlines.

Figure 5 – Mussel lines at the Site 1 fishery looking south.

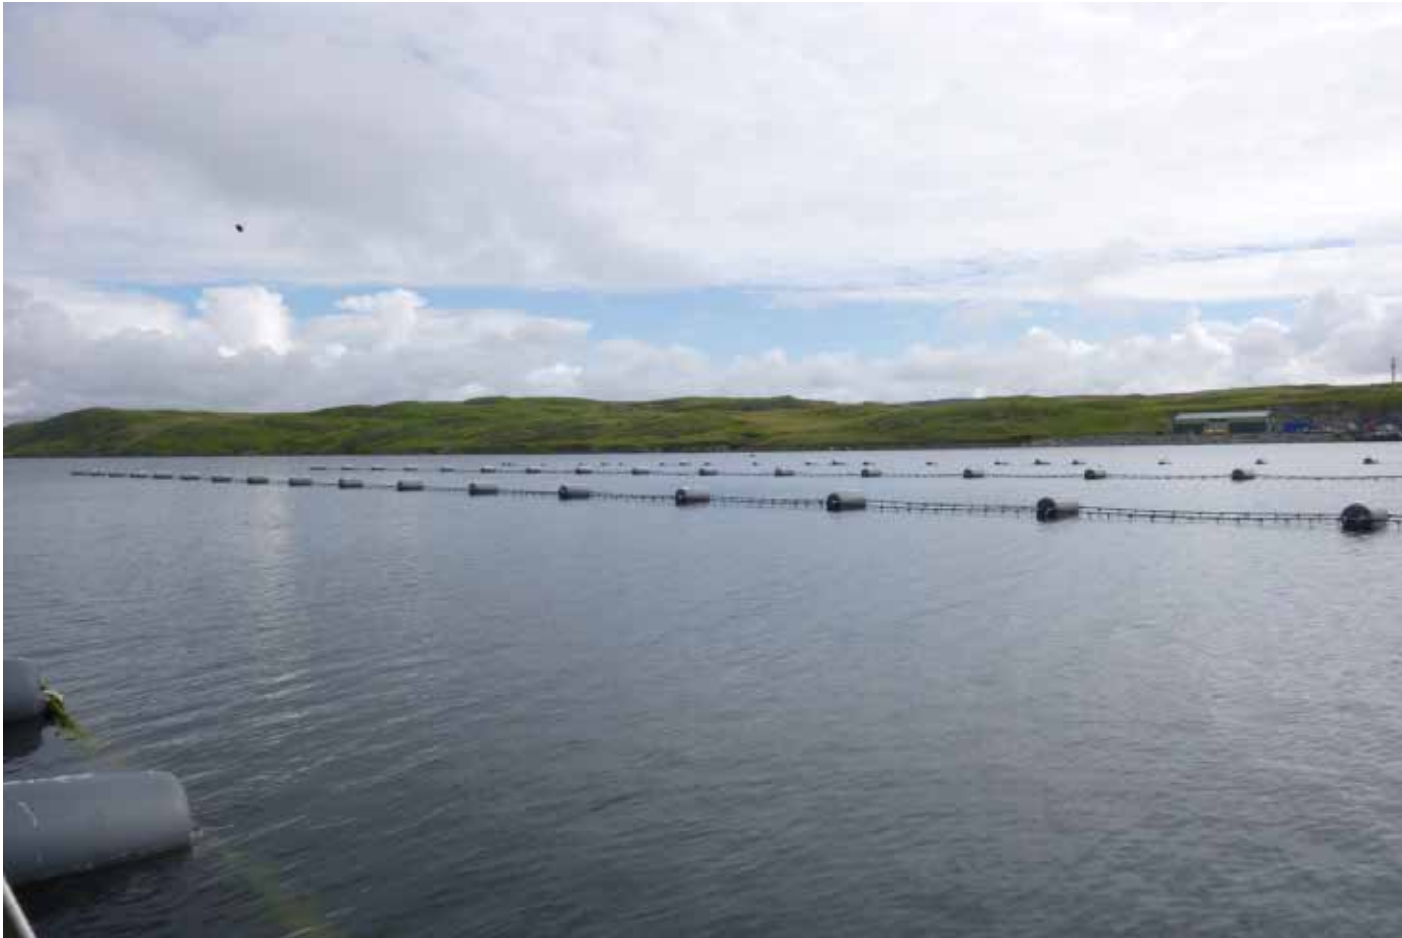
The Site 2 fishery consisted of four mussel lines running parallel to the shoreline (Figure 6). All lines were double headed long lines with 10 metre droppers. Two mussel samples were collected from the south west corner of the site from the line

| No. | Date/Time (UT) | NGR | Easting | Northing | Associated Photograph | Associated Sample | Description |
|---|---|---|---|---|---|---|--|
| 1 | 06/08/2013 09:32 | HU 37853 43511 | 437853 | 1143511 | Figure 6 | SMV-MUSS01 (Top), SMV-MUSS02 (Bottom), SMV-SW01 | Weather: Mostly cloudy with breaks of sunshine, gentle south westerly wind. SW corner of Site 2 fishery, located at the mouth of the voe. 4x double header long lines. Droppers 10m, mussels on site. Salinity Profile 1 collected (ppt/°C): 10m 35.26/12.6, 5m 35.09/12.8, 3m 35.07/12.9, surface 34.41/14.6. Mussels collected from furthest west line at the SW corner buoy. Surface sample collected from the top of a mussel line, bottom sample collected from the bottom of a mussel line. Seawater sample collected. |

Figure 6 – Mussel lines at the Site 2 fishery looking north from the SW corner.

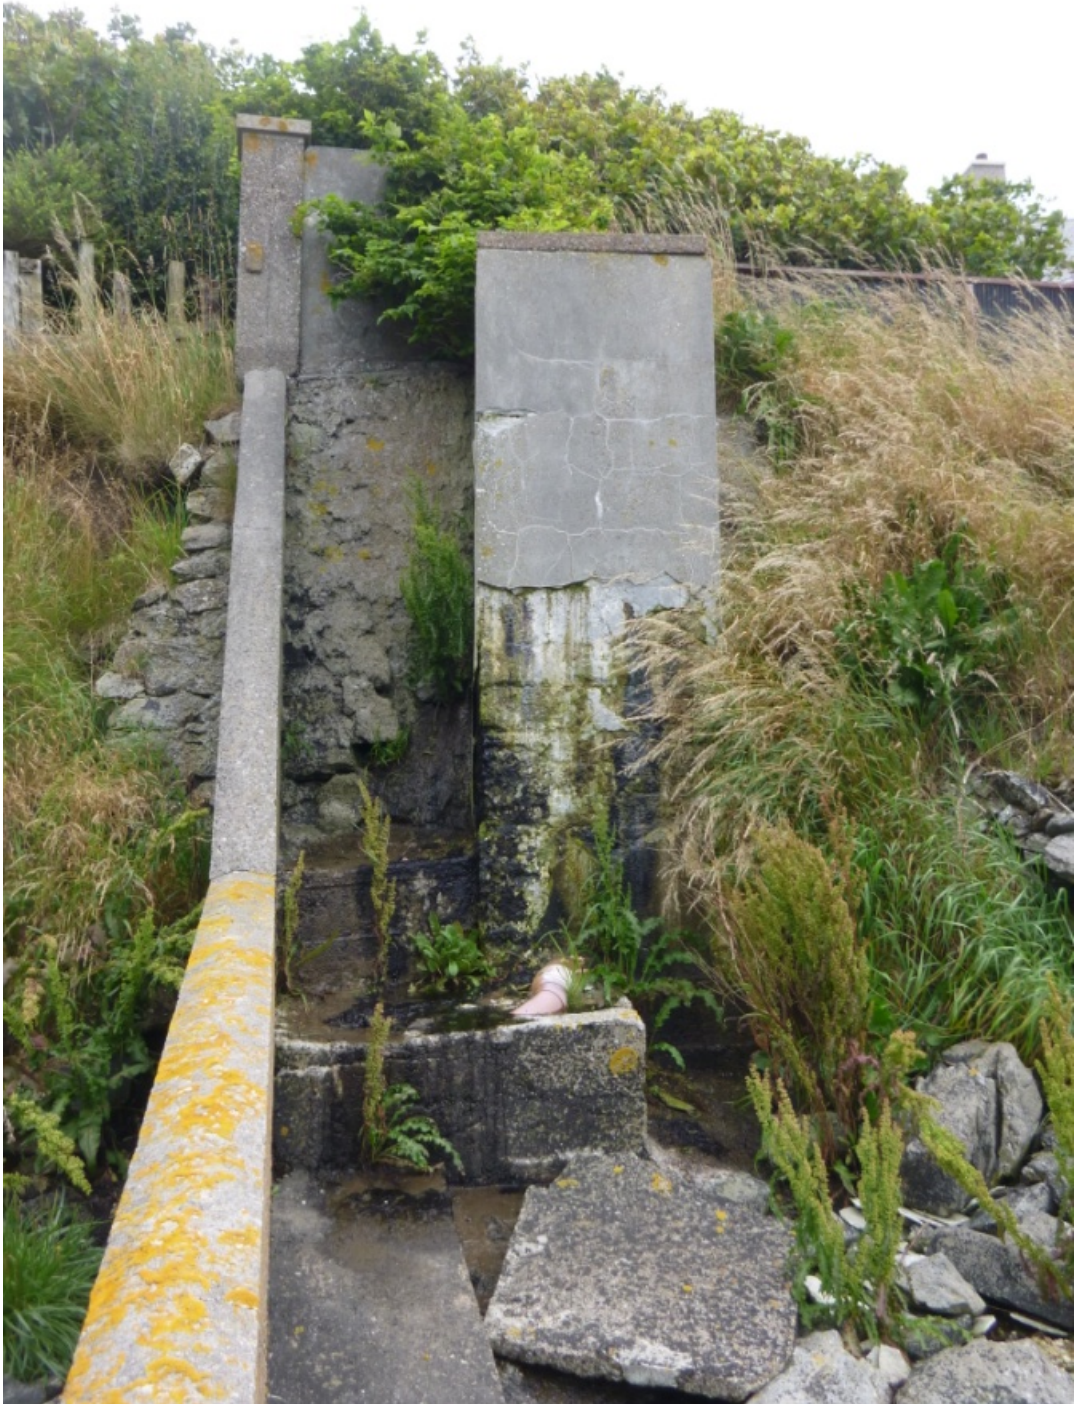
| No. | Date | Associated Photograph | Associated Sample | <i>E. coli</i> cfu/100ml | Description |
|---|---|---|---|---|---|
| 1 | 06/08/2013 | Appendix 5; Figure 7 & 12 | SMV-SW04 | 60 | Septic tank on the shore with a pipe leading to the sea, consented discharge on the survey plan. Septic tank in a poor state with outer casing of the tank and pipe casing damaged, seepage coming from the tank and black/green algae forming on the tank. |

Observation 1 reported a septic tank on the shore with a pipe leading to the sea. The septic tank was reported as being in a poor state of repair with the outer casing of the tank and pipe damaged. Seepage was reported coming from the tank with a black/green biofilm on the tank. A sea water sample

Figure 7 – Septic tank located north of the Strom Bridge.

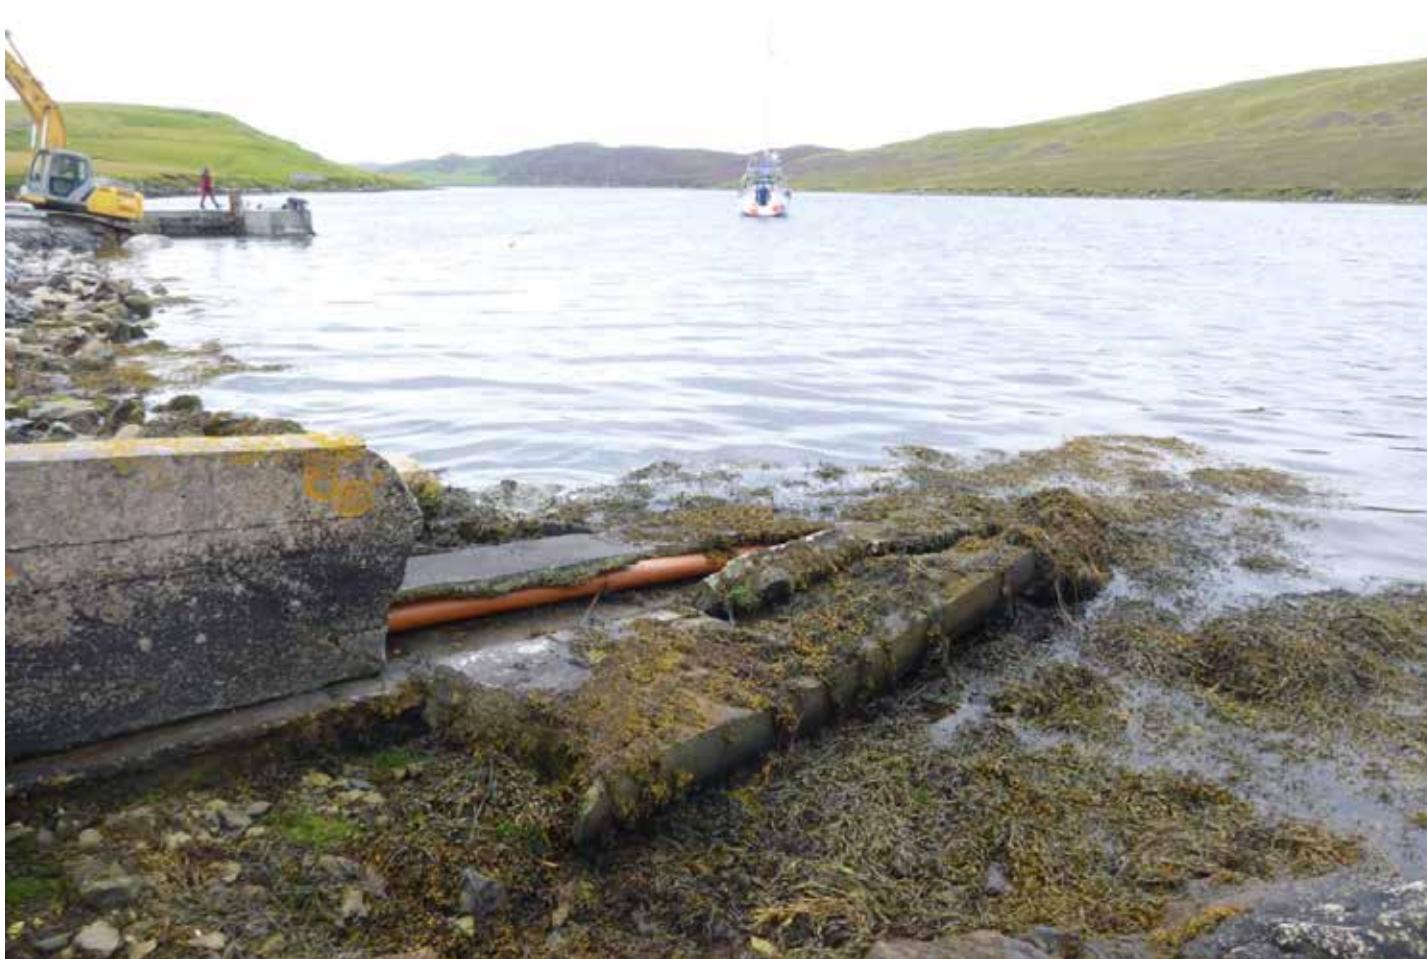
| No. | Date | Associated Photograph | Associated Sample | <i>E. coli</i> cfu/100ml | Description |
|---|---|---|---|---|---|
| 2 | 06/08/2013 | Appendix 5; Figure 8 & Figure 13 | SMV-SW06 | 80000 | Consented discharge noted on the survey plan, pipe observed leading to the water but no septic tank located. Grey discharge seen at the end of the pipe. Seawater sample taken (not on survey plan) from the end of the pipe, slight sewage smell noted whilst the sample was being obtained. |

Observation 2 reported a pipe discharging to Stromness Voe. A grey discharge plume was noted along with a smell of sewage. A seawater sample taken from within this plume returned a value of 80000 *E. coli cfu/100ml*. The salinity of this sample was given as 26.93 PSU indicating some mixing. This observation correlates with CAR/R/1035235 which is reported as being a septic tank with a DPE of 6, discharging to Stromness Voe

Figure 8 – Additional seawater sample obtained in the vicinity of a discharge pipe north of the Strom Bridge.

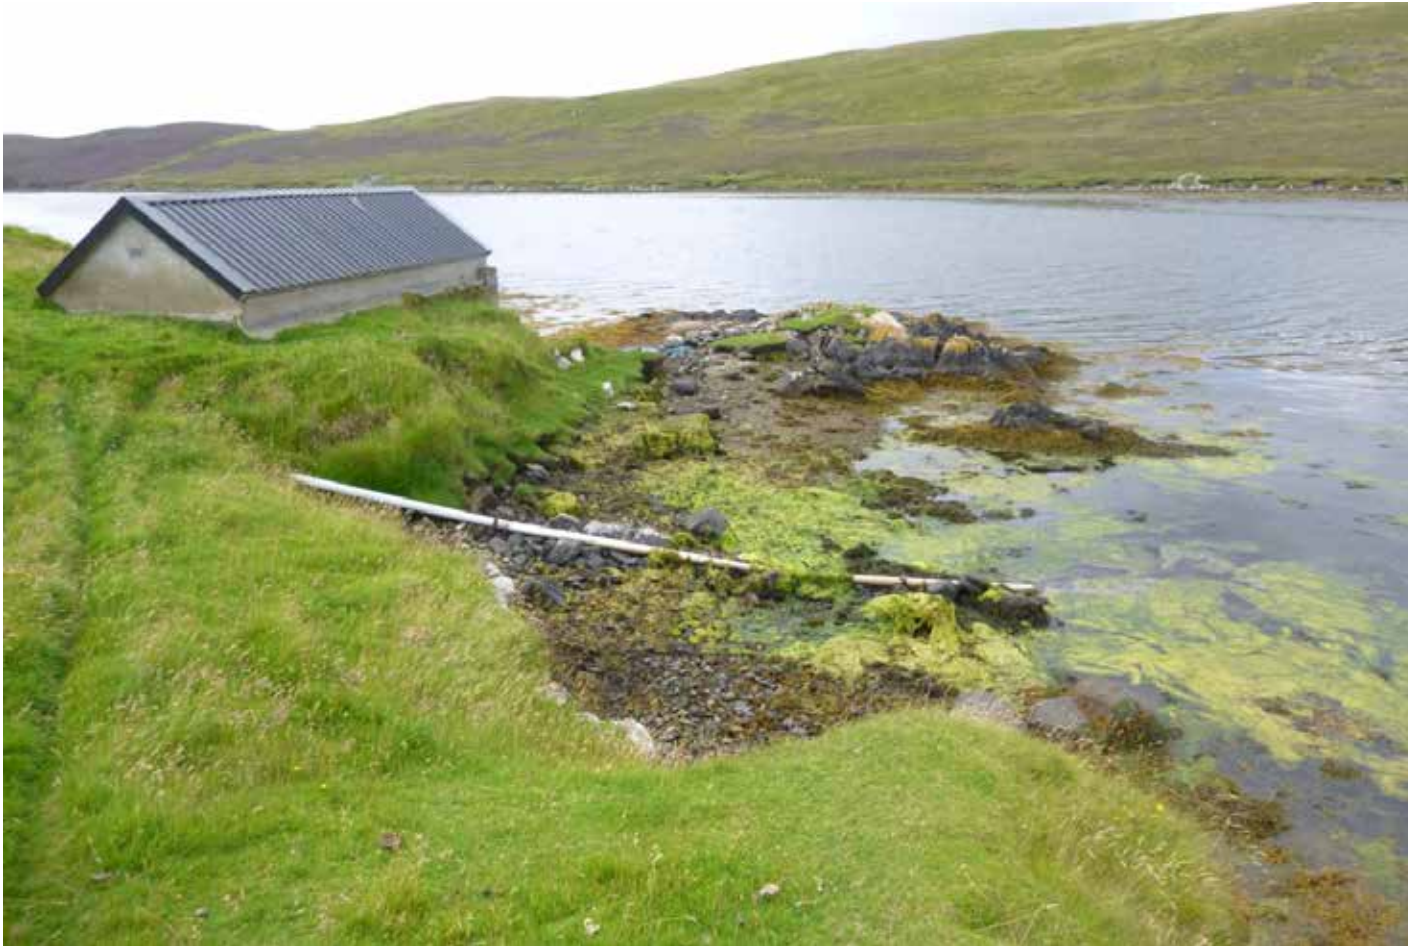
Figure 9 – Discharge pipe leading to the water south of the Strom Bridge.

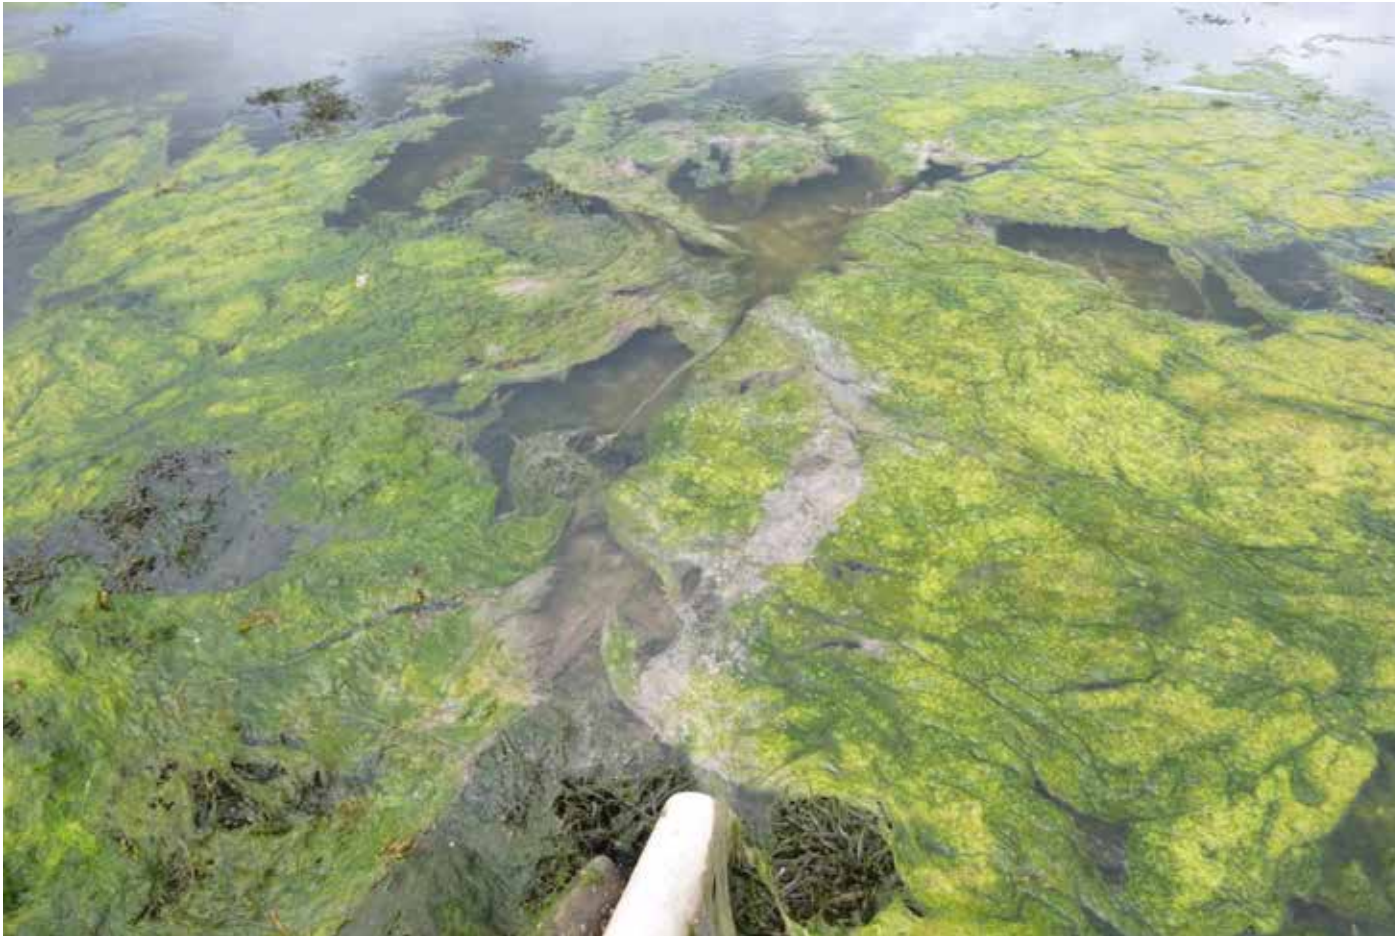
Figure 10 – Additional seawater sample obtained from a discharge pipe south of the Strom Bridge.
