Sanitary Survey Report Stromness Voe SI-273 and New Site November 2013

| Report Title | Stromness Voe Sanitary Survey Report |
| Project Name | Scottish Sanitary Survey |
| Document Number | C5792C_2013_11 |

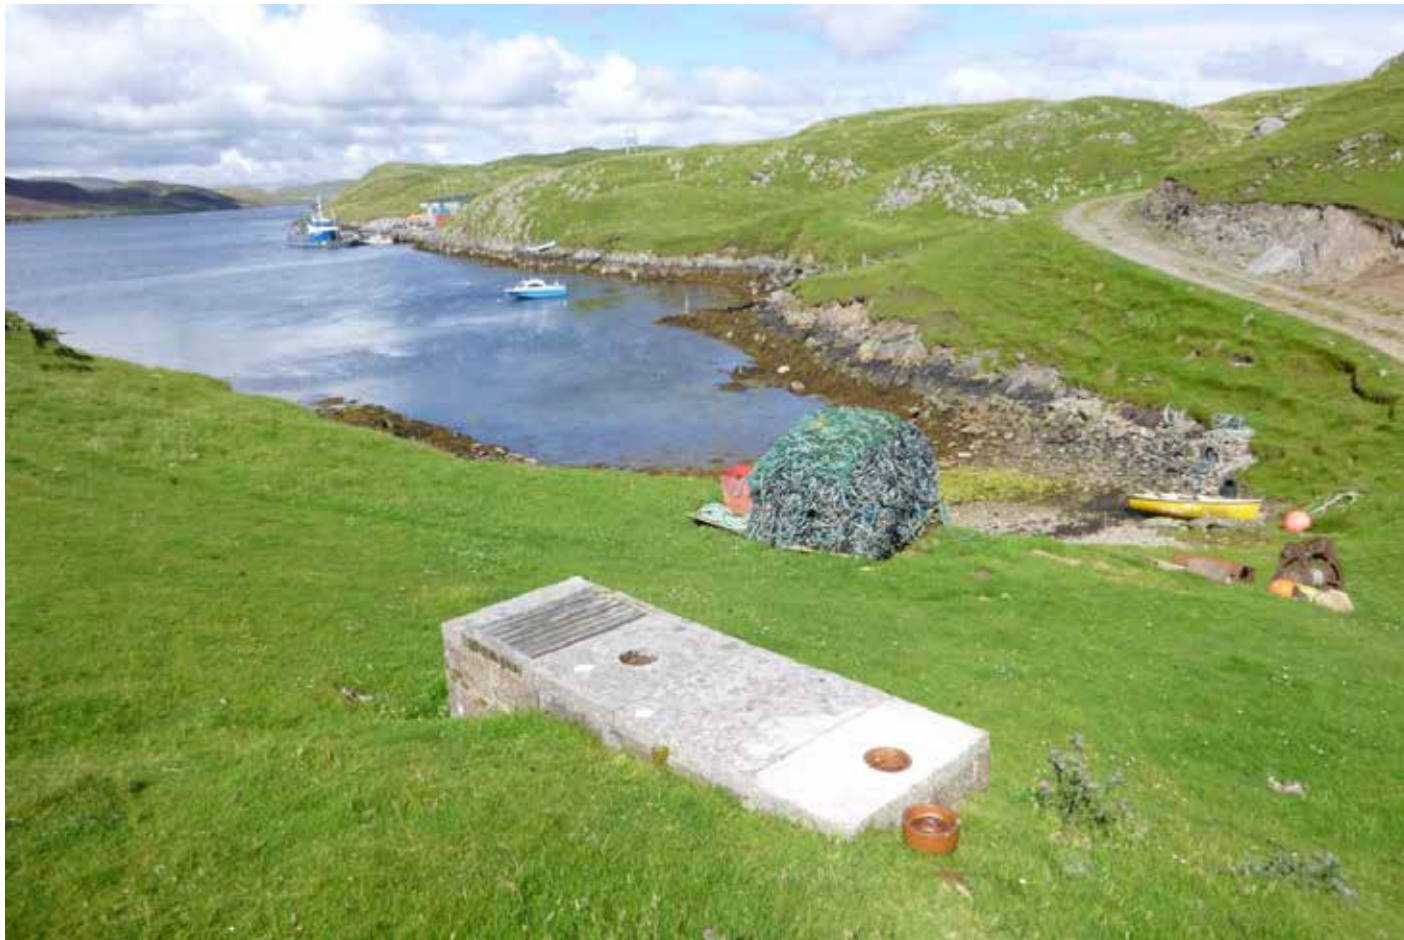
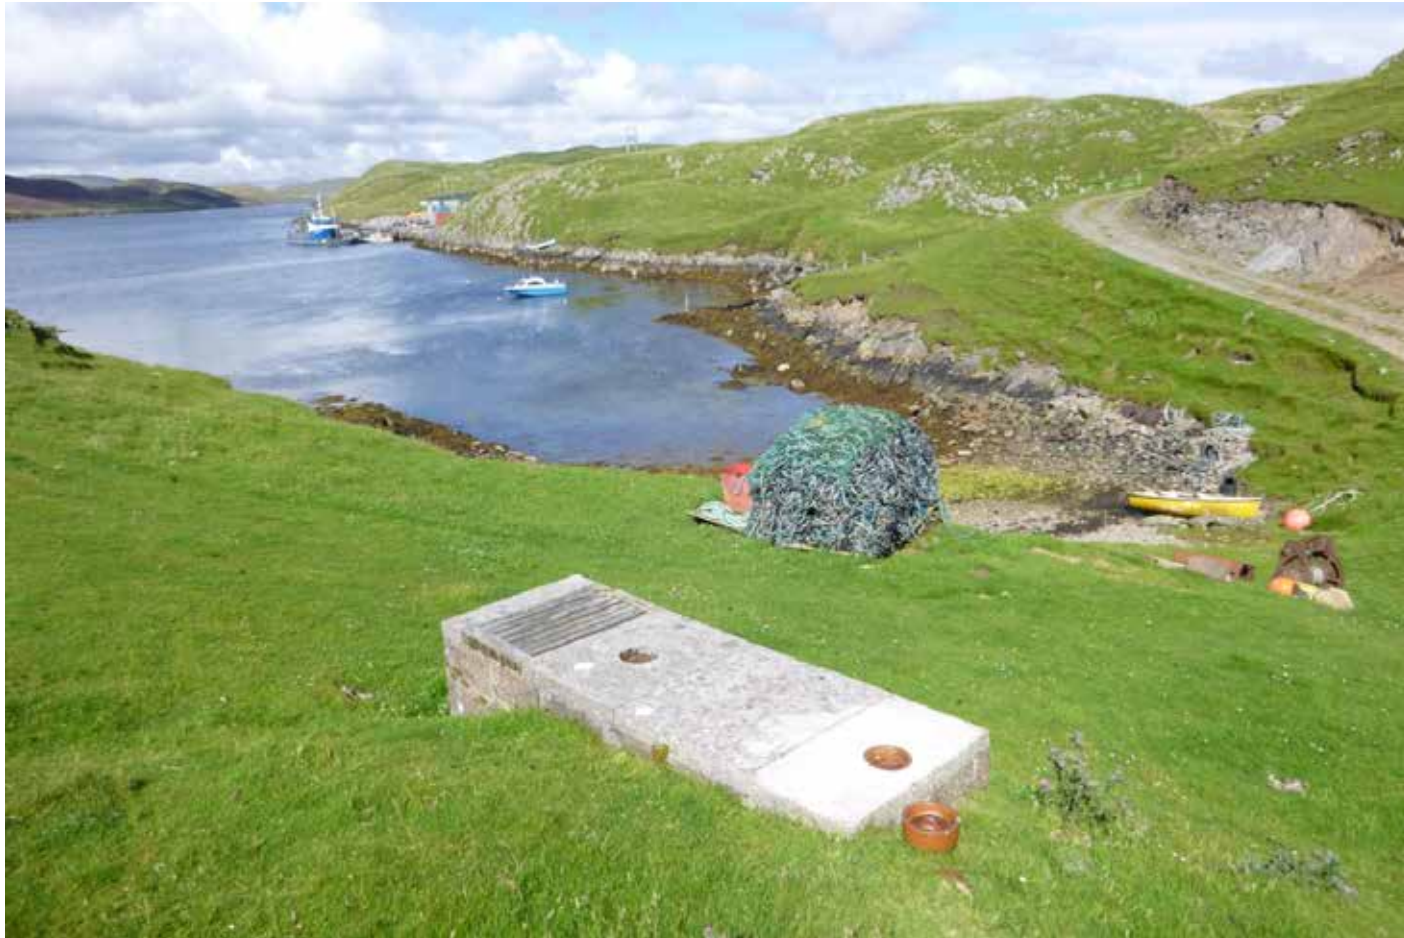
Figure 11 – Septic tank associated with a holiday home at Pund.

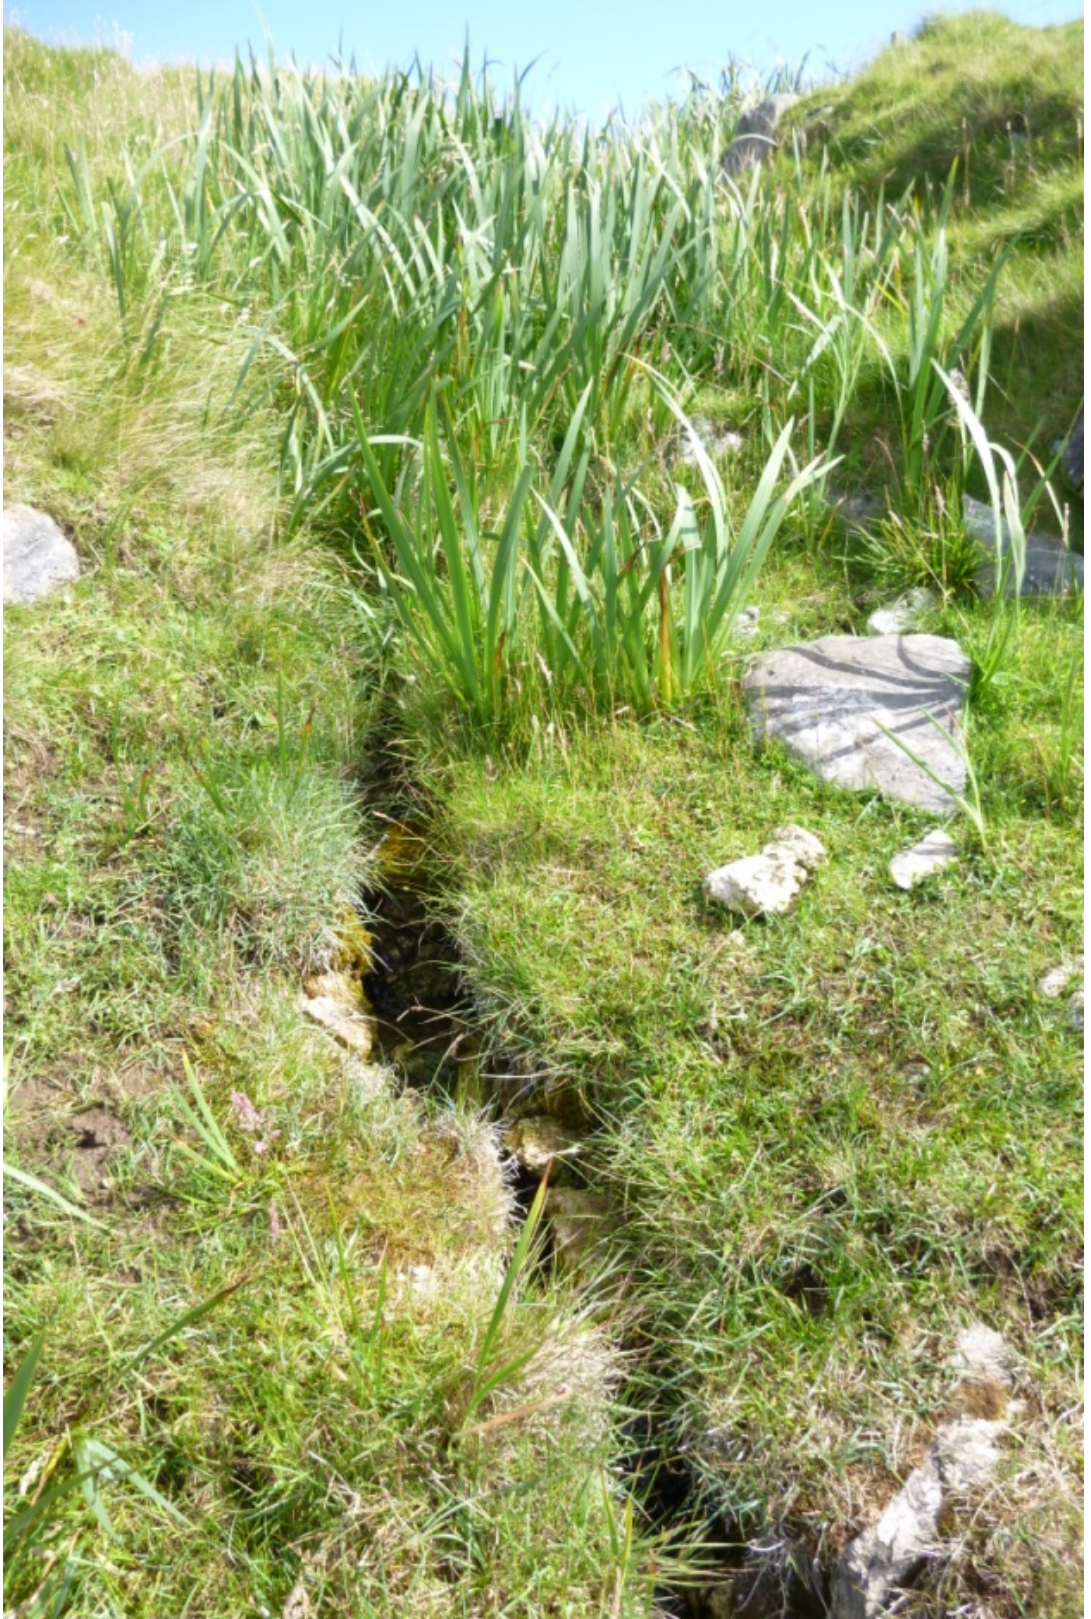
Figure 12 – Small watercourse sampled north of the Site 2 fishery.

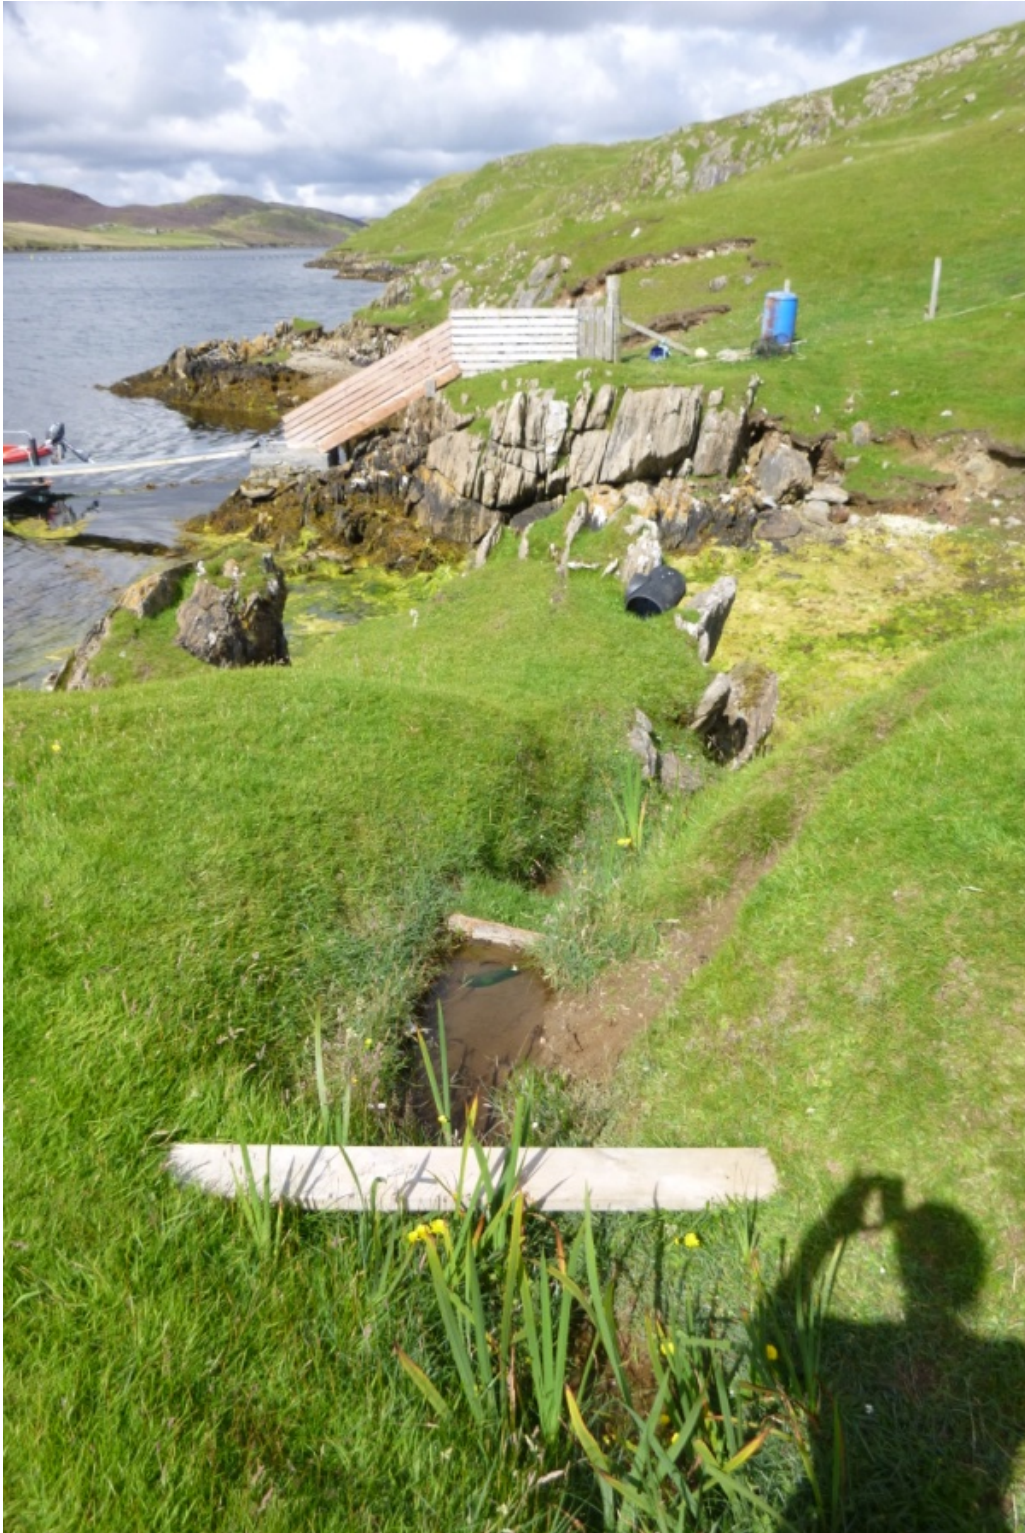
Five freshwater samples were obtained from watercourses on the shoreline survey, all of which were outlined on the sampling plan. Another two freshwater samples were outlined in the plan but on approaching the locations no watercourses were present only areas of boggy ground but no water flowing. Of the five watercourses sampled, three were found to have *E.coli* levels between 20-140 cfu/100ml. The other two samples were from small watercourses, the first just north of the Site 2 fishery which had a small water discharge (Figure 12) recording an *E.coli* count of 240 cfu/100ml. The second sample was collected from a stagnant pool of water (Figure 13) in a watercourse above a small jetty situated between the Site 1 and Site 2 fisheries which recorded an *E.coli* count of 300 cfu/100ml.

Figure 13 – Watercourse sampled up from a jetty situated between the Site 1 and Site 2 fisheries.

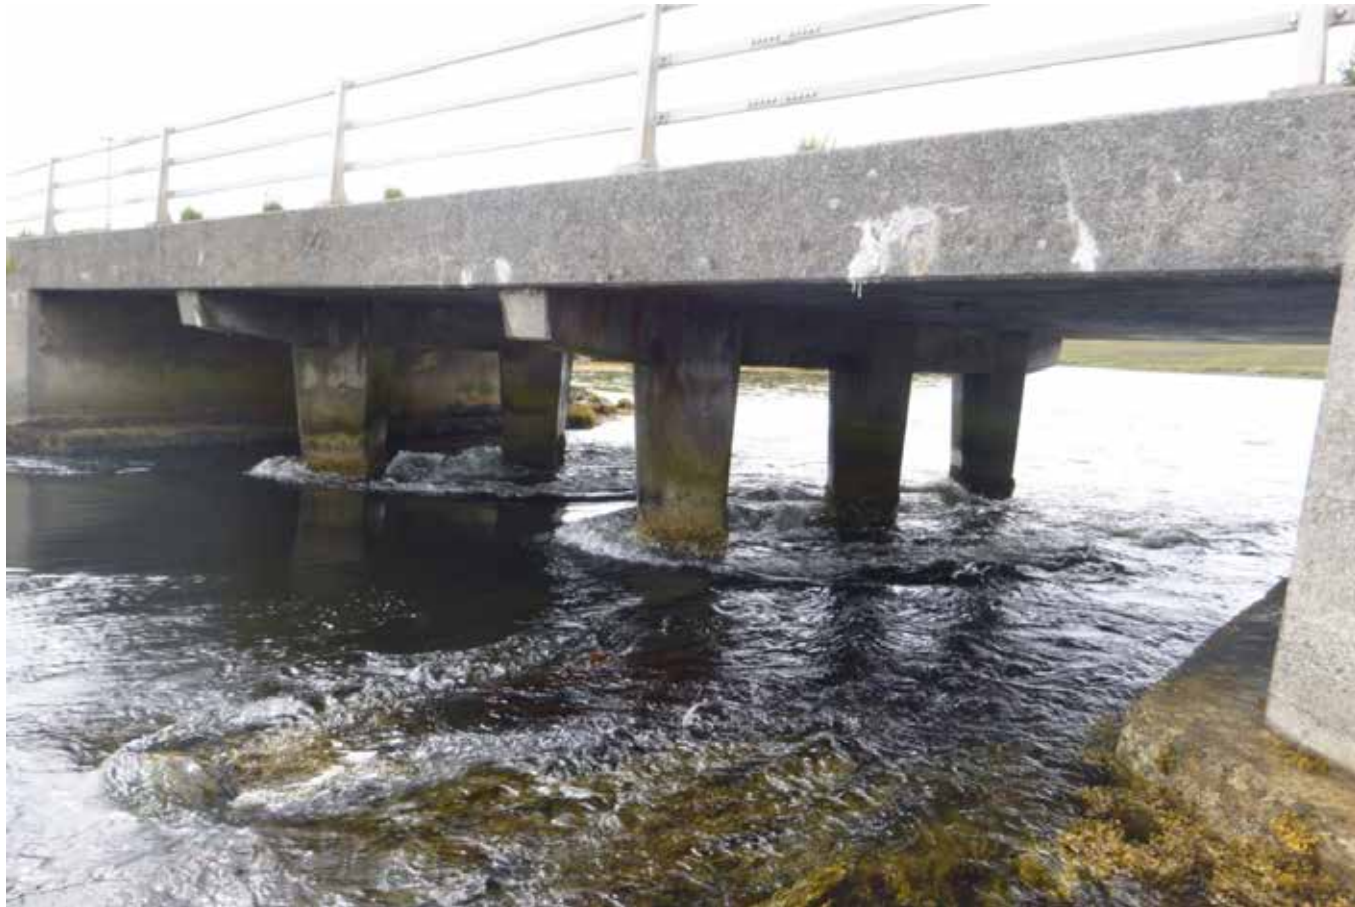
Salinity profiles were collected at all three fisheries from the north end of the Burra Holm fishery and the south ends of the Site 1 and Site 2 fisheries. A salinity reading was also obtained from the surface of the water under the Strom Bridge (Figure 14). The profiles obtained from the fisheries all showed a decrease in salinity from 10 metres to the surface greater than 0.35 ppt which is out with the accuracy of the probe (± 0.35 ppt). The salinity profile which showed the greatest difference (1.91 ppt) in salinity was recorded at the Burra Holm fishery which saw the salinity peak at 5 metres before decreasing to the surface. A full salinity profile could not be obtained at the Strom Bridge as the water was too shallow under the bridge and there was a strong flow of water from the Strom Loch into Stromness Voe which would have made taking more readings at a greater depth difficult. The salinity recorded under the Strom Bridge was 31.95 ppt which is lower than full strength seawater although this would be expected with the strong influence of freshwater coming from the Strom Loch.

Figure 14 – Water flowing under Strom Bridge from Strom Loch to Stromness Voe.

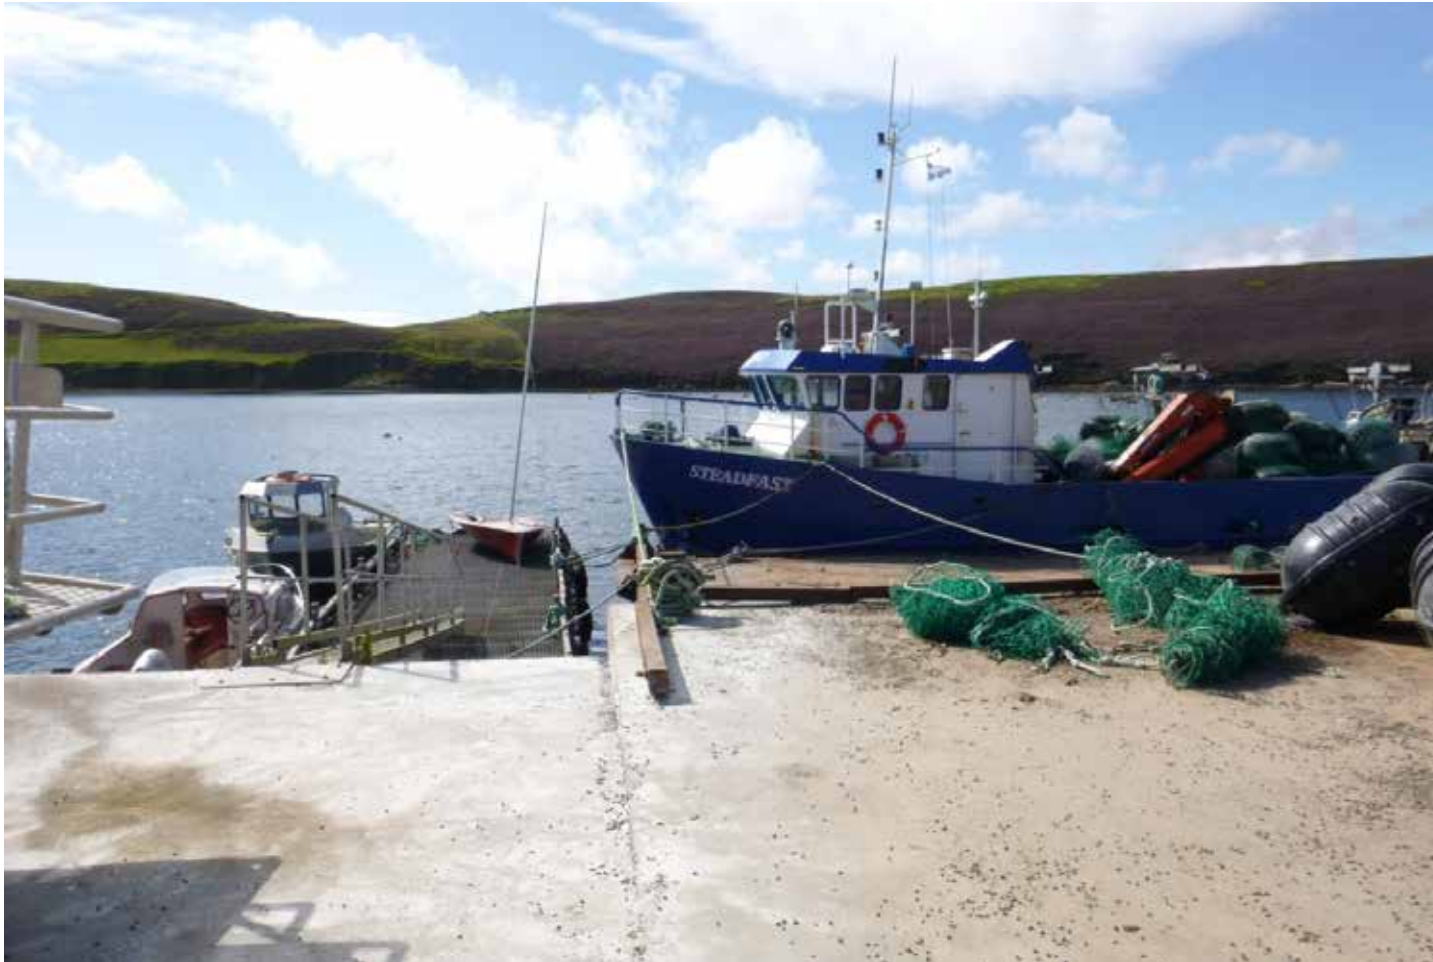
Boat traffic in the Stromness Voe area is largely associated with mussel farming and also leisure boats. Blueshell Mussels who manage both the Site 1 and Site 2 fisheries on behalf of Pund Shellfish berth a small workboat at the Scottish Sea Farms Ltd. shorebase near the mouth of the voe to service sites both in Stromness Voe and the surrounding area. A large Blueshell Mussel workboat was present at the pier during the shoreline walk which had been servicing a mussel farm outside Stromness Voe that day (Figure 15). Scottish Sea Farms Ltd. do have salmon farms in the surrounding area outside Stromness Voe but the shorebase is not frequently used for servicing their sites, it is more commonly used for storage (Figure 16). A number of leisure boats were observed during the shoreline survey, as well as three privately owned jetties (Figure 17).

Figure 15 – Workboats berthed at the shorebase near the mouth of Stromness Voe.

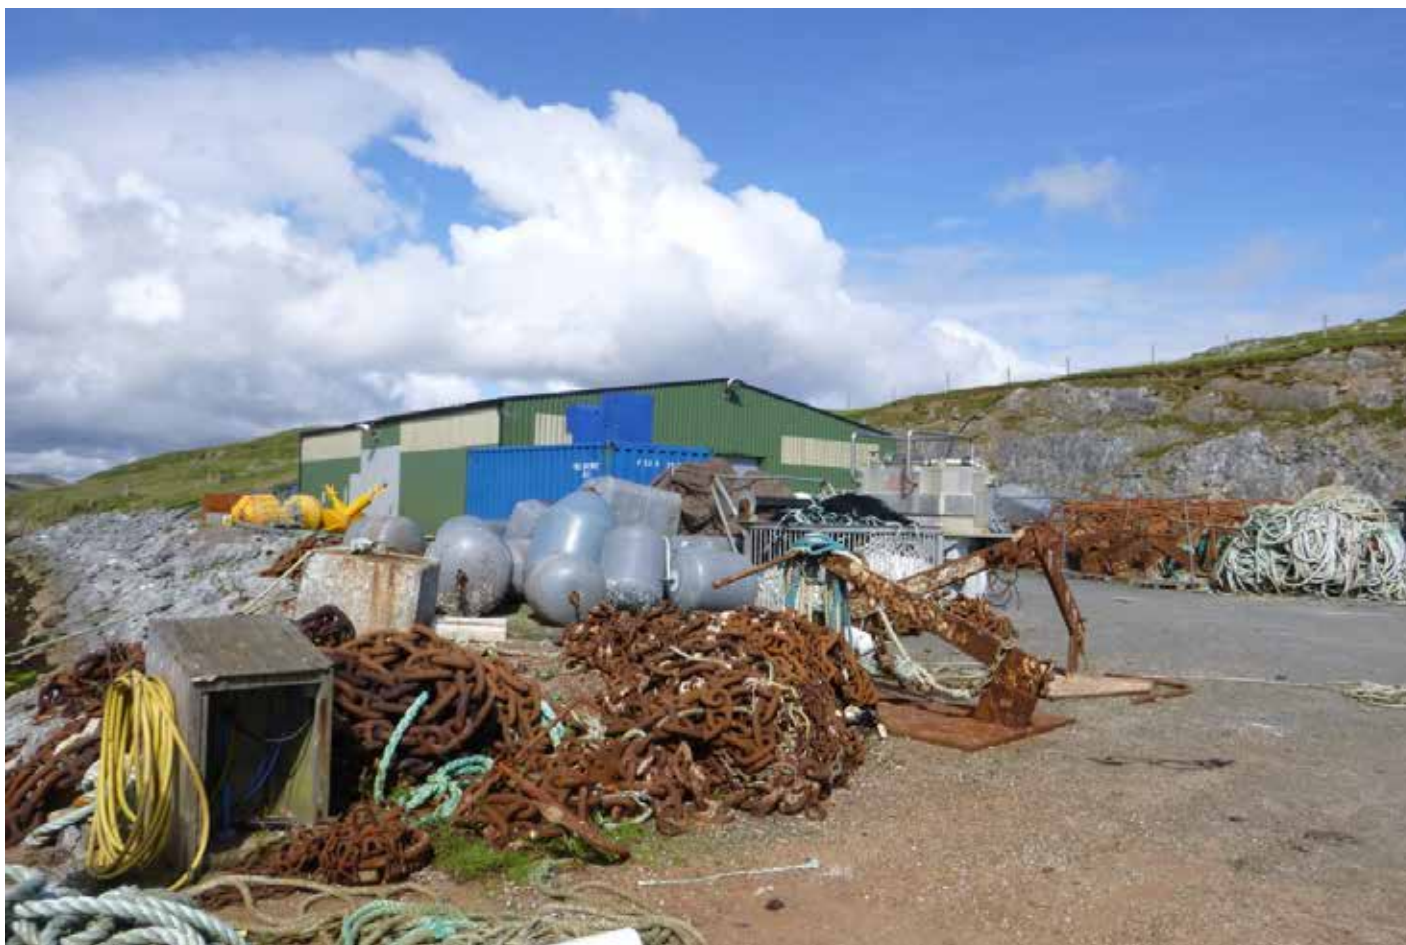
Figure 16 – Equipment being stored at the Scottish Sea Farms Ltd. shorebase.

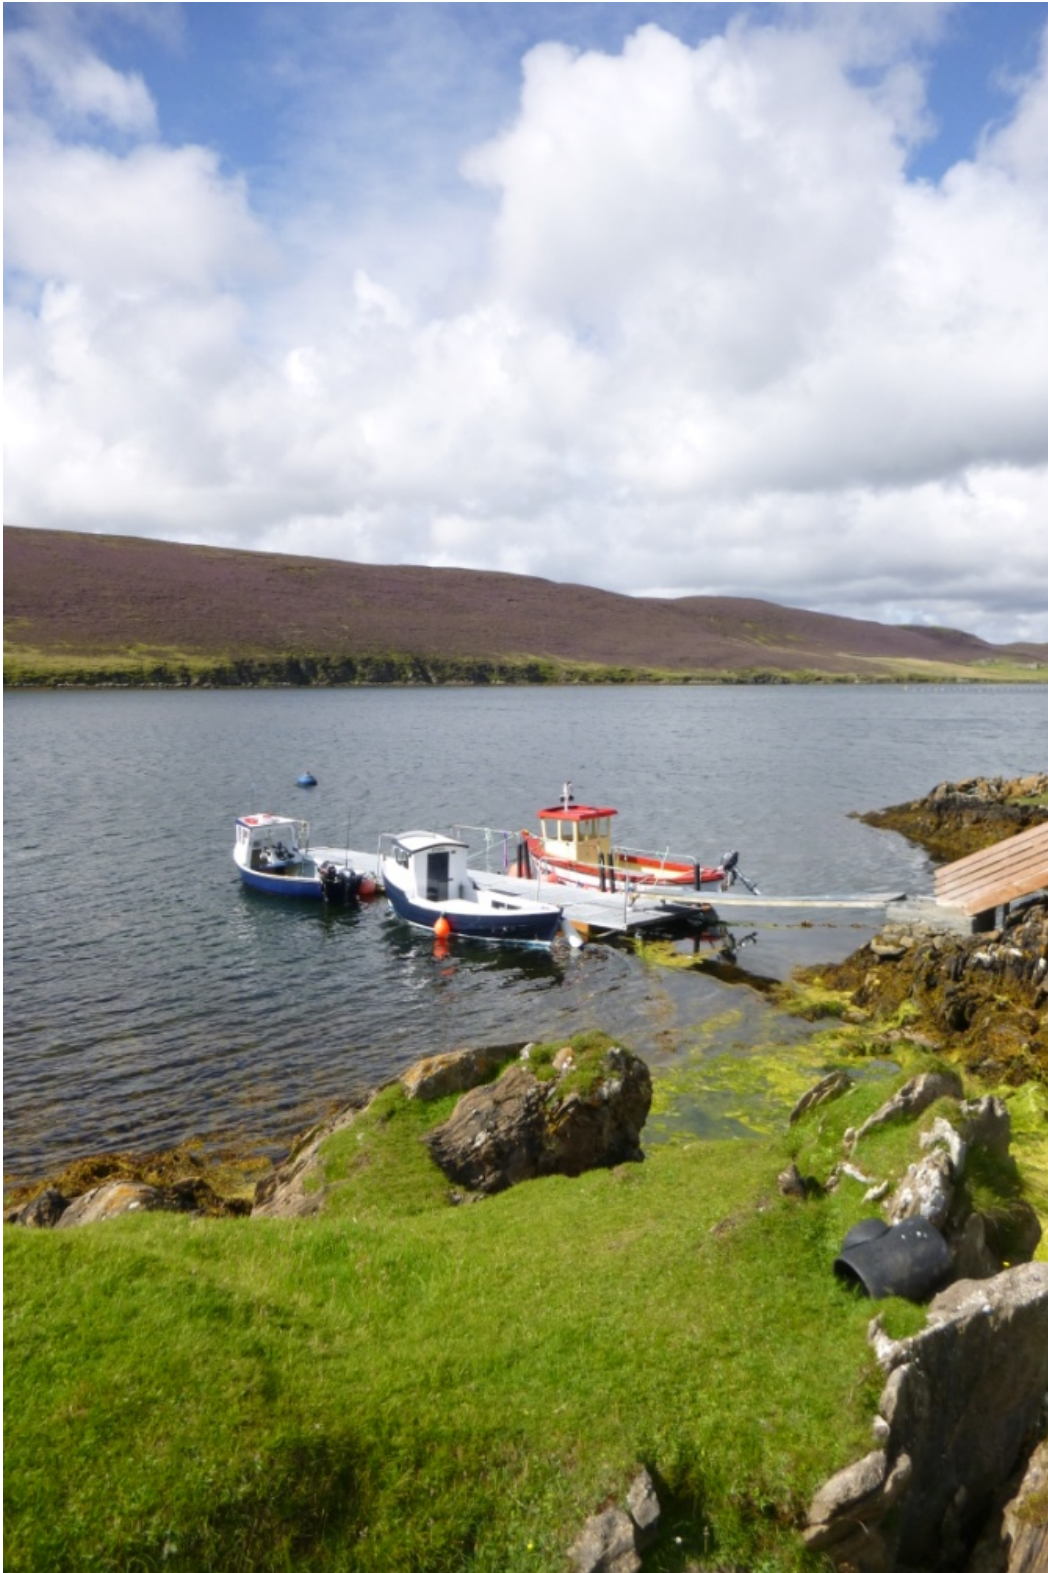
Figure 17 – Leisure boats moored at a jetty between the Site 1 and Site 2 fisheries.

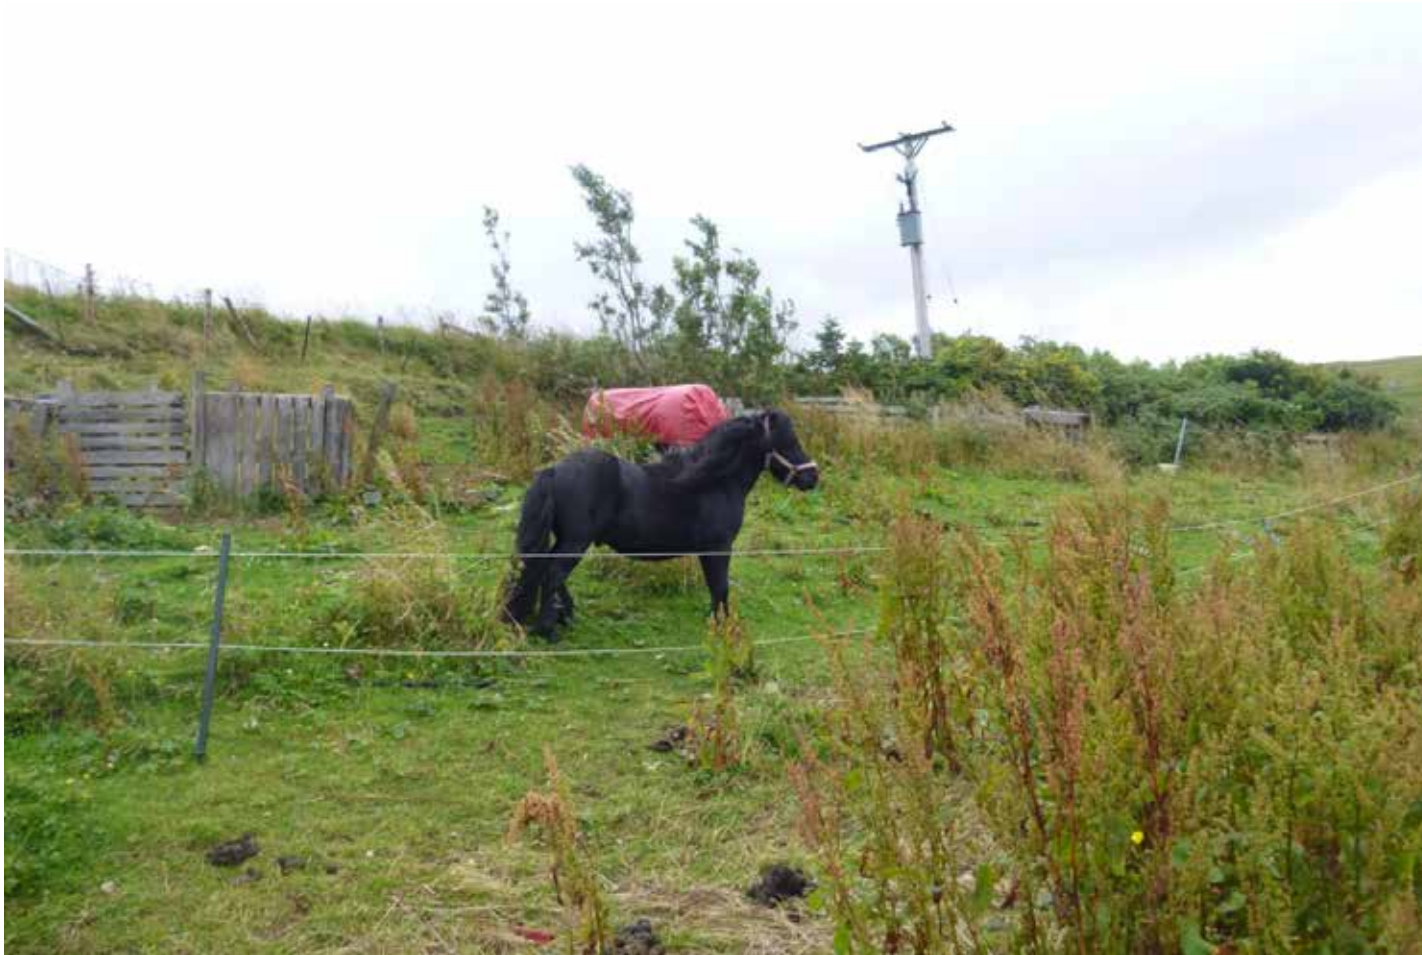
A Shetland pony was observed in a fenced area north of the Strom Bridge adjacent to a house (Figure 18). Equine faeces were observed on five occasions in fields from the head of voe until the Strom Bridge, however no animals were present but there was evidence of grazing with hoof prints, feed buckets and a small wooden shelter (Figure 19) noted. On two of the occasions large piles of equine faeces had been gathered near the shore in the north and south corners of a field (Figure 20). Equine faeces was also noted south of the Site 1 fishery near a small jetty, however no animals were present but animals grazing at this location would have access to the shore.

Figure 18 – Shetland pony grazing in a field adjacent to a house north of the Strom Bridge.

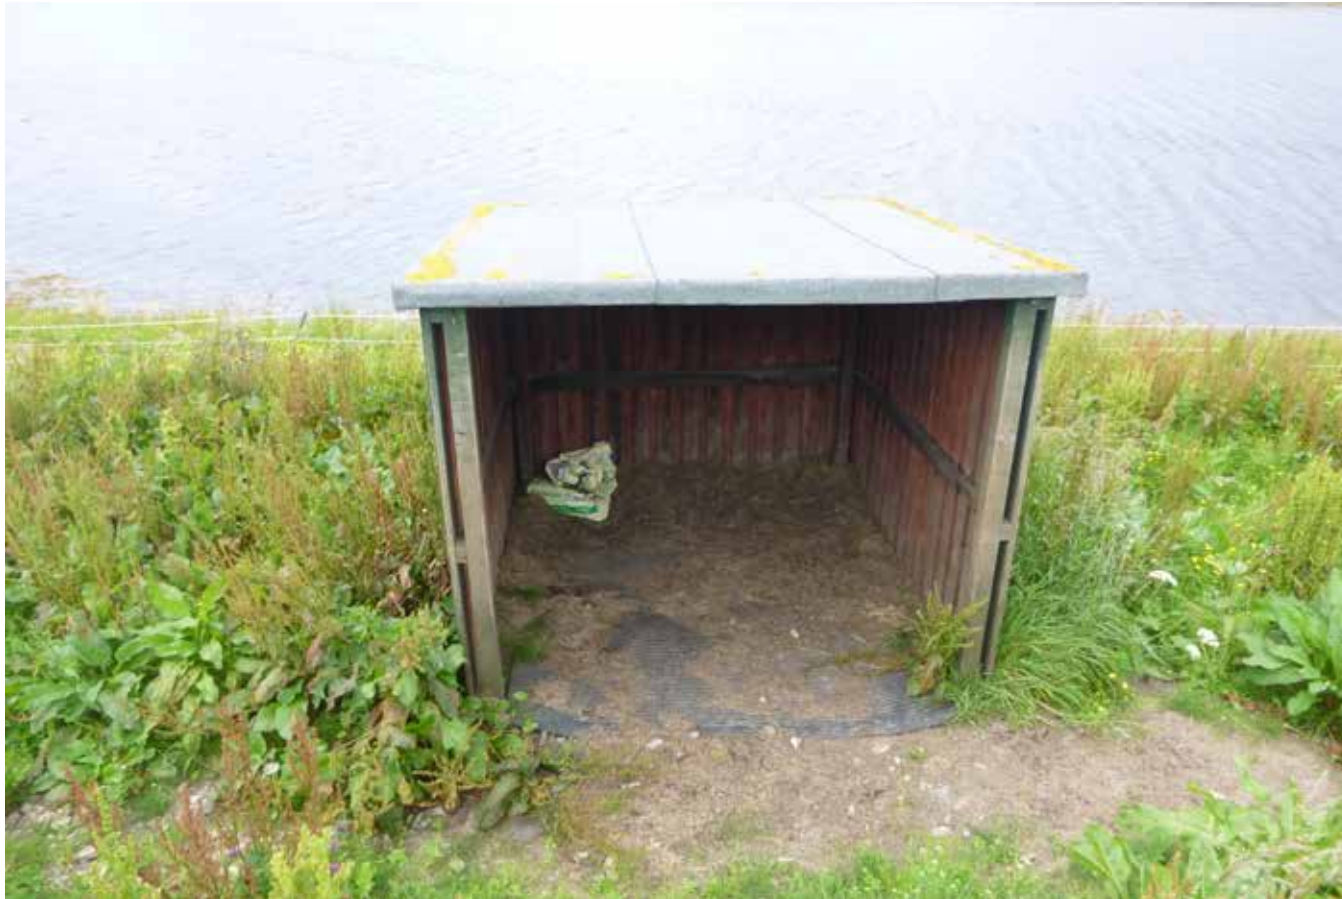
Figure 19 – Equine shelter in a field north of the Strom Bridge.

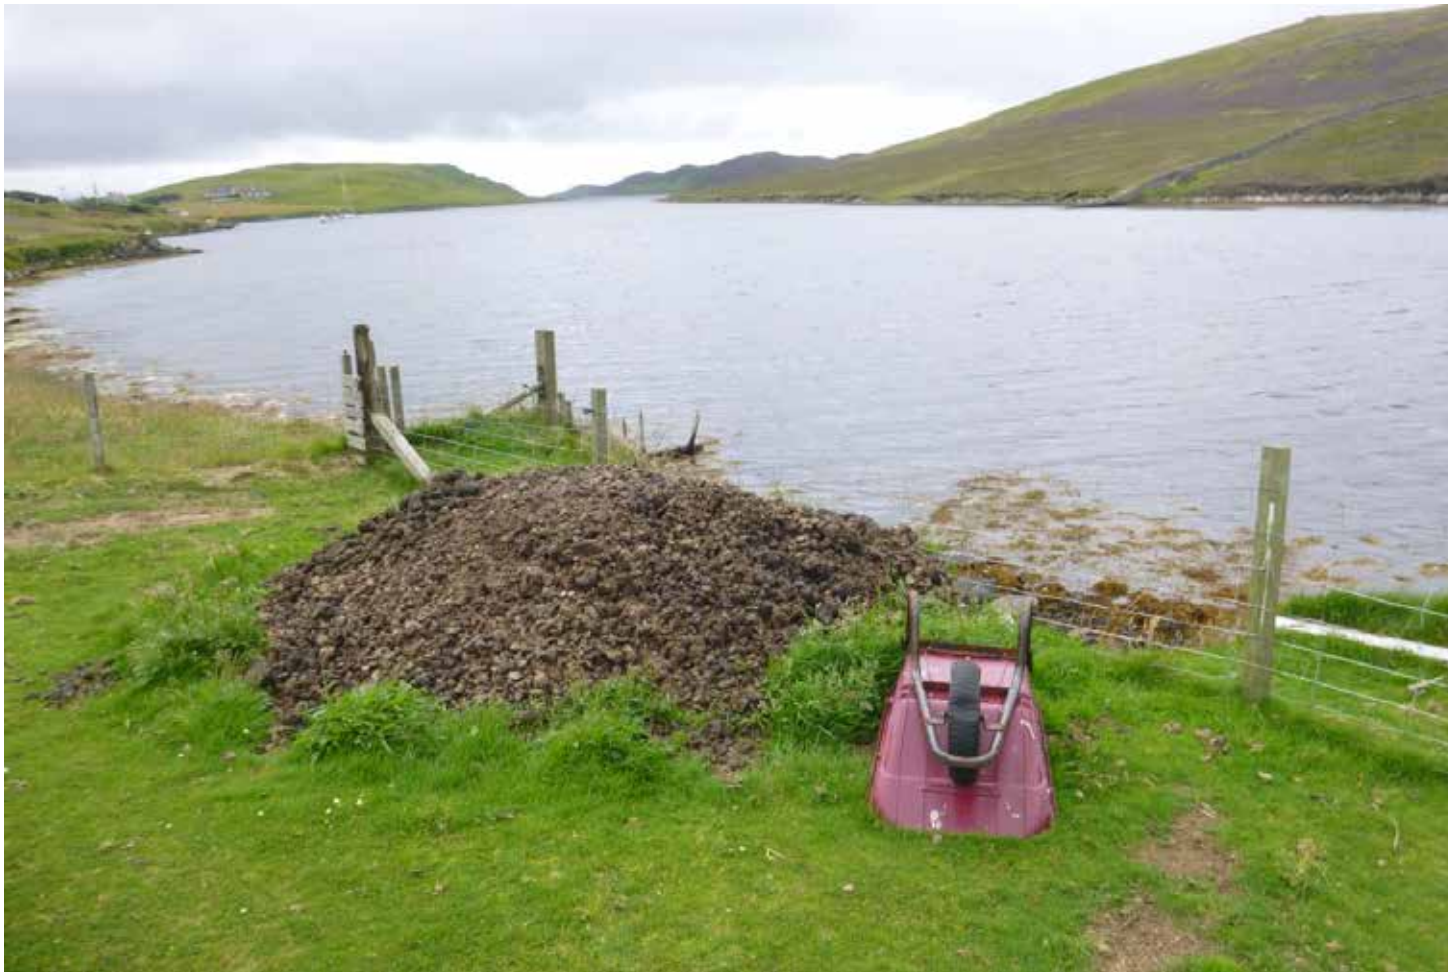
Figure 20 – Large pile of equine faeces observed in a field near the head of Stromness Voe.

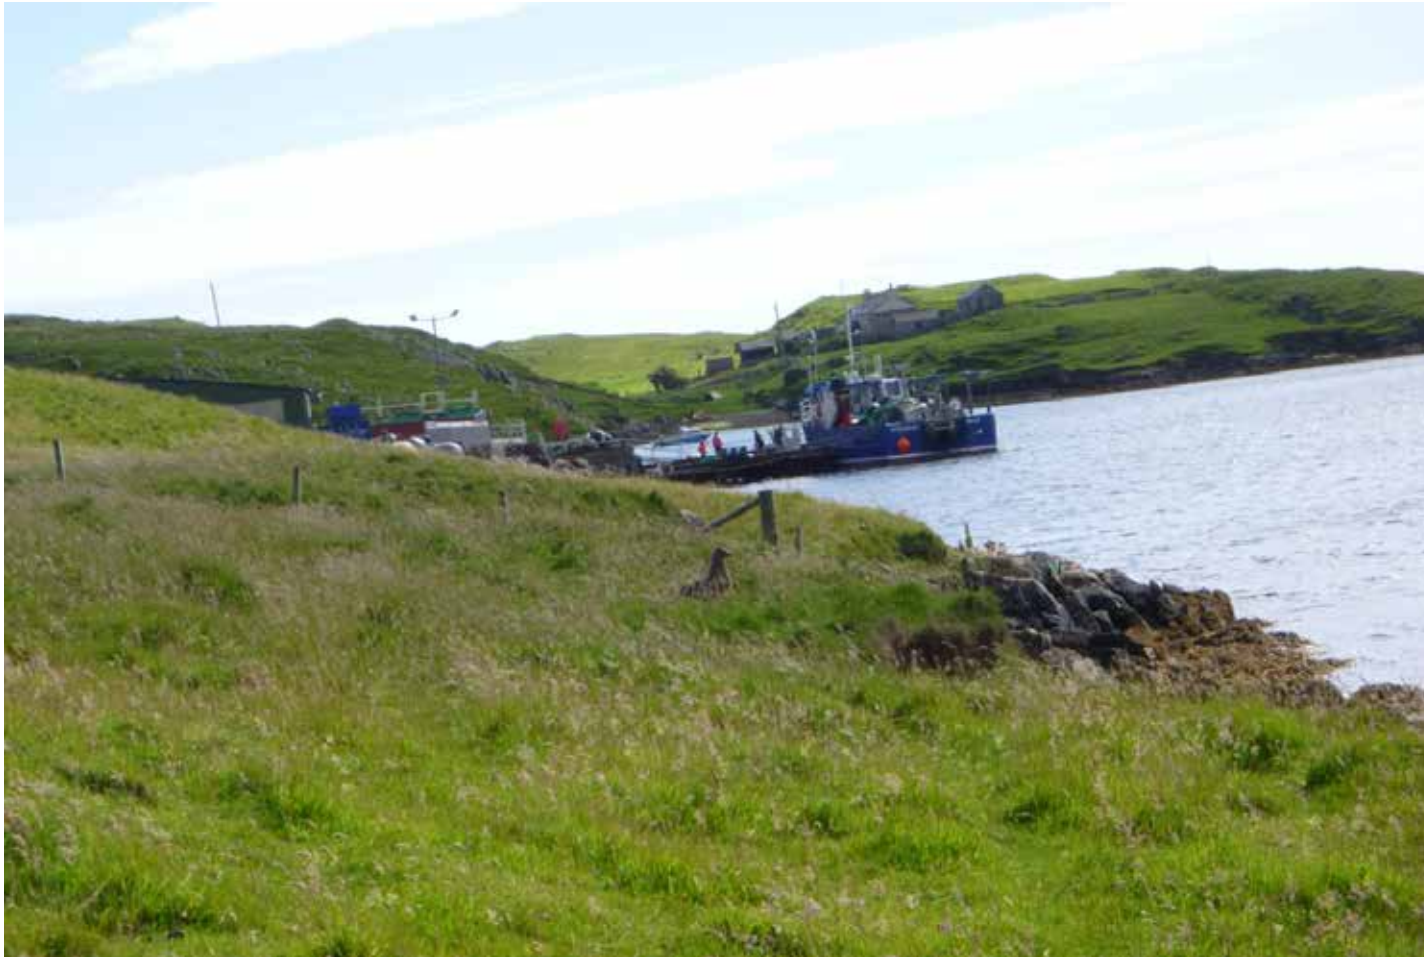
Figure 21 – Great Skua feeding on a rabbit carcass north of the Site 2 fishery.
