Scottish Sanitary Survey Project

Sanitary Survey Report Vaila Sound and Vaila Sound: Riskaness SI288 and SI289 August 2009

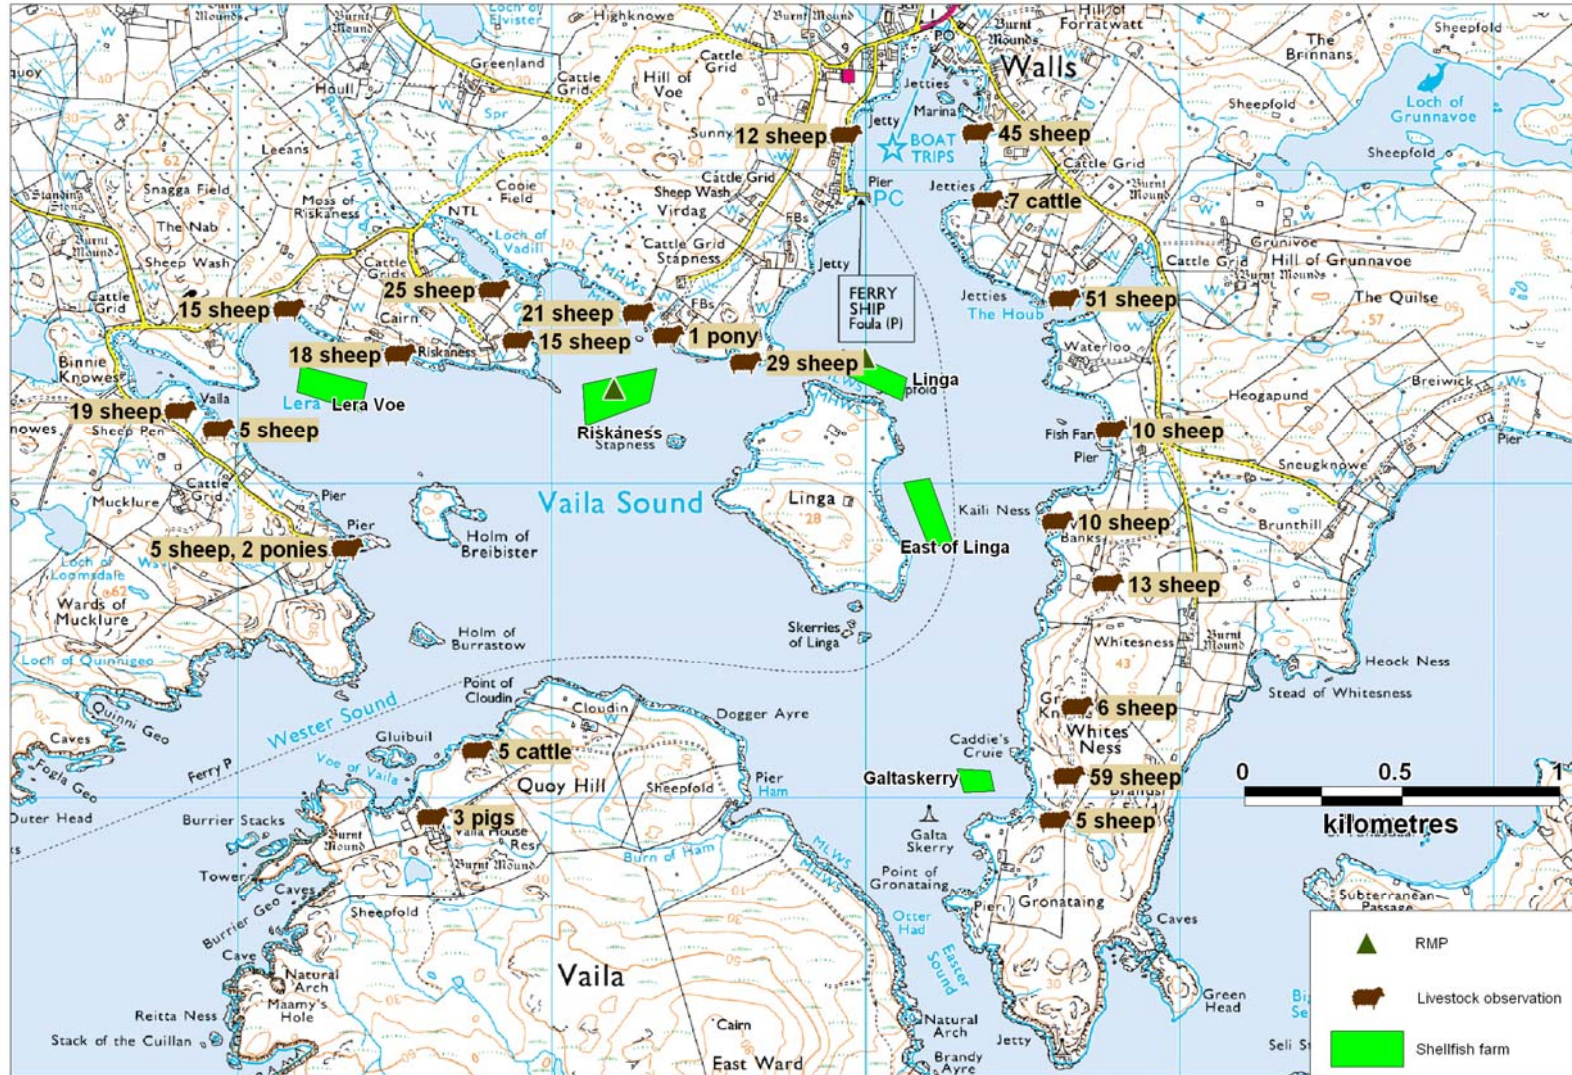
Figure 7.1 Livestock observations at Vaile Sound

The shoreline survey confirmed that sheep grazed widely around the Vaila Sound coastline. Several cattle and three pigs were also observed on the nearby island of Vaila, although no pigs were reported by RERAD in the agricultural census on confidentiality grounds due to the small number of holdings. Sheep were fairly evenly spread around the shoreline of the two production areas. Geographical spread of contamination at the shores of the sound is therefore likely to be fairly even.

Numbers of sheep will approximately double during May following the birth of lambs, and decrease in the autumn as they are sent to market. Therefore higher impacts from livestock may be expected during this period.

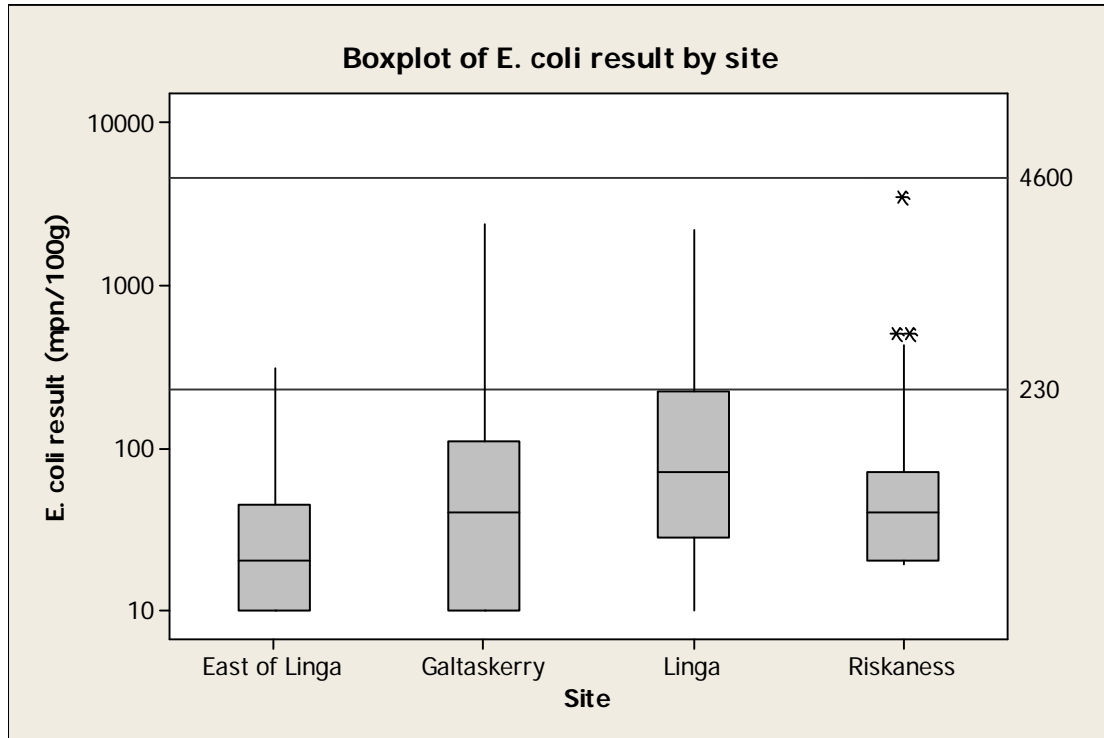
Figure 11.2 Boxplot of all *E. coli* results by site

Levels of contamination at Linga were highest, and were significantly higher than those at Riskaness and East of Linga, but not Galtaskerry. No significant differences were found between Riskaness, Galtaskerry and East of Linga, but sample numbers were low for some comparisons. Overall, contamination was highest at Linga, intermediate at Galtaskerry and Riskaness, and lowest at East of Linga. Lera Voe was not sampled.

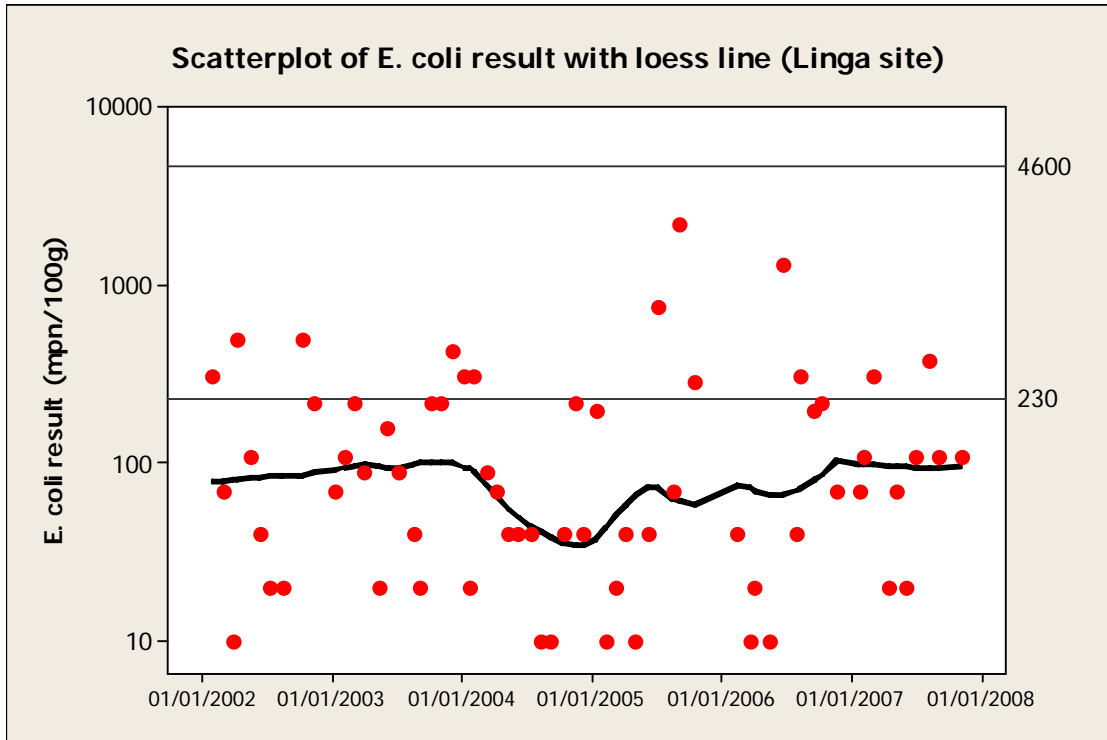
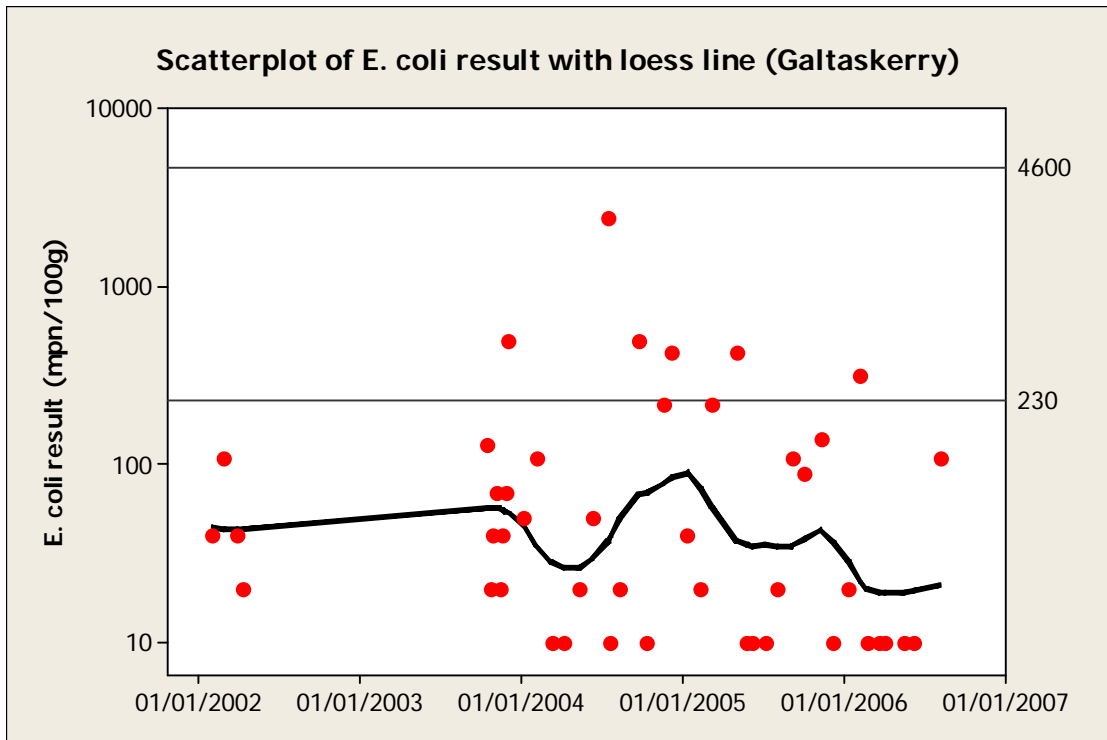
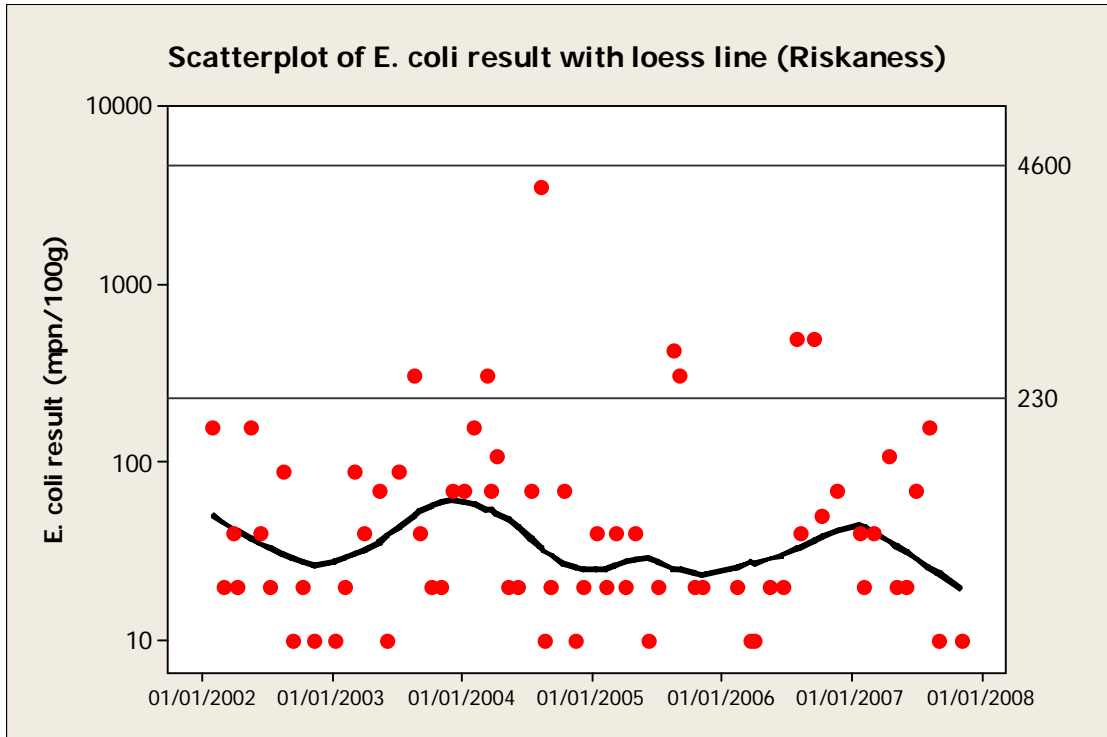
Figures 11.3 to 11.5 present scatter plots of individual results against date for all mussel samples taken from the three sites for which sufficient data was available. They are fitted with Loess trend lines to help highlight any apparent underlying trends or cycles.

No obvious trends or cycles are apparent in Figures 11.3 – 11.5, aside from a possible tendency for higher results during the winter months at Galtaskerry. During 2004, peak results at Linga were lower than those observed at the other two sites.

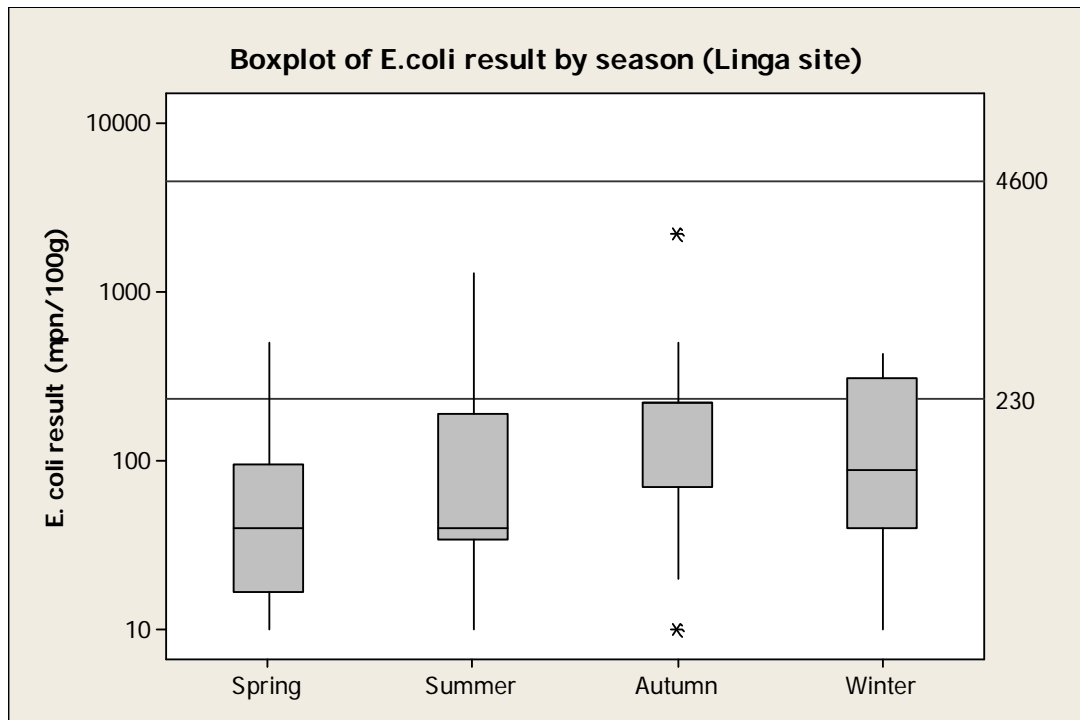
Figure 11.9 Boxplot of *E. coli* result by season (Linga)

For Linga, no significant difference was found between results by season (One-way ANOVA, $p=0.067$, Appendix 5).

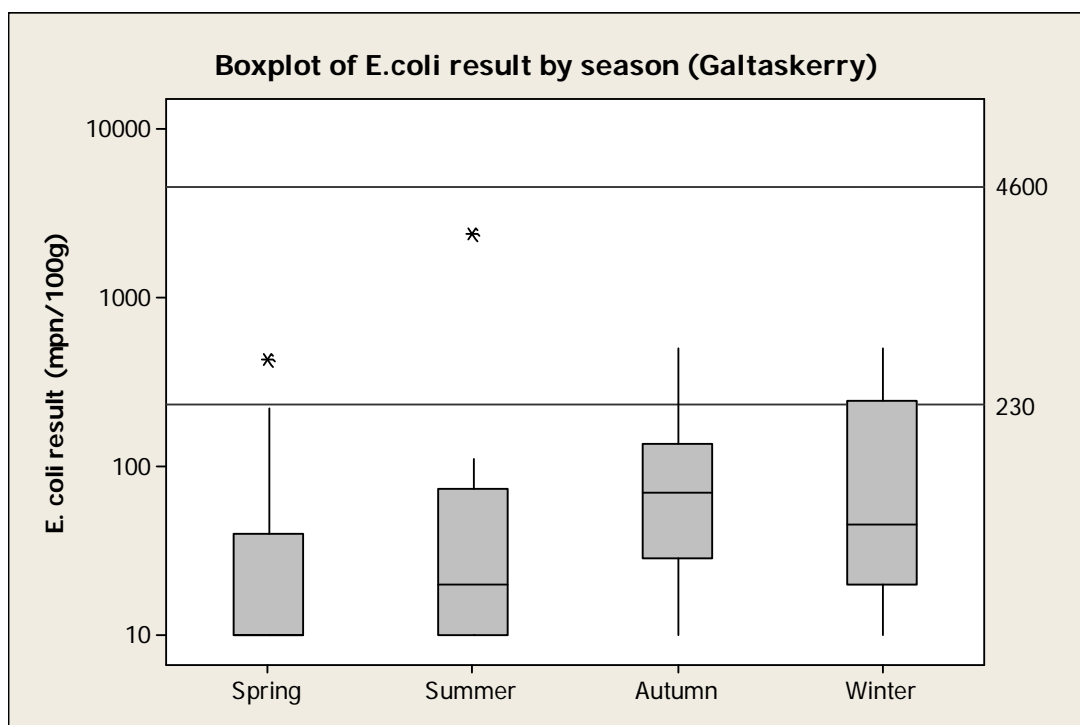
Figure 11.10 Boxplot of *E. coli* result by season (Galtaskerry)

For Galtaskerry, no significant difference was found between results by season (One-way ANOVA, $p=0.243$, Appendix 5).

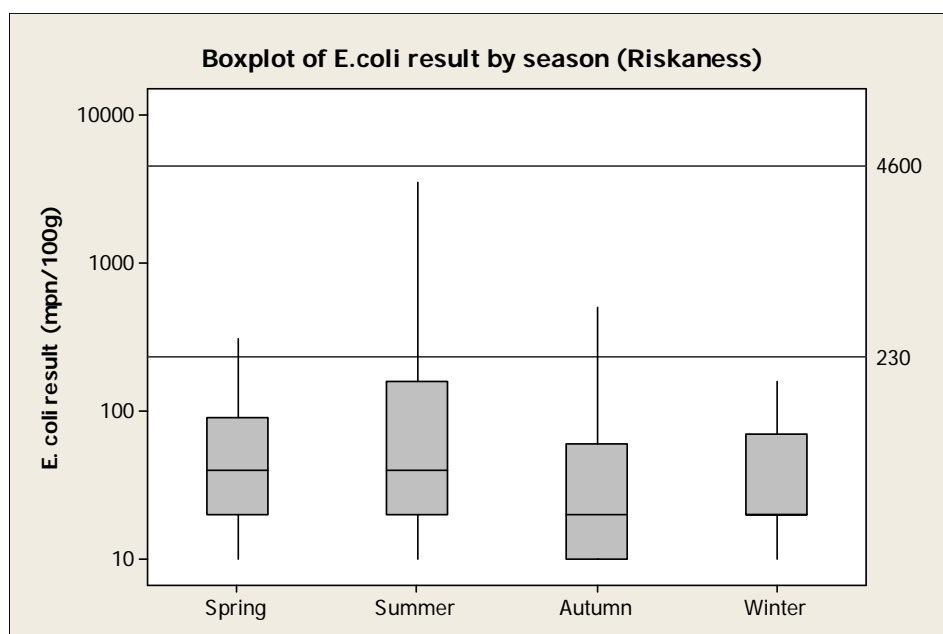
Figure 11.11 Boxplot of *E. coli* result by season (Riskness)

For Riskness, no significant difference was found between results by season (One-way ANOVA, $p=0.324$, Appendix 5). However, the range of results is higher in summer, with highest peak results occurring at this time.

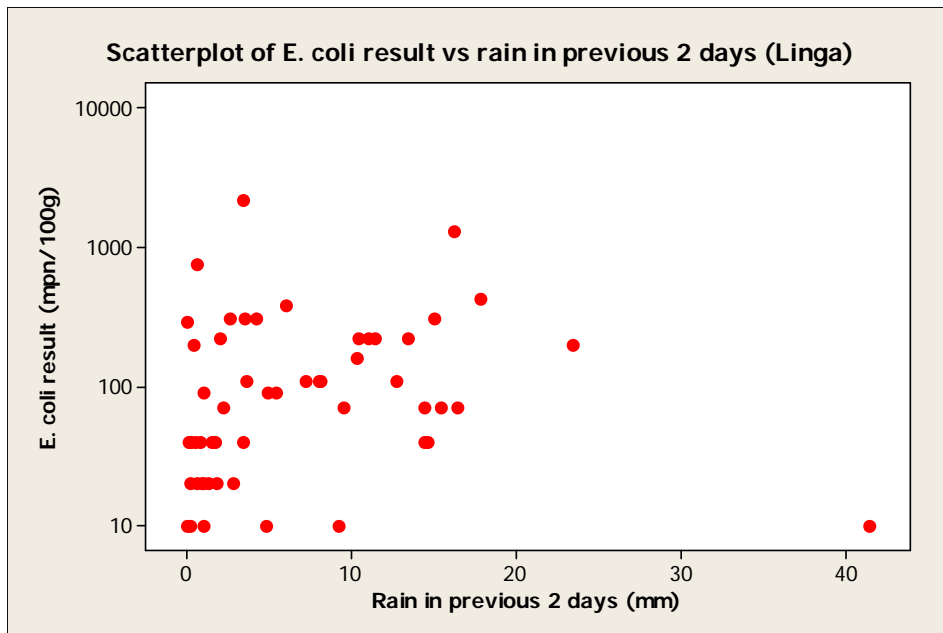
Figure 11.12 Scatterplot of *E. coli* result vs rainfall in previous 2 days (Linga)

A significant positive correlation was found between the ranked *E. coli* result and the ranked rainfall in the previous two days for Linga (Spearman's Rank correlation=0.349, p=0.010, Appendix 5).

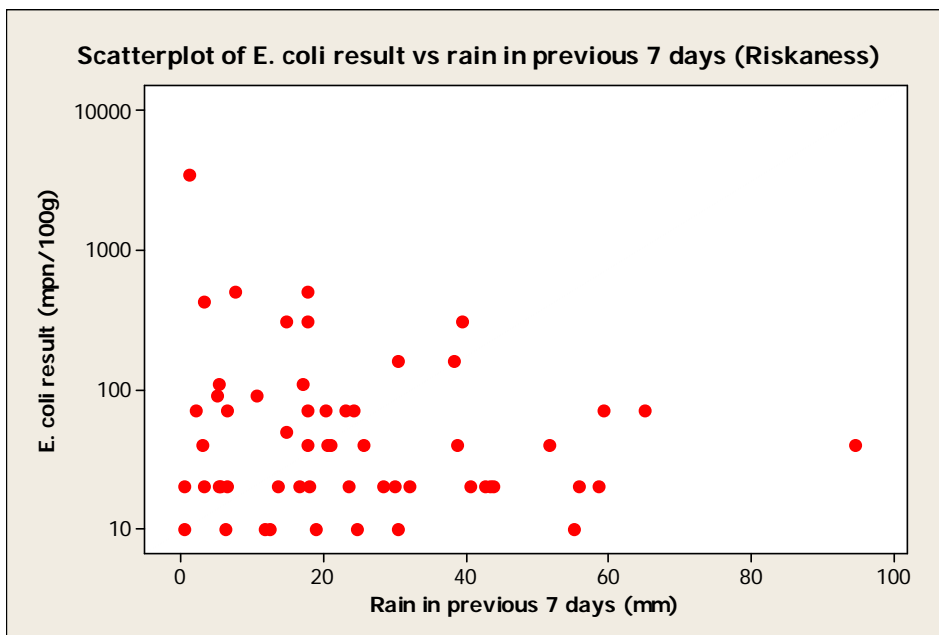
Figure 11.17 Scatterplot of *E. coli* result vs rainfall in previous 7 days (Riskness)

No correlation was found between the ranked *E. coli* result and the ranked rainfall in the previous seven days for Riskness (Spearman's Rank correlation=-0.112, $p=0.410$, Appendix 5).

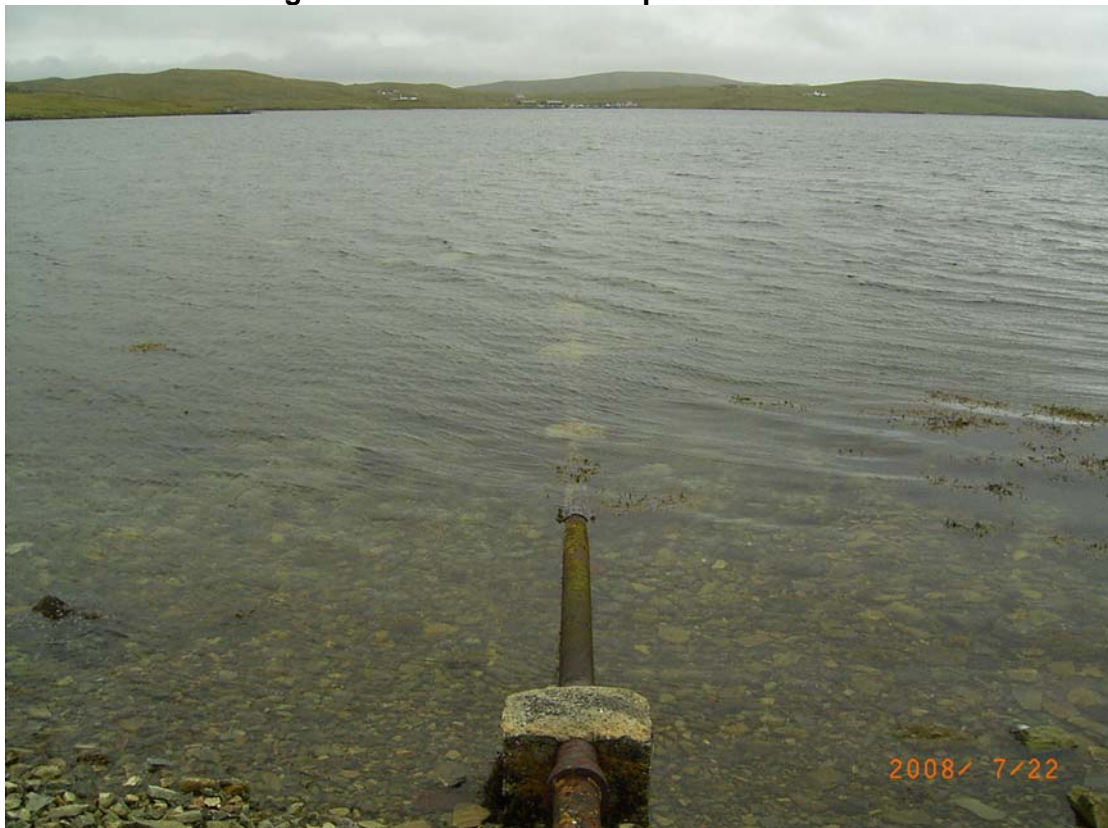
Figure 8 Communal septic tank

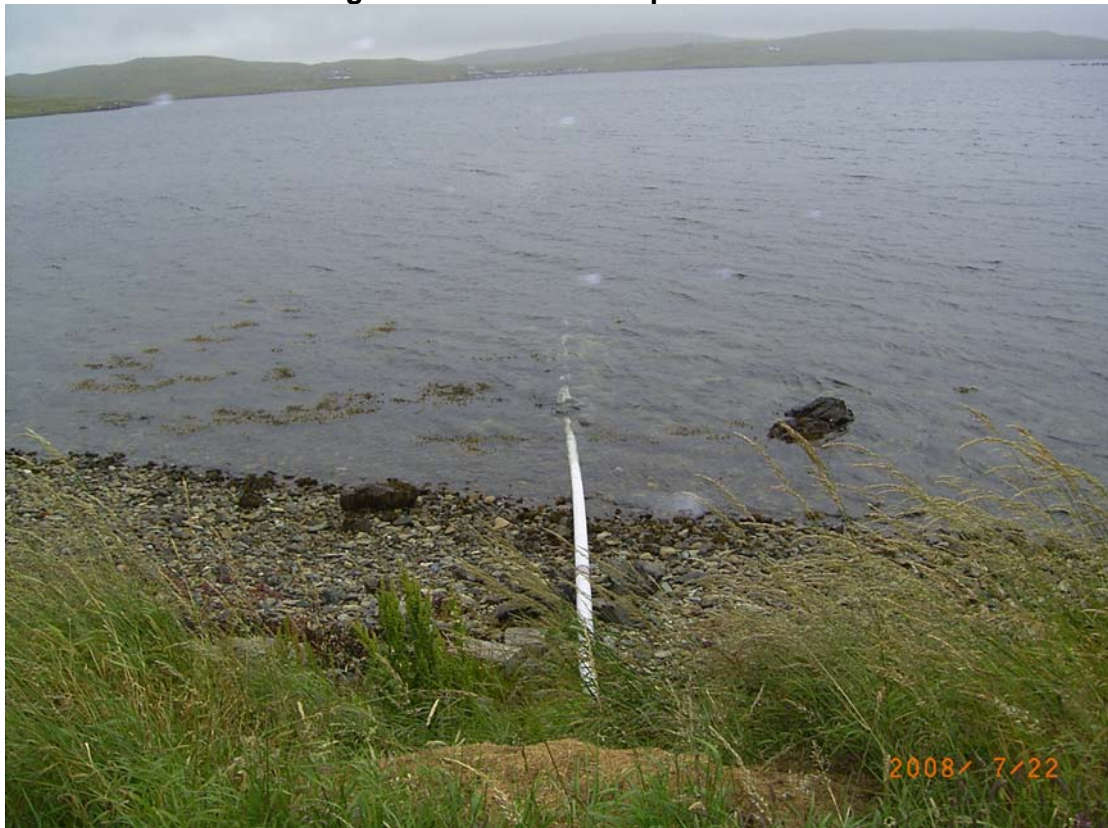
Figure 10 Private septic outfall

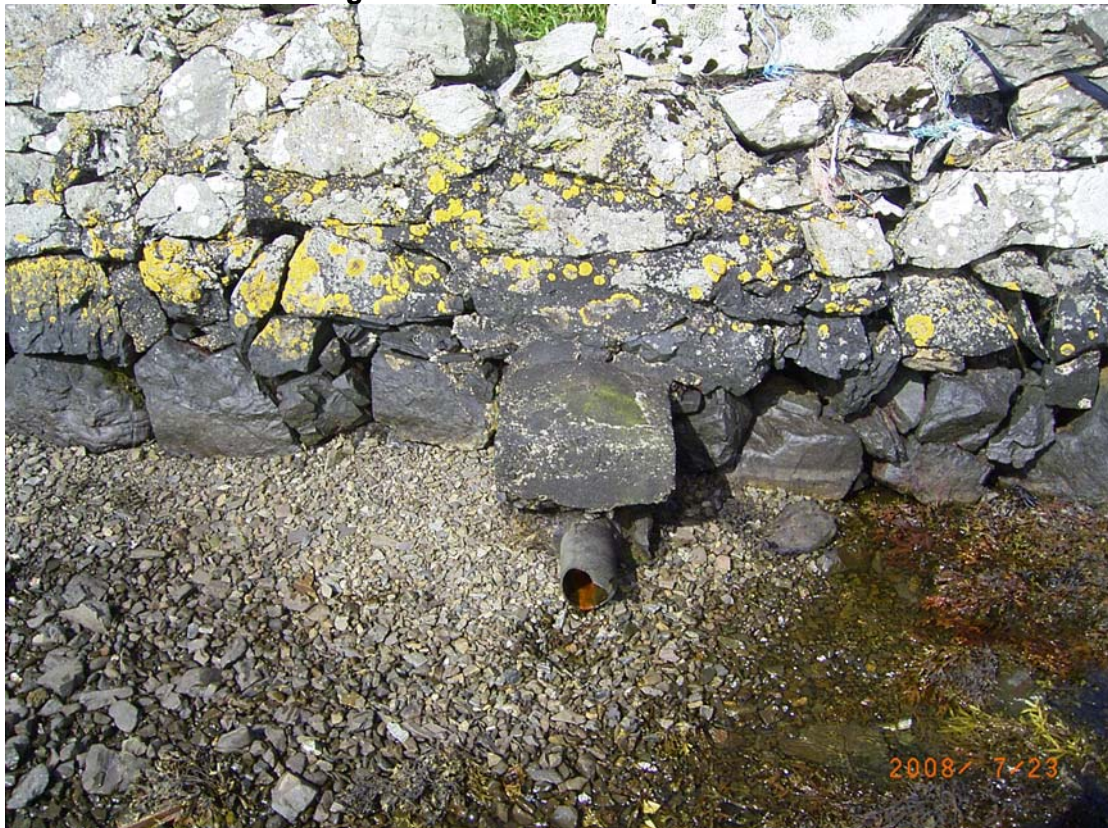
Figure 18 Private septic outfall

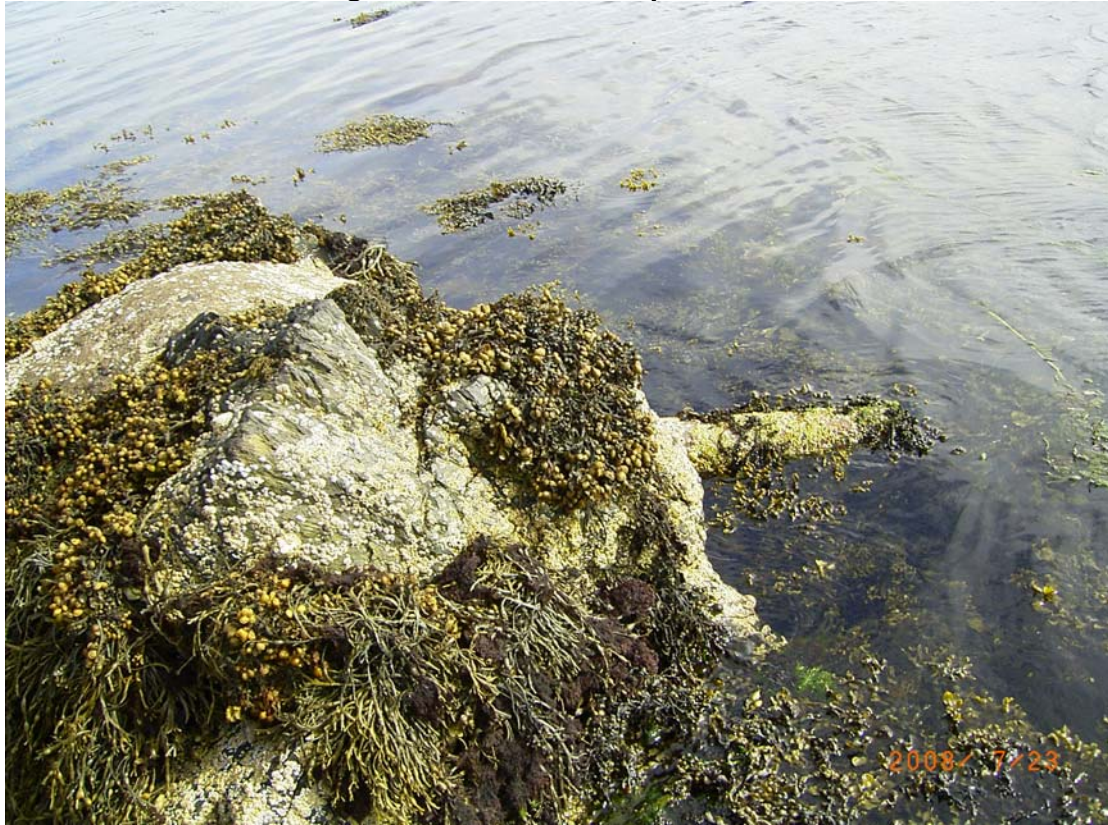
Figure 19 Private septic outfalls

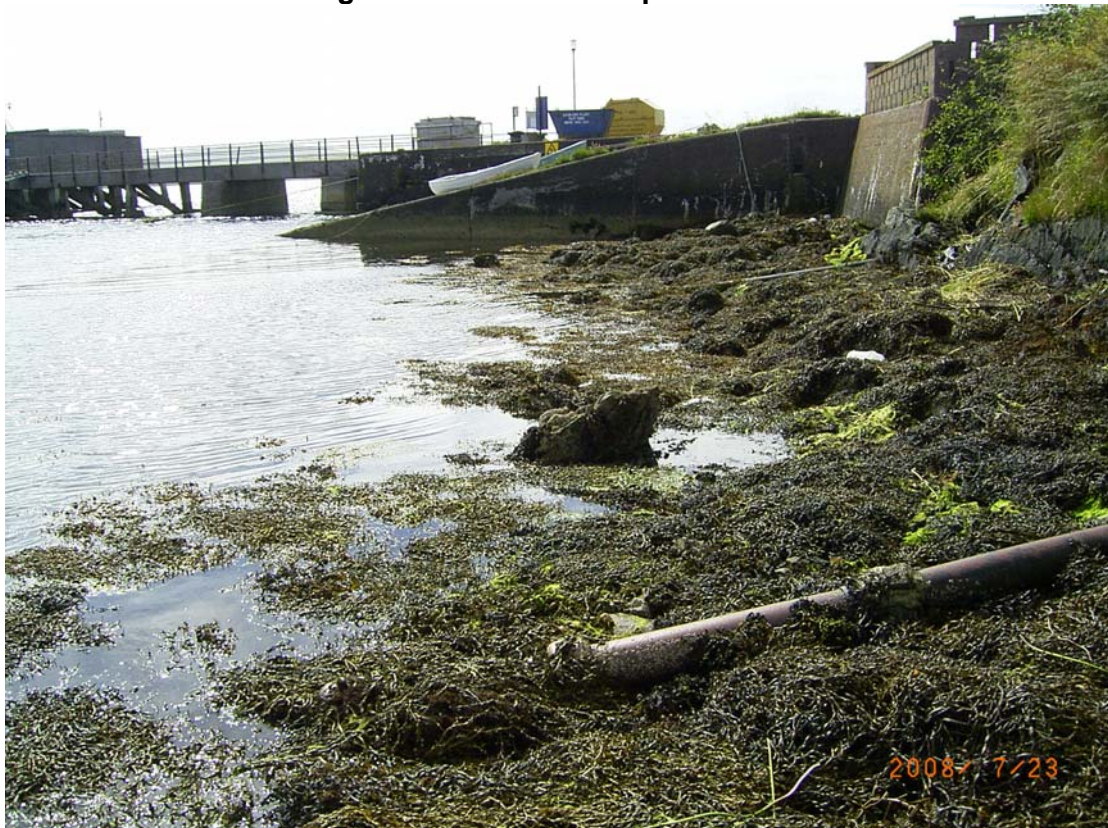
Figure 20 Private septic outfall and stream

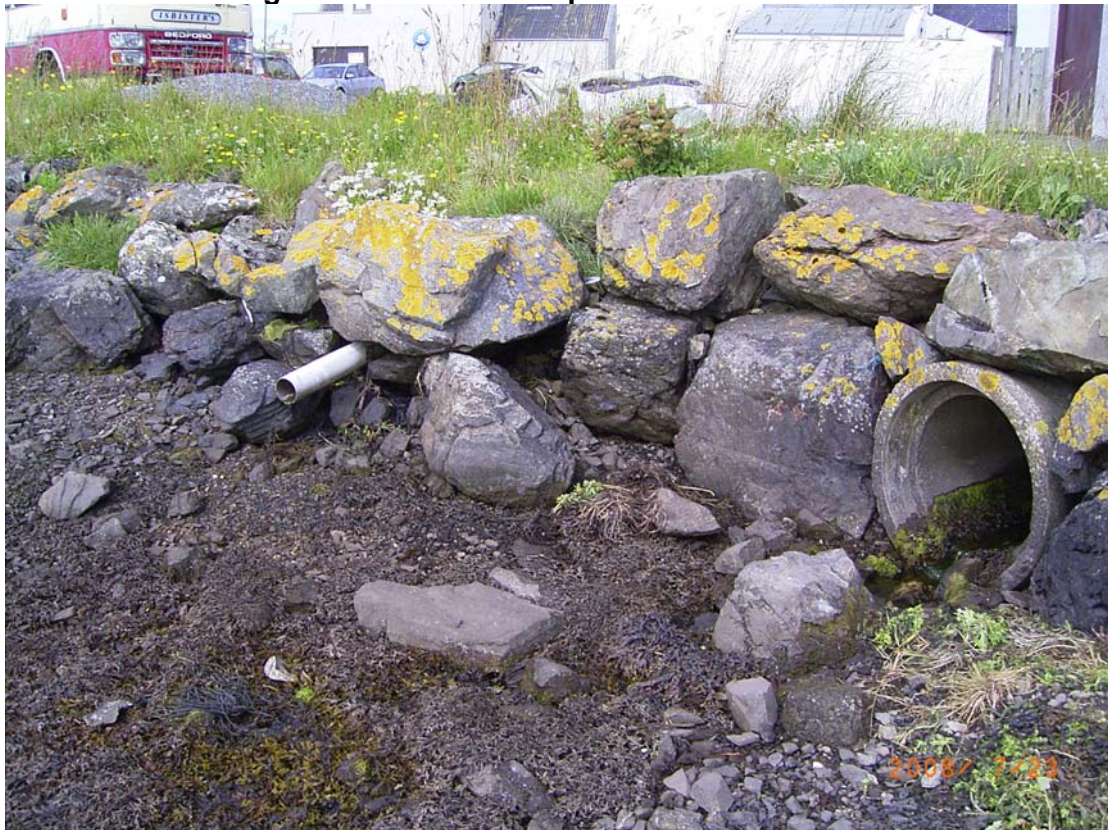
Figure 21 Private septic outfall
