Scottish Sanitary Survey Review

Weisdale Voe
Sanitary Survey Review
SI 468, 469 and 768
May 2014

Report Title	Weisdale Voe Review
Project Name	Scottish Sanitary Survey
Client/Customer	Food Standards Agency Scotland
Cefas Project Reference	C5792F
Document Number	C5792F_2013_3
Revision	V1.1
Date	30/05//2014

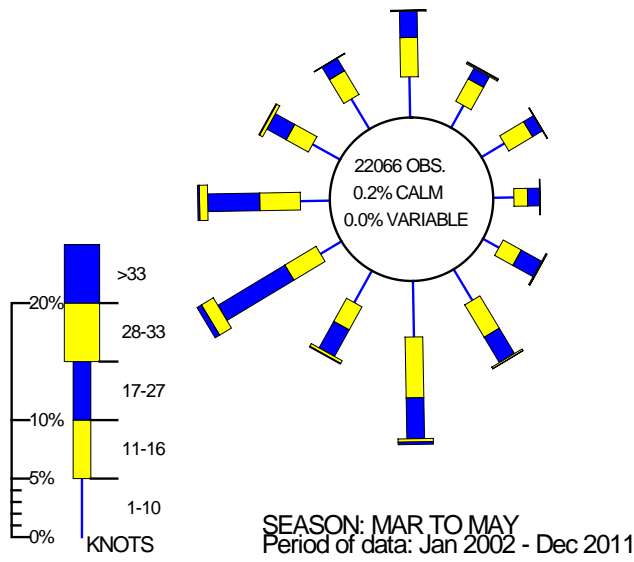
Figure 6.3 Seasonal wind roses for Lerwick (2002-2011)

Prevailing winds throughout all four seasons are between south and southwesterly particularly in autumn and winter. Strong north and northeasterly winds also occurred in summer. This is trend is seen in both datasets from 1996-2005 and 2002-2011.

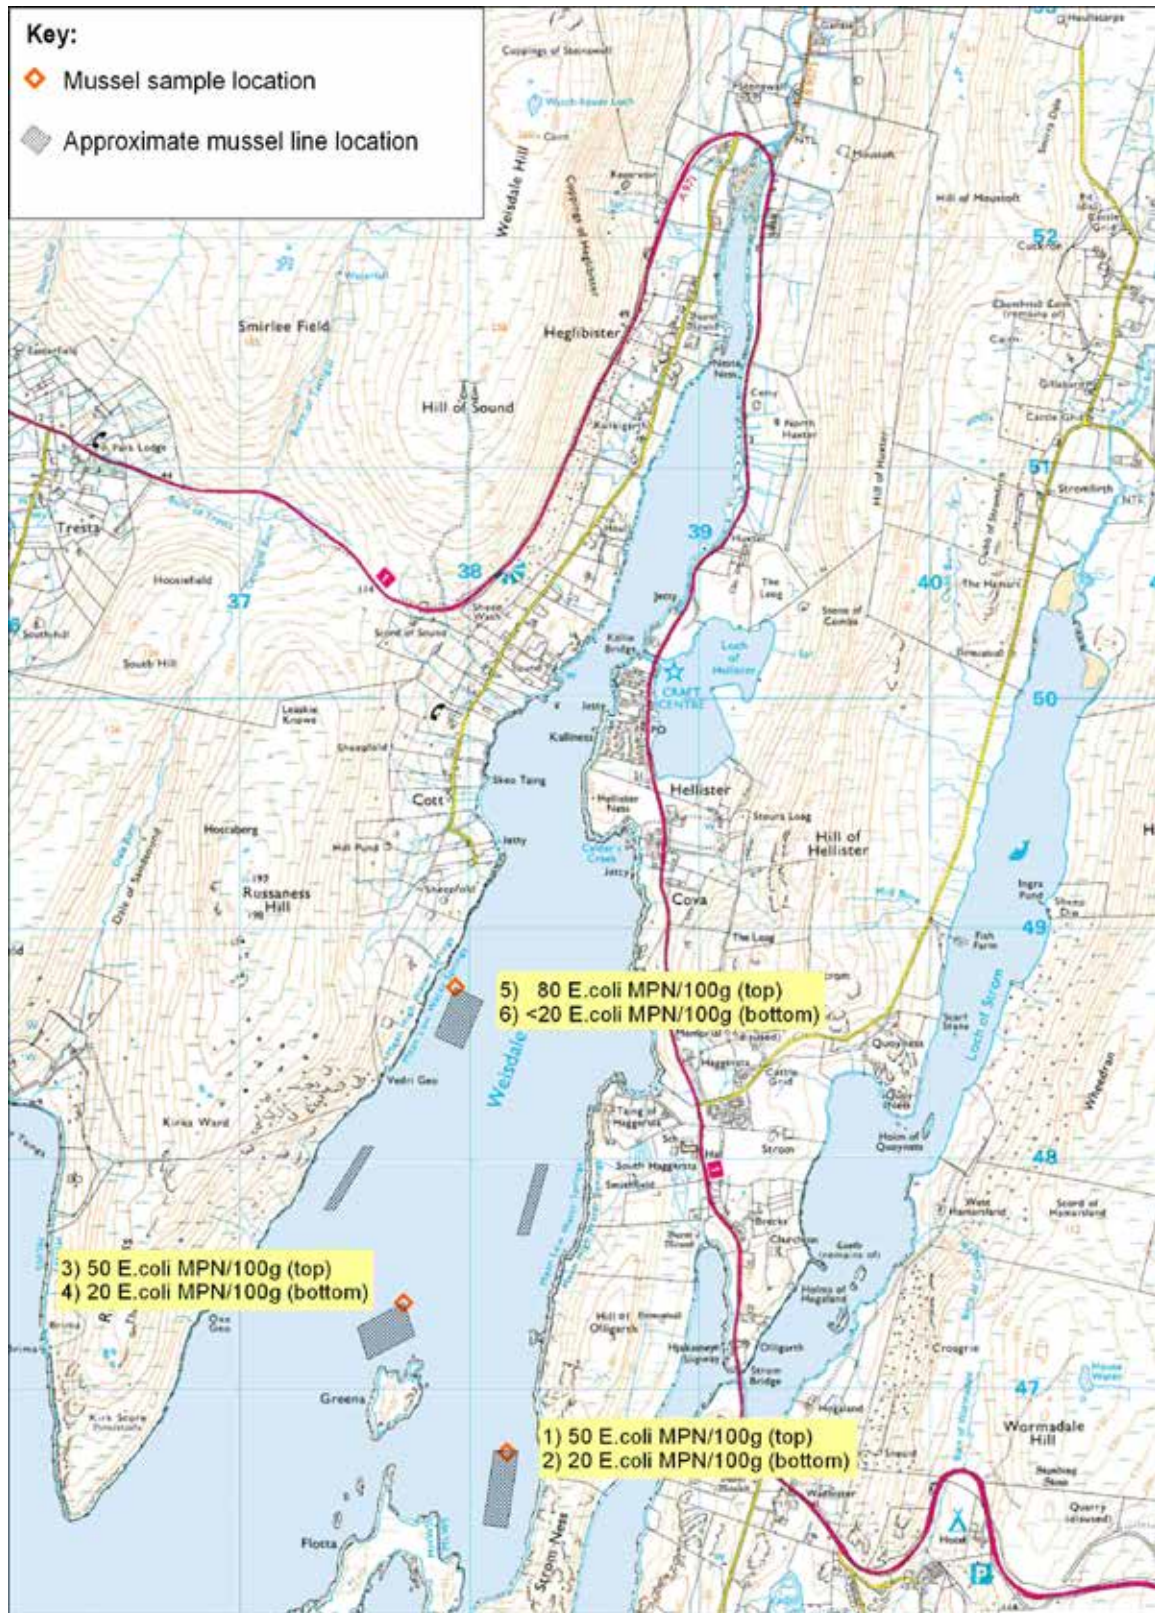
Figure 3 Map of shellfish sample results Weisdale Voe

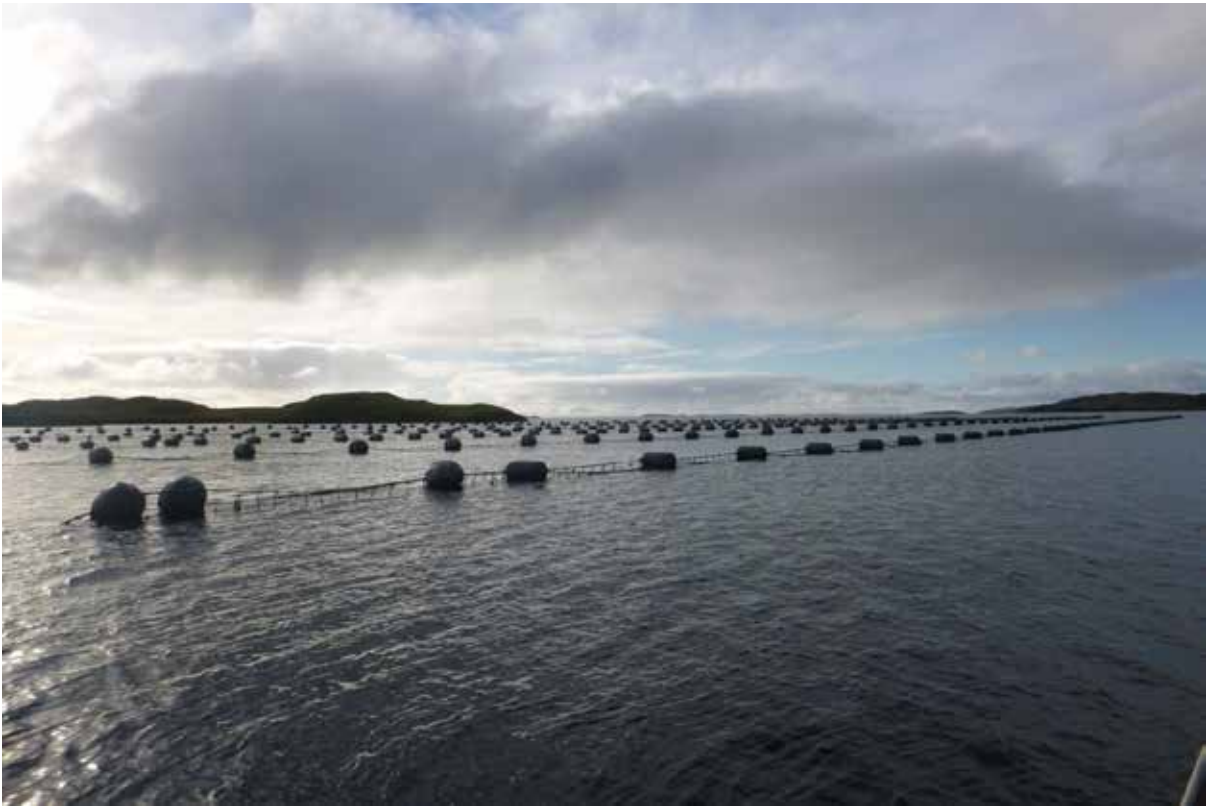
Figure 4 – Mussel lines at the Greena fishery looking south.

The Greena fishery consisted of nine mussel lines running parallel to the western shoreline of the island of Greena (Figure 4). All lines were double headed longlines with 10 metre droppers on the majority of the lines, however due to the depth of the water at the south east corner approximately 100 droppers are present at a depth of 7-8 metres on the innermost line nearest the island of Greena. Two mussel samples were collected from the north west corner of the site. The site is licenced for six 210 metre quad-headline longlines.

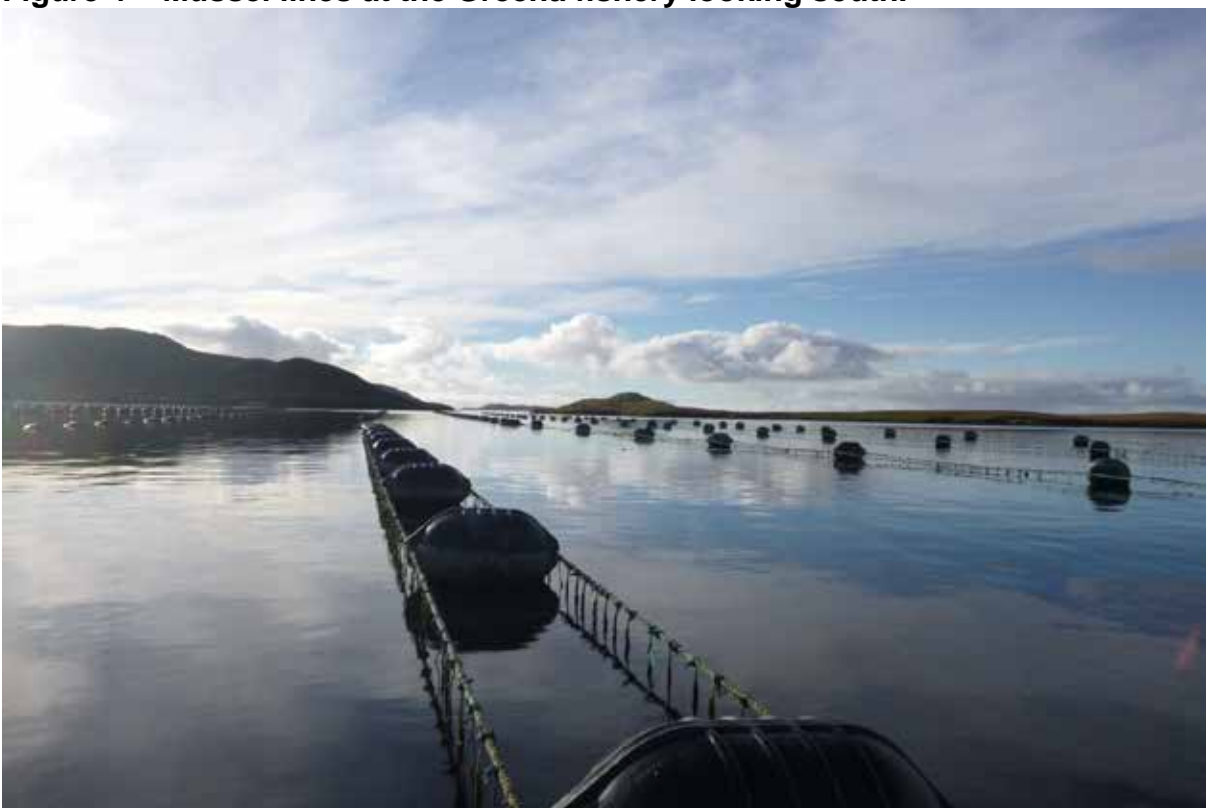
Figure 5 – Mussel lines at the North Flotta fishery looking south.

The North Flotta fishery consisted of seven mussel lines running parallel to the eastern shoreline (Figure 5). All lines were double headed longlines with 10 metre droppers. Two mussel samples were collected at the north end of the site. The site is licenced for seven 330 metre twin-headline longlines.

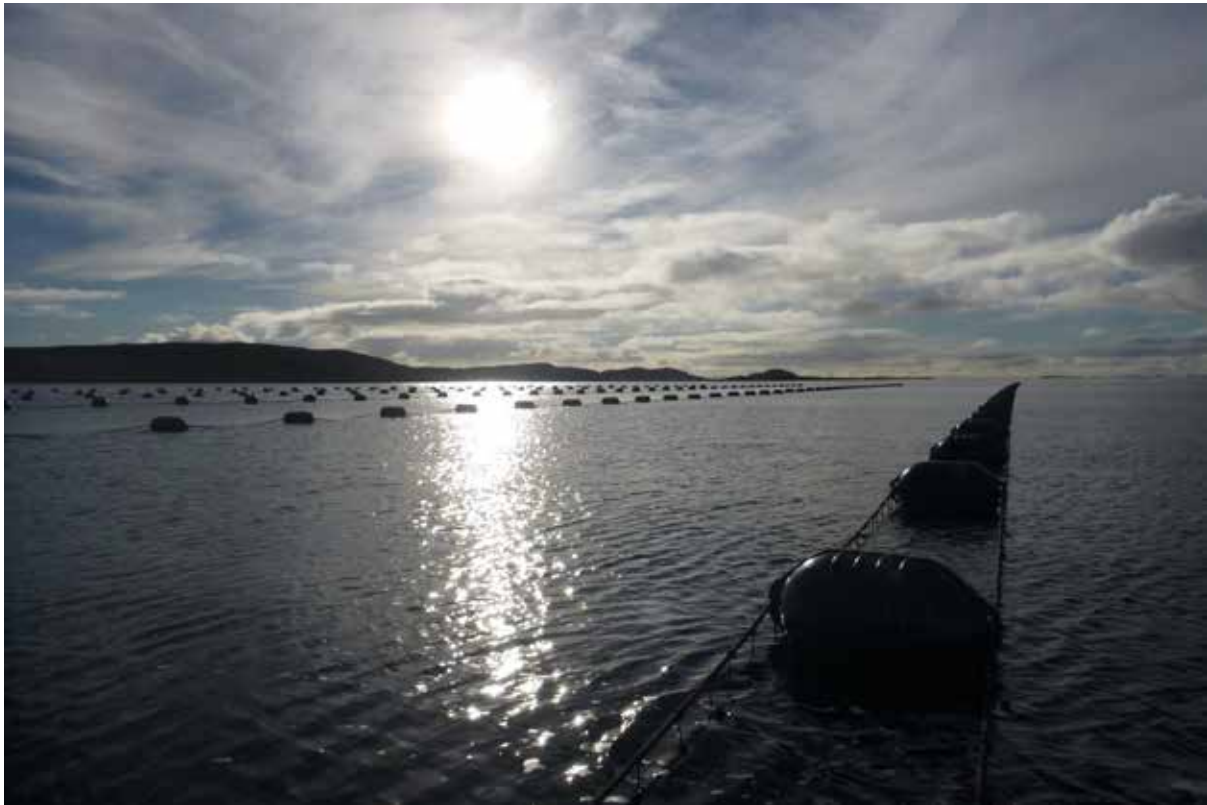
Figure 6 – Mussel lines at the Vedri Geo fishery looking south.

The Vedri Geo fishery consisted of six mussel lines running parallel to the western shoreline (Figure 6). All lines were double headed longlines with 10 metre droppers. Two mussel samples were collected from the north west corner of the site. The site is licenced for six 210 metre quad-headline longlines.

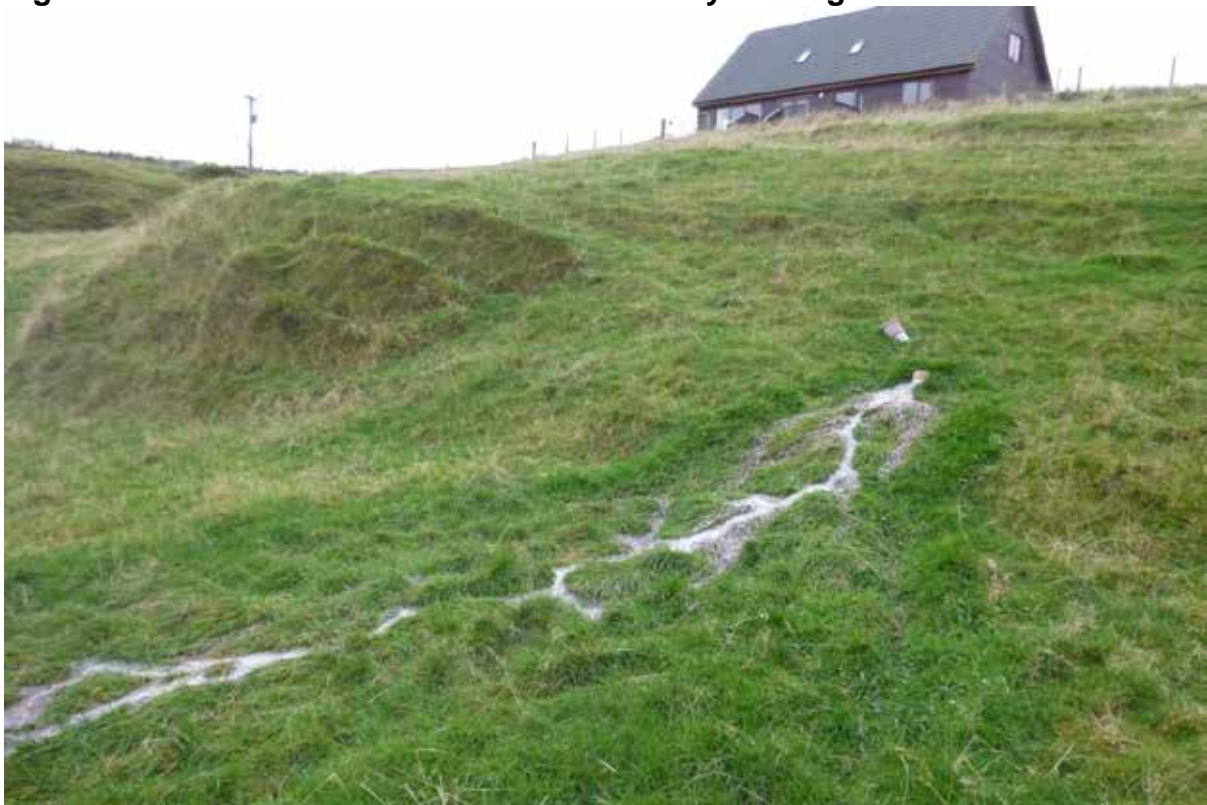
Figure 7 – Overflow from a septic tank for a property in the Cott area.

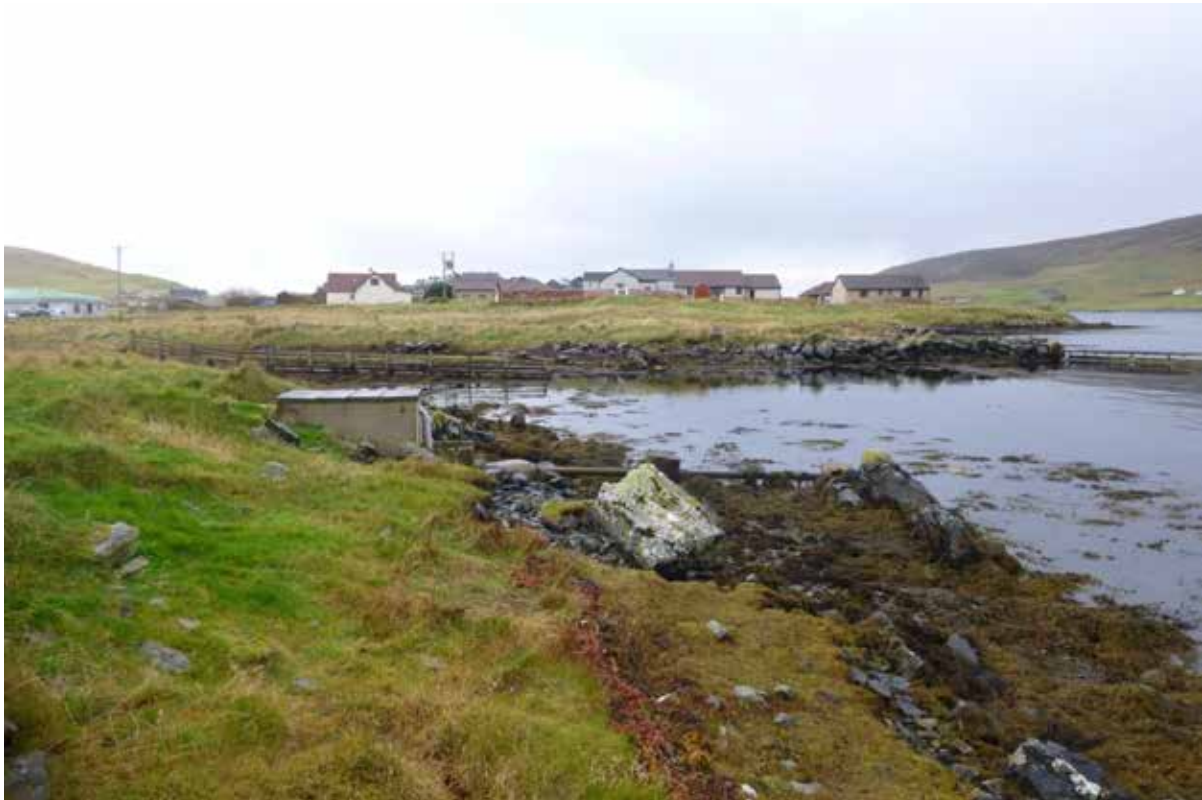
Figure 8 – Septic tank and discharge pipe at the north end of Kalliness where a seawater sample was obtained.

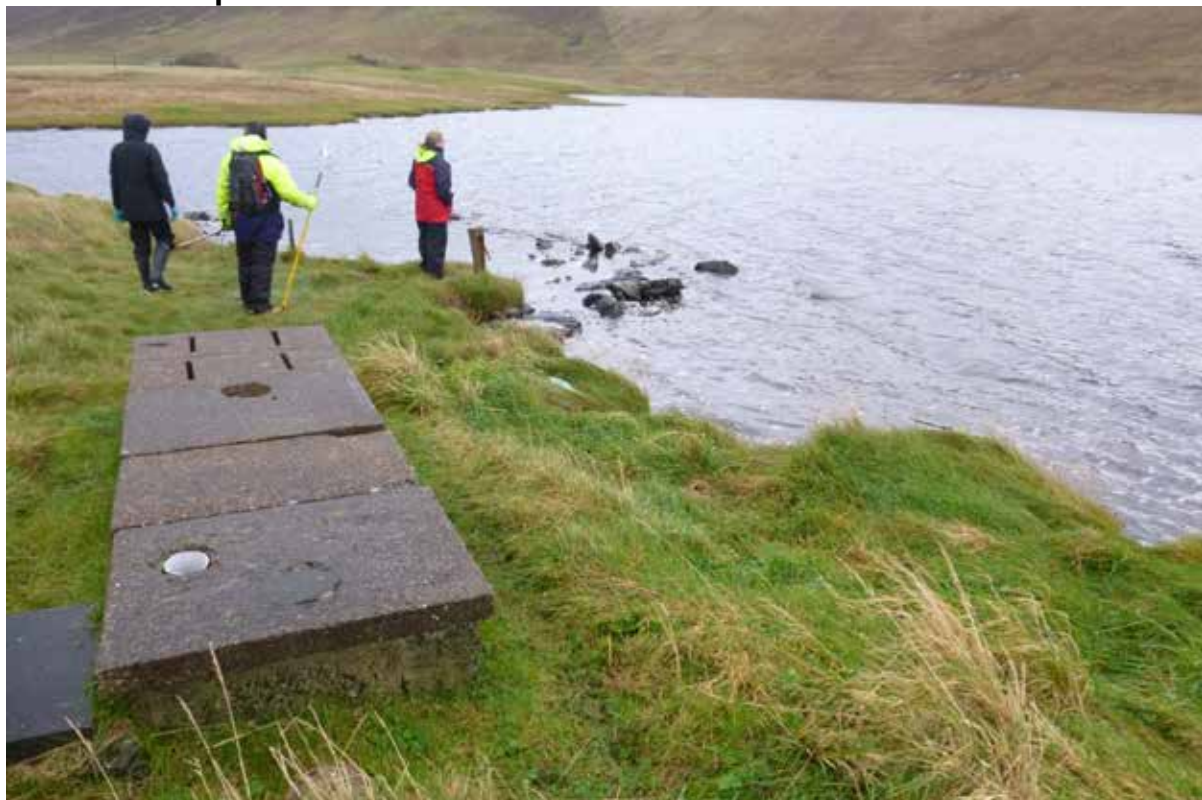
Figure 9 – Septic tank servicing the Shetland Jewellery workshop and visitors centre adjacent to the Loch of Hellister.

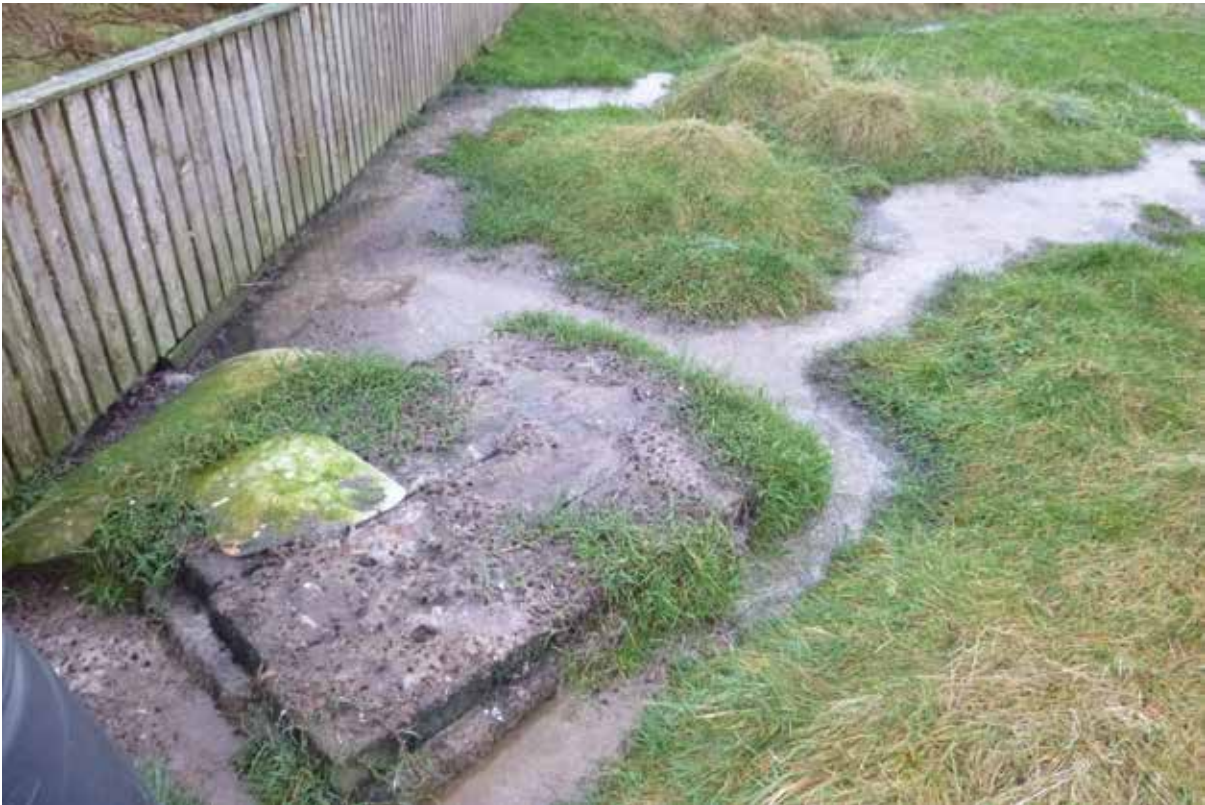
Figure 10 – Overflowing septic tank at Calder's Creek.

Subsequent to consultation on the draft of this review report, SEPA operations identified that they intended to carry out an inspection of the septic tanks identified as overflowing to determine if they pose any risks.

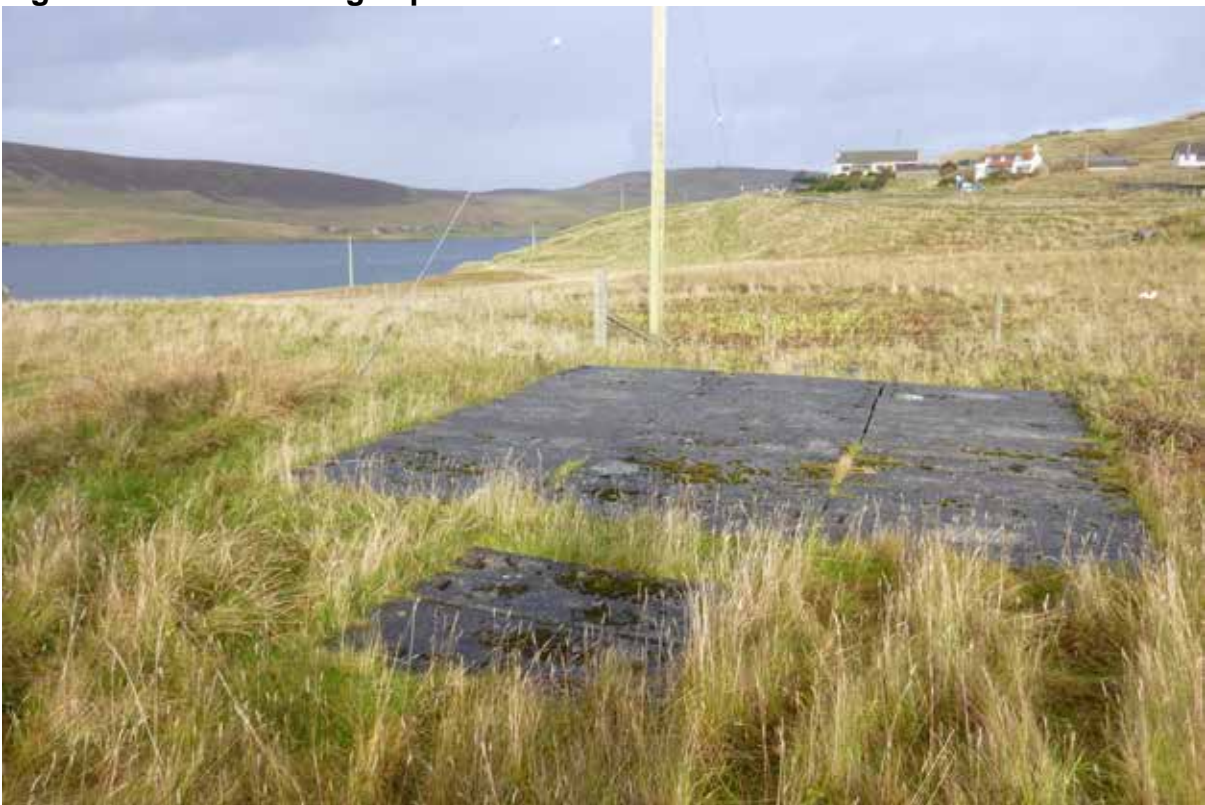
Observations of associated sewage related infrastructure were made in the close vicinity of the three community STs during the 2013 survey. However, the Clach-na-Strom ST was observed to be more than 200 m southeast and further inland than the original location stated in the 2007 sanitary survey report.

Figure 11 – Clach-na-Strom community septic tank.

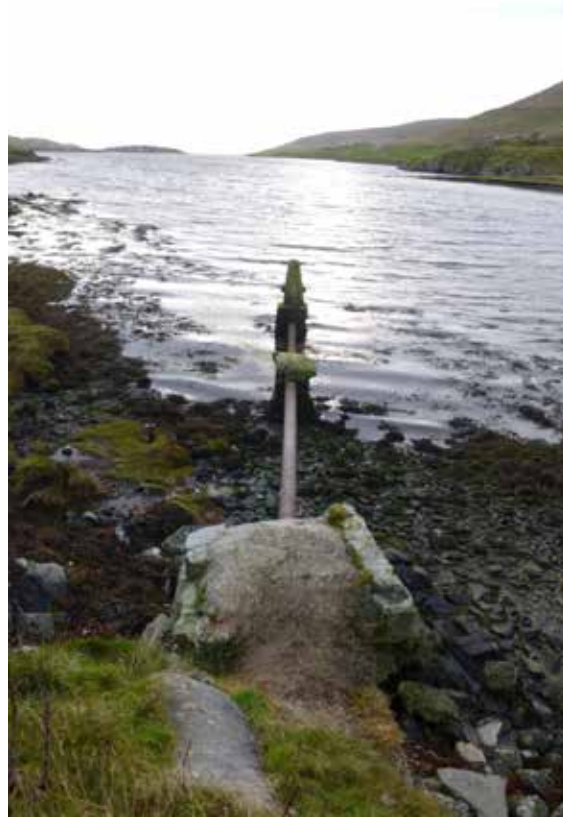
Figure 12 – Discharge pipe associated with the Swedish Houses community septic tank.

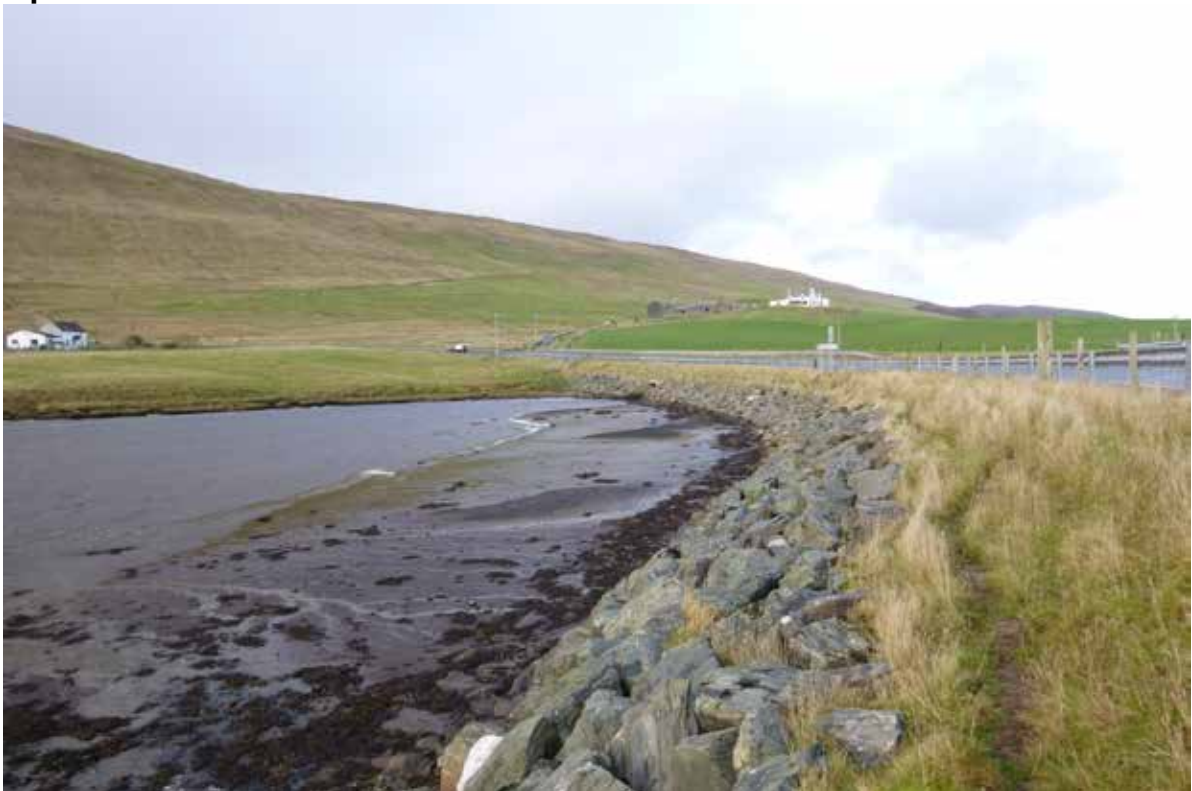
Figure 13 – Head of Weisdale Voe where the Burn of Weisdale joins the voe.

shore. A freshwater sample which was planned in Kalliness was exchanged for a seawater sample due to multiple discharges noted in the area. The six watercourses sampled were found to have *E.coli* levels between 2-60 cfu/100ml. The sample with the highest *E.coli* count (60 cfu/100ml) was obtained from the Burn of Weisdale at the head of Weisdale Voe (Figure 13).

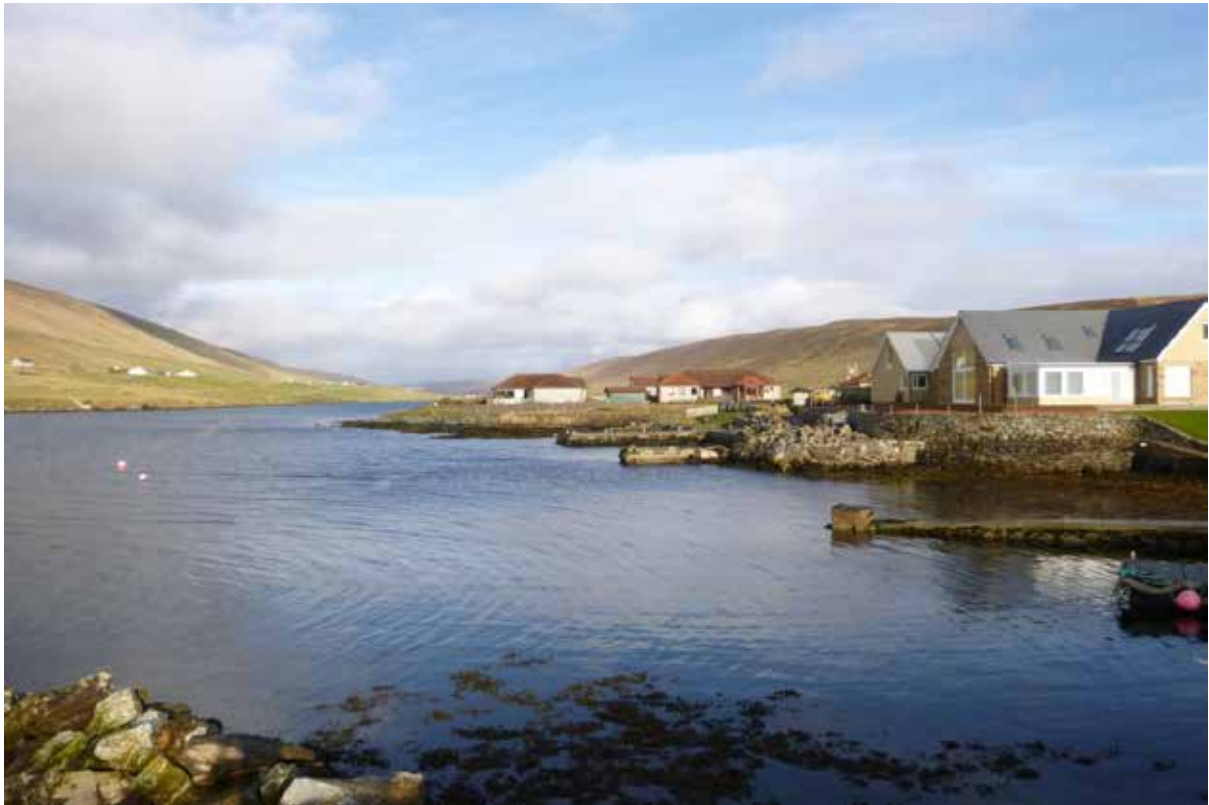
Figure 14 – Seawater sample obtained from a jetty in a small embayment at Kalliness where multiple discharge pipes were observed.

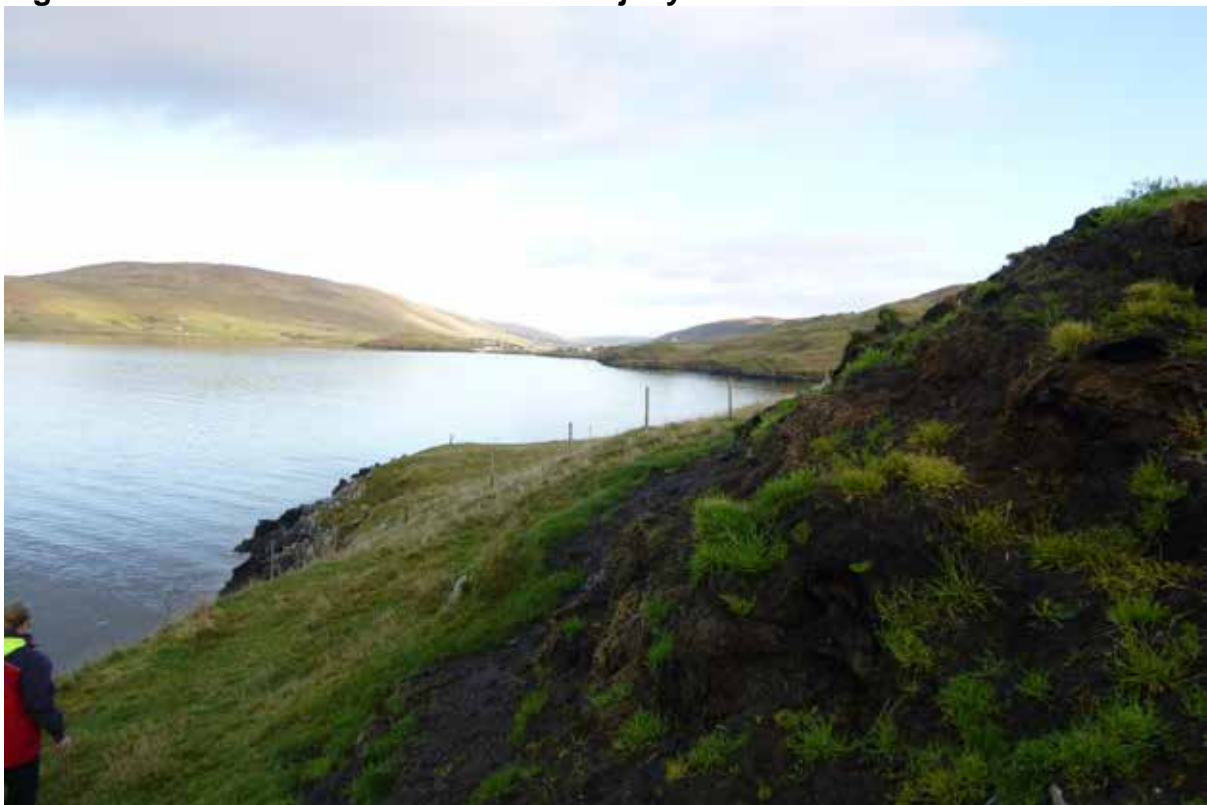
Figure 17 – Pile of manure at the south end of Haggersta.

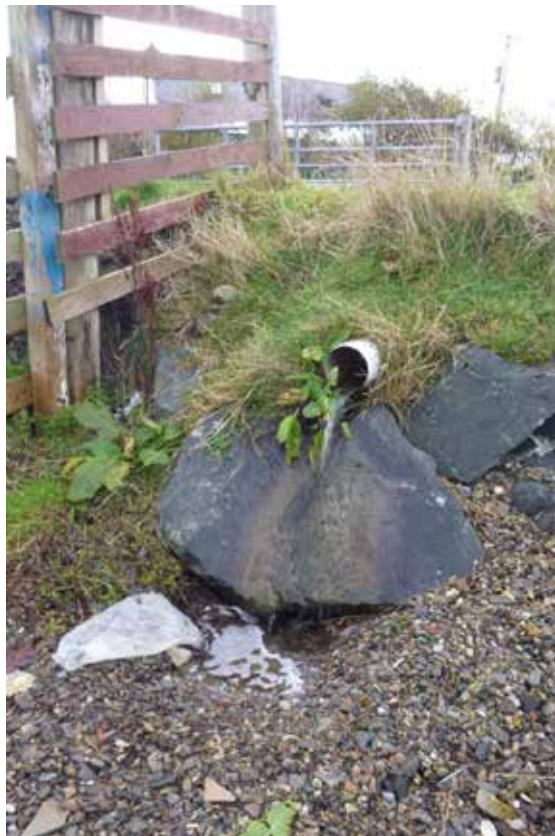
Figure 21 – Additional freshwater sample obtained from a discharge pipe next to a property in the Haggersta area.

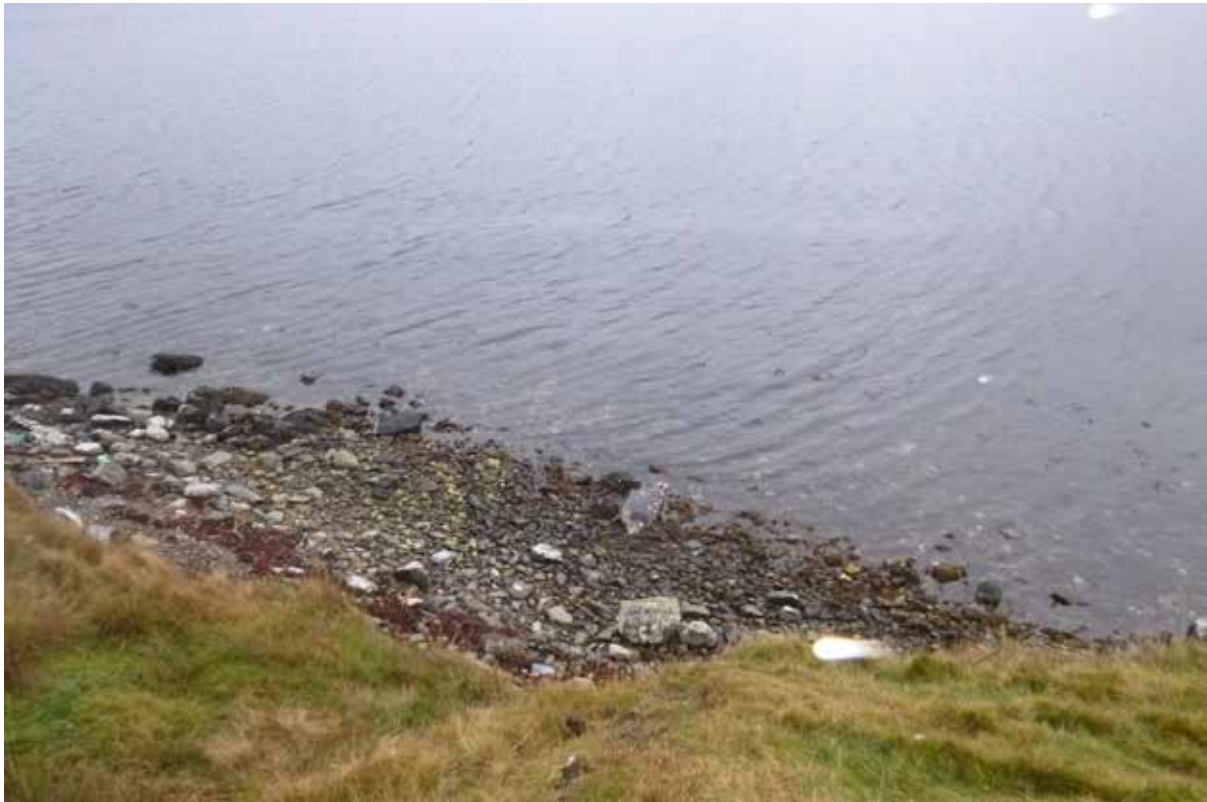
Figure 22 – Dead seal carcass on the shore located south of Cott.

shore, one at the southern end of the western shoreline walk (Figure 22) and one at the southern end of the Kalliness walk.
