Scottish Sanitary Survey Project

Sanitary Survey Report

West Duart Bay

AB 406 807 13

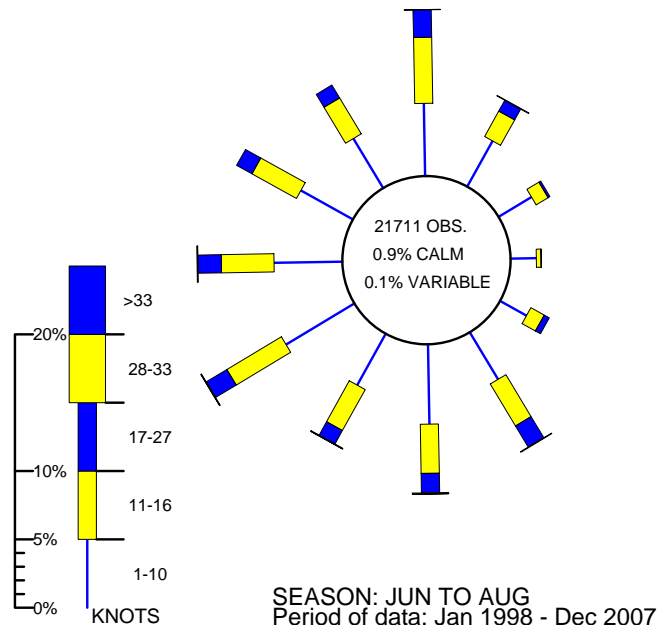
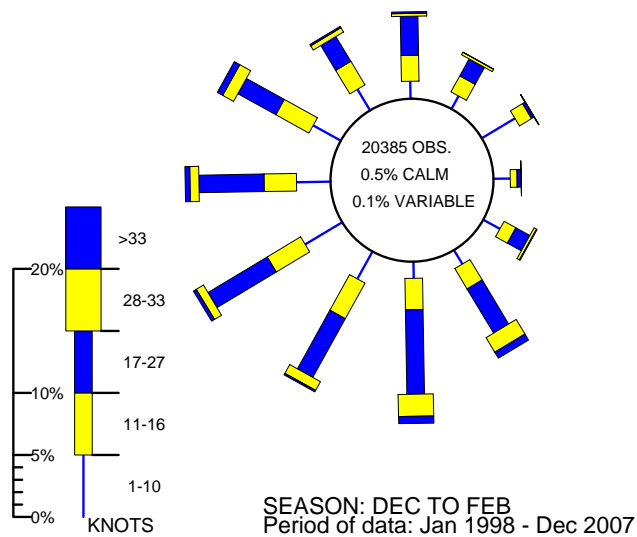
Figure 9.3 Wind rose for Tiree (March to May)

Figure 9.4 Wind rose for Tiree (June to August)

Figure 9.5 Wind rose for Tiree (September to November)

Figure 9.6 Wind rose for Tiree (December to February)

Figure 9.7 Wind rose for Tiree (All year)

The prevailing wind direction at Tiree is from the south and west, but wind direction often changes markedly from day to day with the passage of weather systems. Winds are lightest in the summer and strongest in the winter. A significant proportion of winds in spring and summer are from the north.

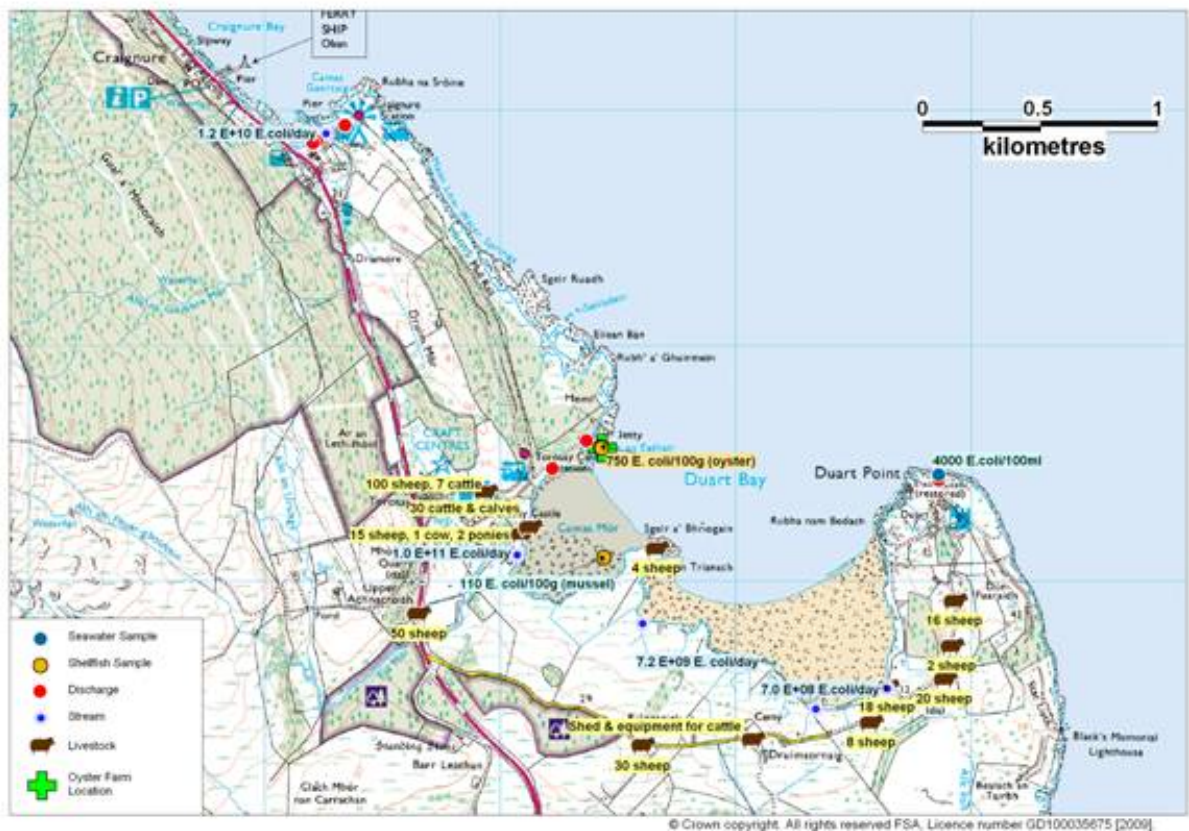
Figure 15.1 Summary of shoreline survey observations

There were three rows of oyster trestles in place in a small bay to the north of the main bay at Camas Mor. The harvester found the main body of the bay at Camas Mor to be too exposed and shifted the trestles to the smaller area at Port an Eathair. Oysters of varying sizes were present, including some mature stock.

The land immediately surrounding Duart Bay was primarily rough grassland used for grazing livestock. Sheep and cattle grazed here had free access to the shoreline, and were observed wading in the bay and across the streams feeding into the bay. Highest densities of livestock were seen around Torosay Castle. To the north of Camas Mor was mixed woodland. To the west of main road at Torosay and extending northward was a large area of coniferous forest. A recently cut area of this was accessible from the road north of Craignure. Otters and deer were reported to be present in the area, though none were observed during the survey. Geese were present in the area and though roughly 20-30 were observed the evening before the survey, only two were observed and counted during the survey walk itself. Oystercatchers and other wading birds were present but not in large concentrations. Several clusters of gulls numbering fewer than 20 birds were observed on the exposed seabed at low tide.

Seawater samples generally had low levels of *E. coli* (<10 cfu/100ml). The one exception to this was a sample taken next to the Duart Castle septic tank outfall, which contained 4000 cfu/100ml. Oyster samples were taken from the small area of trestles on three occasions as part of a bacteriological survey, giving results of 50 *E. coli* MPN/100g on the 21/5/08, and 750 MPN/100g on the 3/6/08 and 3/7/08. A shore mussel sample taken from Camas Mor on 21/5/08 gave a result of 110 *E. coli* MPN/100g.

All larger streams were measured and sampled. *E. coli* levels in the streams sampled ranged from <100 to 1200 cfu/100ml. The largest of these streams, Eas Mor, which also contributed the highest loading in terms of *E. coli* per day, discharges south of where the trestles are located.

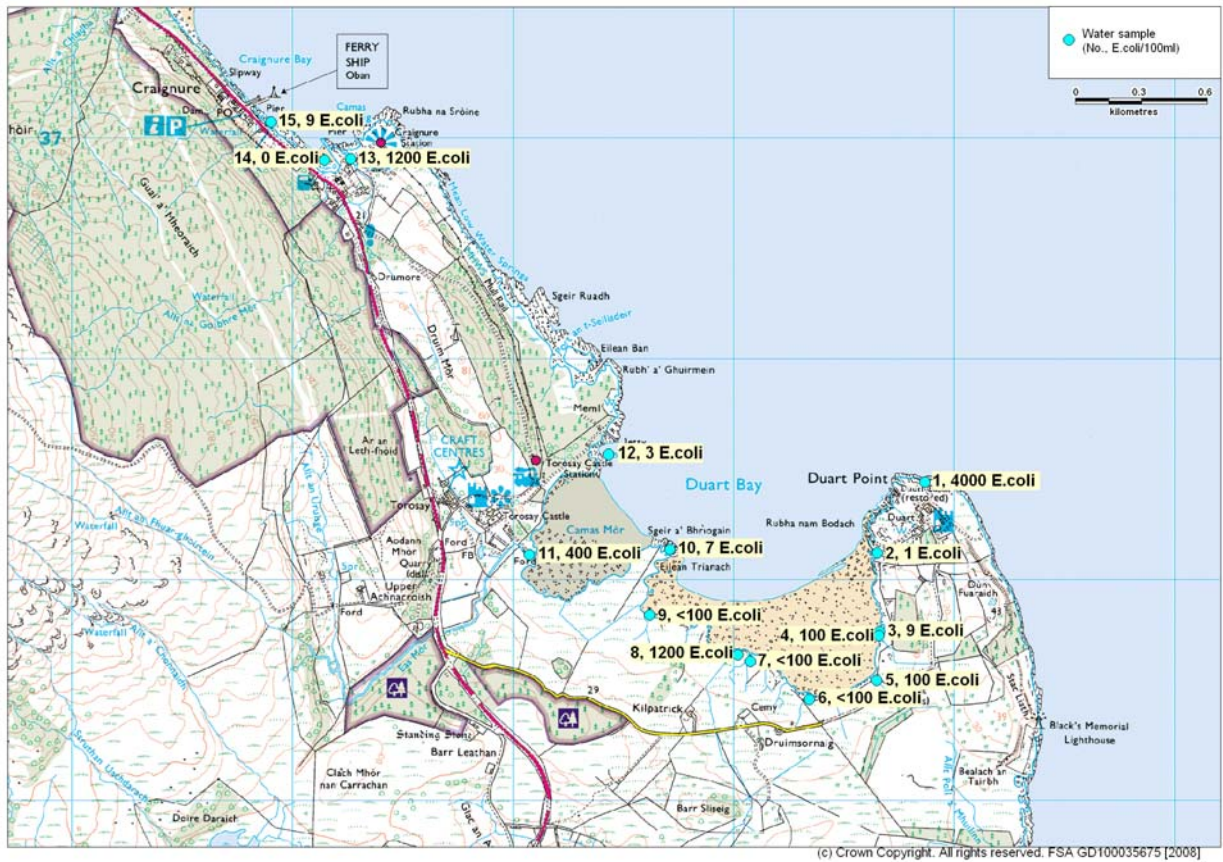
Figure 4. Shellfish sample results map

No.	Date	Sample	Grid Ref	Type	E. coli (mpn/100g)
1	21/05/08	WD Mussel	NM 73441 35104	shore mussel	110
2	21/05/08	WD Oyster 1	NM 73432 35569	oyster	50
3	03/06/08	WD Oyster 2	NM 73427 35573	oyster	750
4	03/07/08	WD Oyster 3	NM 73431 35569	oyster	750

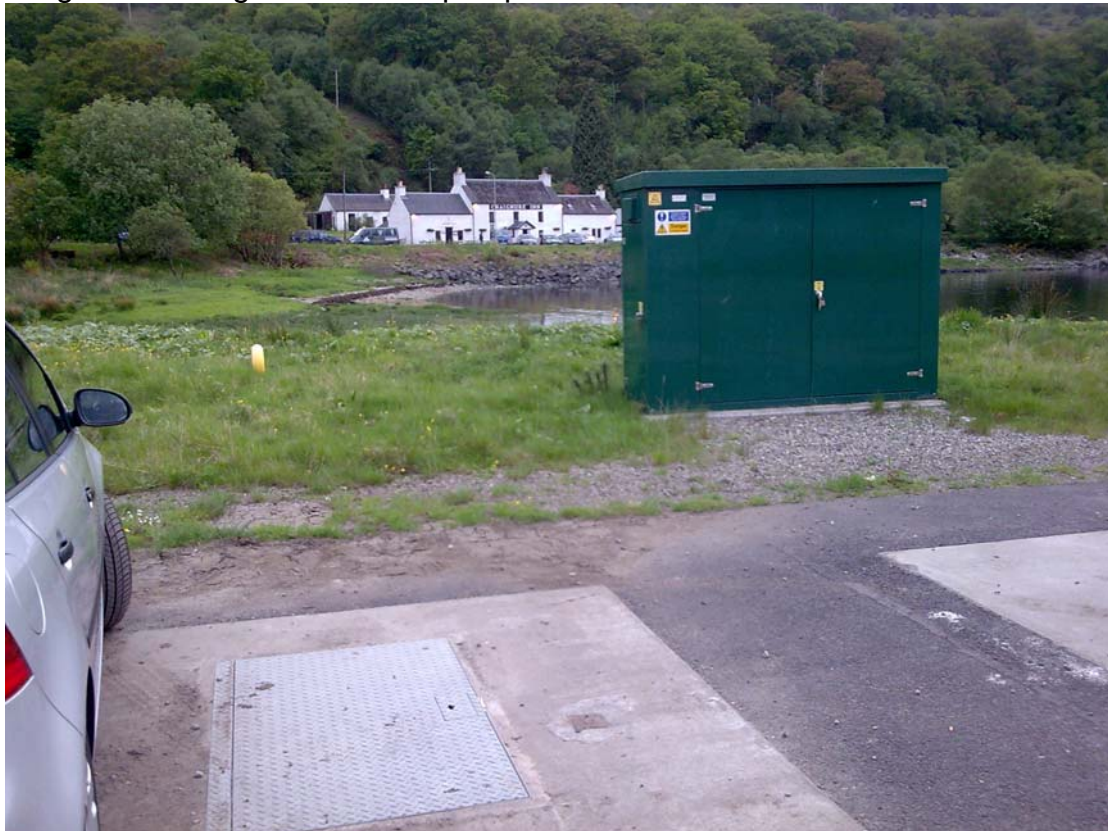
Figure 5. Criagnure WWTW pump and tanks

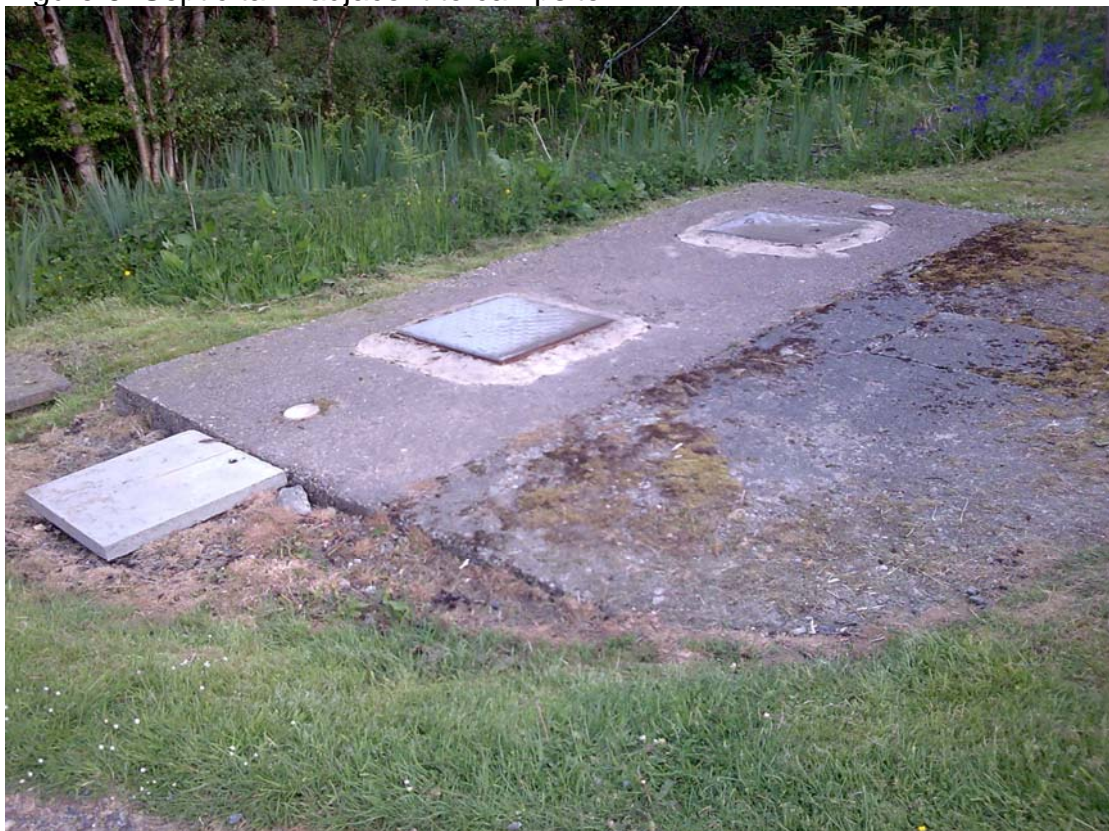
Figure 6. Septic tank adjacent to campsite

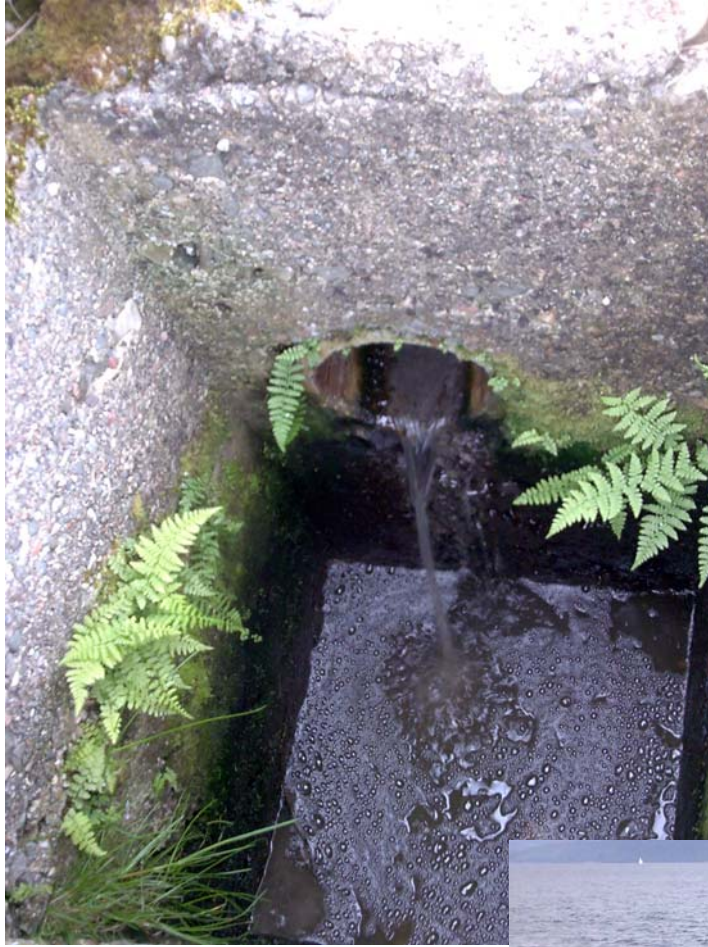
Figure 7. Open tank with dirty water flow

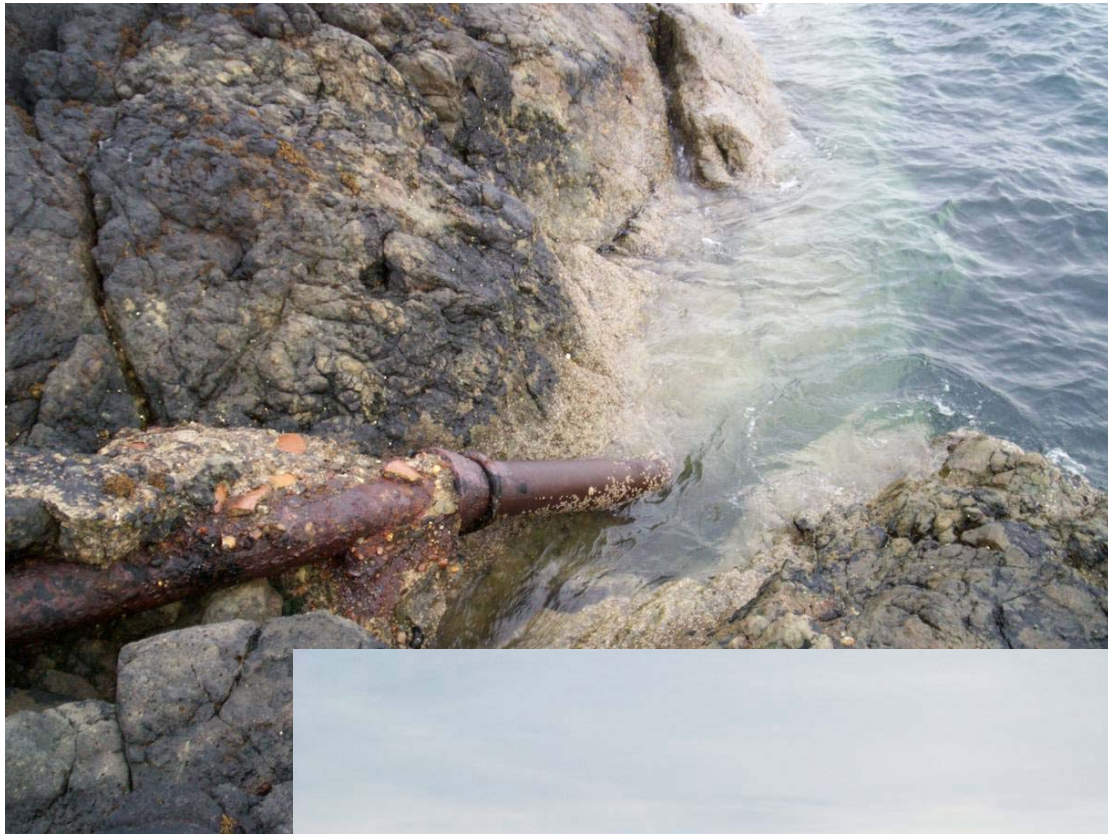
Figure 9. Discharge pipe

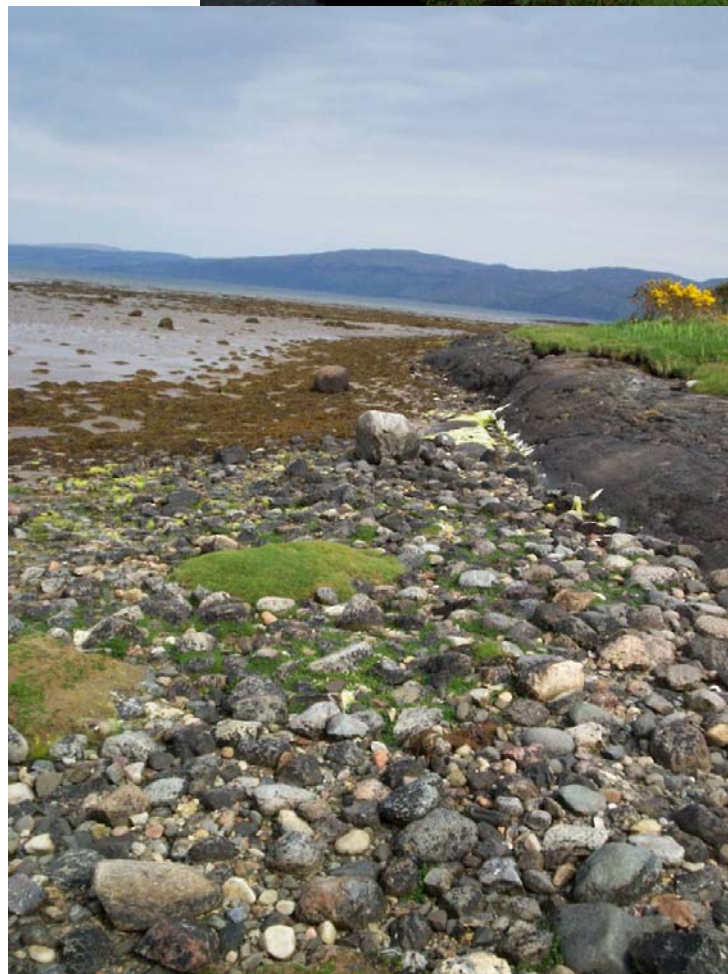
Figure 13. Stream

20	21/05/08	10:55	NM 74341 34459	174341	734459		Stream, water sample 6, 0.58 m x 0.04 m, flow 0.2 m/s
21	21/05/08	11:08	NM 74158 34588	174158	734588		Small stream, barely flowing. Sheep hoof prints in mud. Shore side of cemetery
22	21/05/08	11:11	NM 74073 34631	174073	734631		Stream, flow low, no suitable run for measurement. Water sample 7
23	21/05/08	11:18	NM 74031 34654	174031	734654		Occasional sheep droppings, 1 every 1-2 metres
24	21/05/08	11:20	NM 74016 34662	174016	734662	Figure 13	Stream, 0.29 m x 0.08 m, flow 0.3 m/s. 2 dead sheep nearby. Water

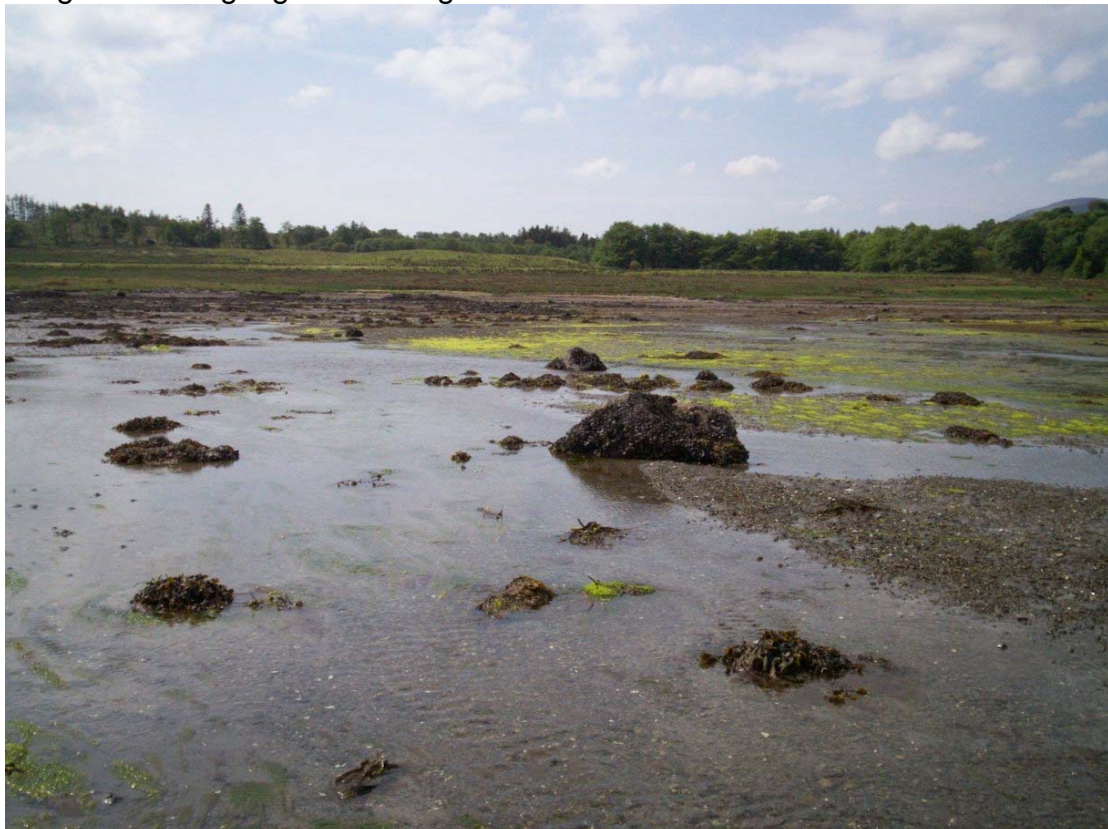
Figure 14. Algal growth along stream on shoreline

livestock origin. Extensive algal/bacterial growth was observed in this stream, suggesting high nutrient inputs. Additionally a number of smaller, unfenced streams drain the pasture on the shore adjacent to Duart Bay, and these will contribute to overall levels of contamination in the area. Further afield, a stream discharges just south of Craignure, and contamination from this may be carried in the direction of the fishery by the tide. However, as it is approximately 2 km away any bacterial contamination in the discharge may be sufficiently diluted by the time it reaches the fishery that its impact would be minor.

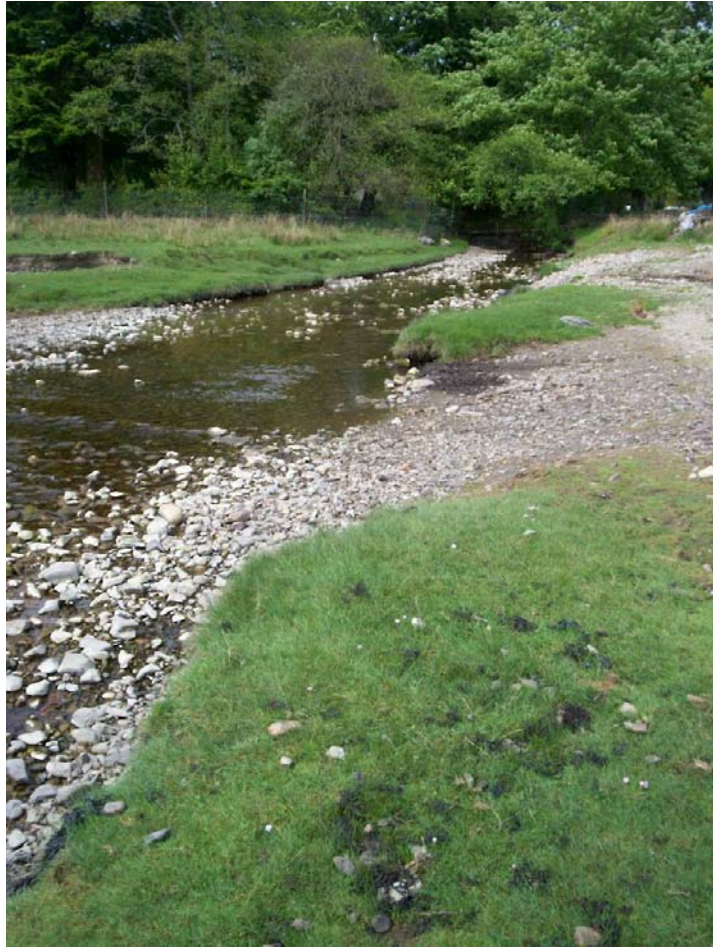
Figure 16. Sheep at shoreline near Torosay

35	21/05/08	12:26	NM 73073 35115	173073	735115	Figure 15	Cow dung, large stream 8 m x 0.06 m, flow 0.6 m/s. Water sample 11. Flows past Torosay castle farm and gardens
36	21/05/08	12:40	NM 73097 35196	173097	735196	Figure 16	Stand of trees, 15 sheep, 1 cow, 2 ponies
37	21/05/08	12:42	NM 73131 35226	173131	735226	Figure 17	30 cattle and calves
38	21/05/08	13:04	NM 73367 35601	173367	735601		Self catering cottage, on septic tank with soak away and overflow discharge. Dry
39	21/05/08	13:08	NM 73223 35481	173223	735481		Septic tank for staff using railroad engine shed, 2-3 staff during summer only
40	21/05/08	13:11	NM 73033 35325	173033	735325		Septic tank for Torosay castle
41	21/05/08	13:46	NM 73412 35585	173412	735585		Waters edge, oyster trestles approx 30 m from here
42	21/05/08	13:47	NM 73432 35569	173432	735569		Shellfish sample 2, oyster, 3 rows of trestles, 8 bags wide. Water sample 12. Only one nearest to shore exposed.

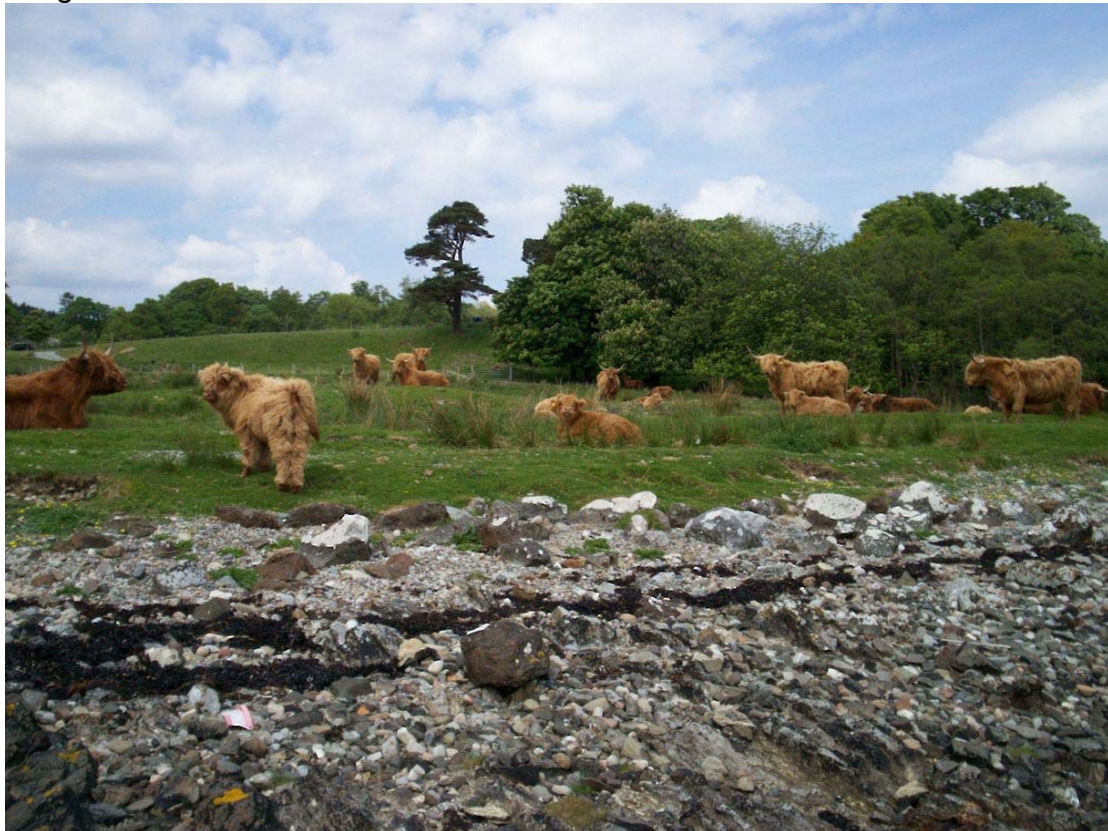
Figure 17. Cattle herd on shoreline

The land immediately surrounding Duart Bay is primarily rough grassland used for grazing livestock. The livestock that are grazed here have free access to the shoreline, and cattle and sheep were observed wading in the bay and across the streams feeding into the bay. The highest concentrations of livestock were seen around Torosay Castle. Contamination from these animals will be carried into the bay either by direct deposition on the shore below the high water mark, or via land runoff. Given their fairly high densities around Torosay Castle, and their

unrestricted access to watercourses and the shore, livestock are likely to be an important source of contamination to the shellfishery. On the basis of their distribution at the time of survey, the northern end of the bay is likely to be most contaminated by livestock, although it must be noted that shoreline observations only apply to the date of survey.

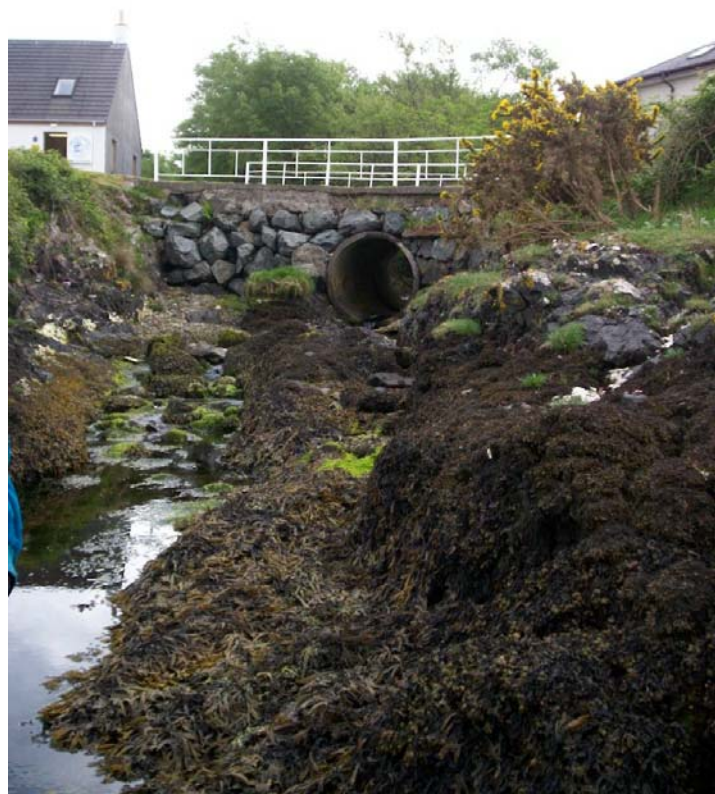
Figure 18. Stream and culvert near Craignure
