# Scottish Sanitary Survey Project

## Restricted Sanitary Survey Report Eriska Shoal AB 490 February 2010

Eriska Shoal  
AB 490

## Shoreline Survey Report

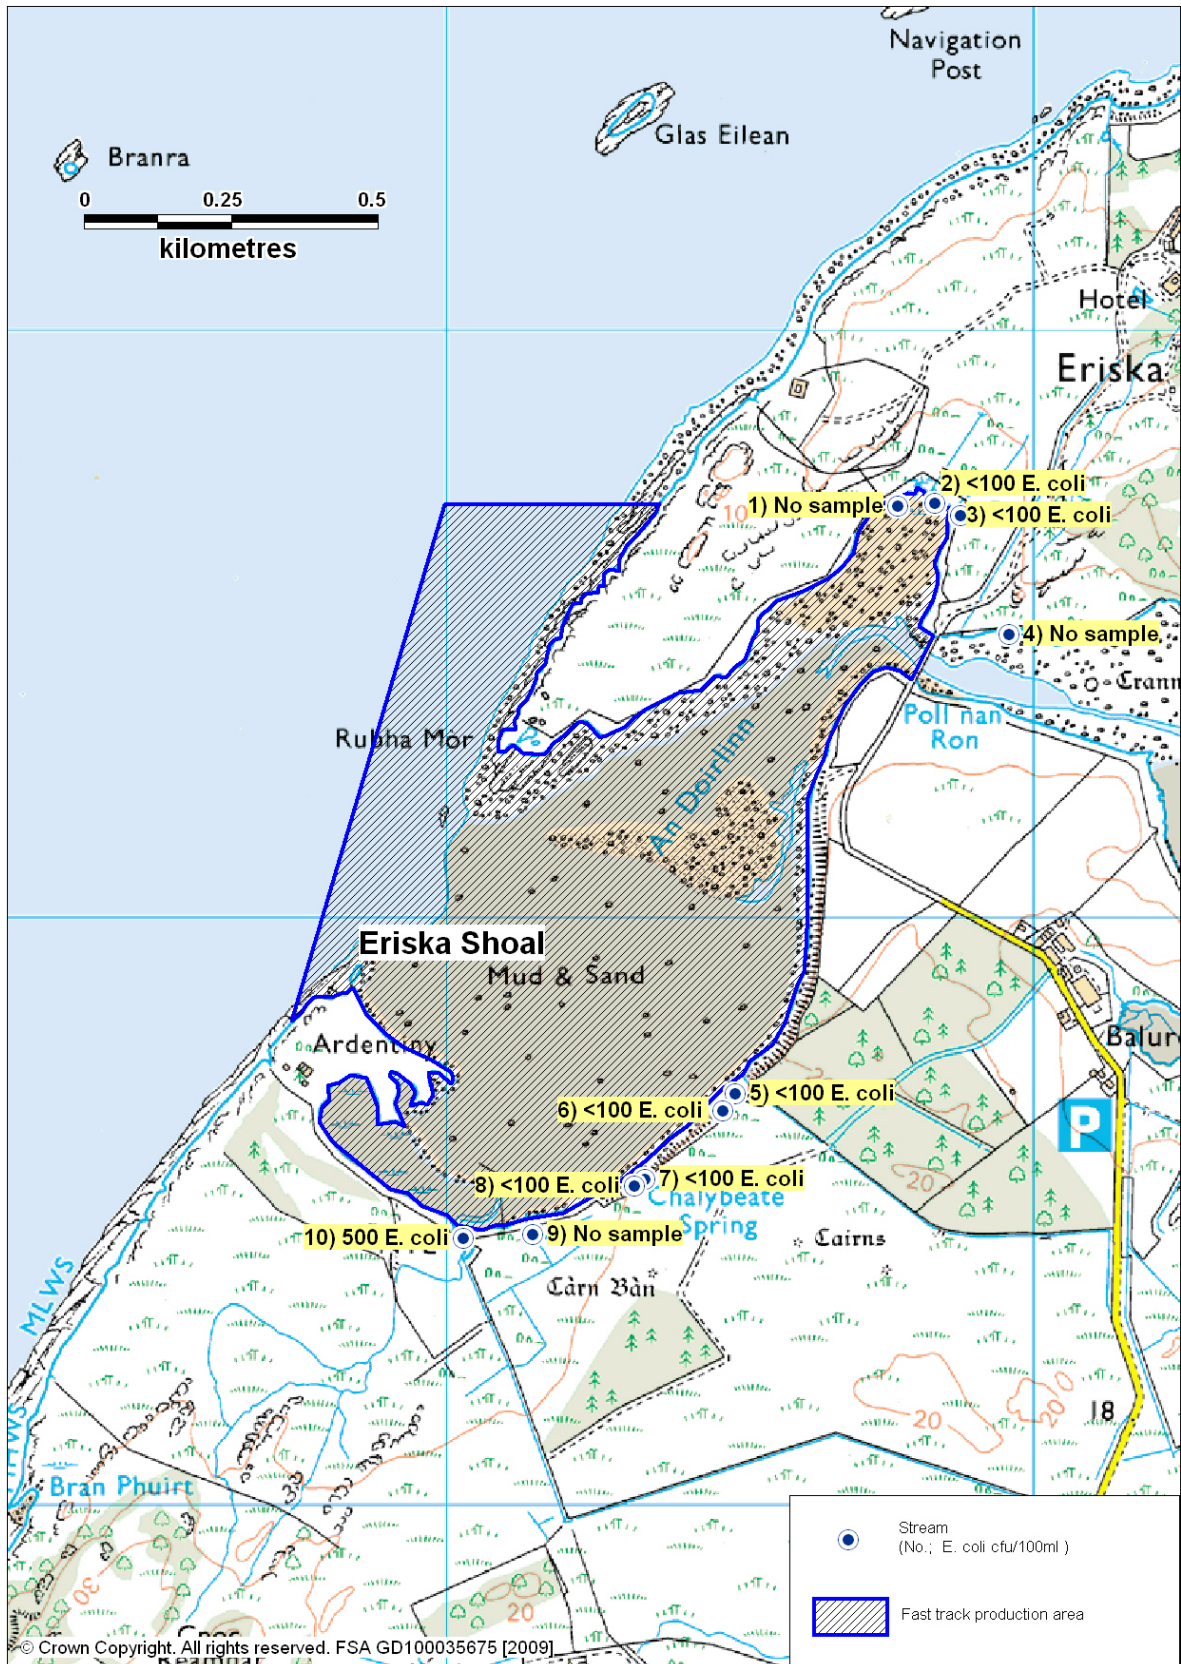
Figure 6.1. Location of river flows and loadings at Eriska Shoal

There is no river gauging station in the vicinity of Eriska Shoal. A total of ten fresh water inputs were observed discharging into Eriska Shoal. In total, only six were of sufficient size to obtain a water sample. Only two of these were of a measurable size. The details of these streams are listed in Table 6.1 and mapped in Figure 6.1.

The only stream that yielded a measurable *E. coli* result (i.e. one at or above the limit of detection of the test) was too small for the flow to be measured. The other streams all gave results below the limit of detection of the test (100 *E. coli* / 100 ml) as performed on these samples. No *E. coli* loadings could therefore be calculated. The predominant freshwater inputs to the Shoal in terms of size were to the south-east of the embayment. However, these would not have necessarily been the predominant freshwater sources of contamination in terms of *E. coli*.

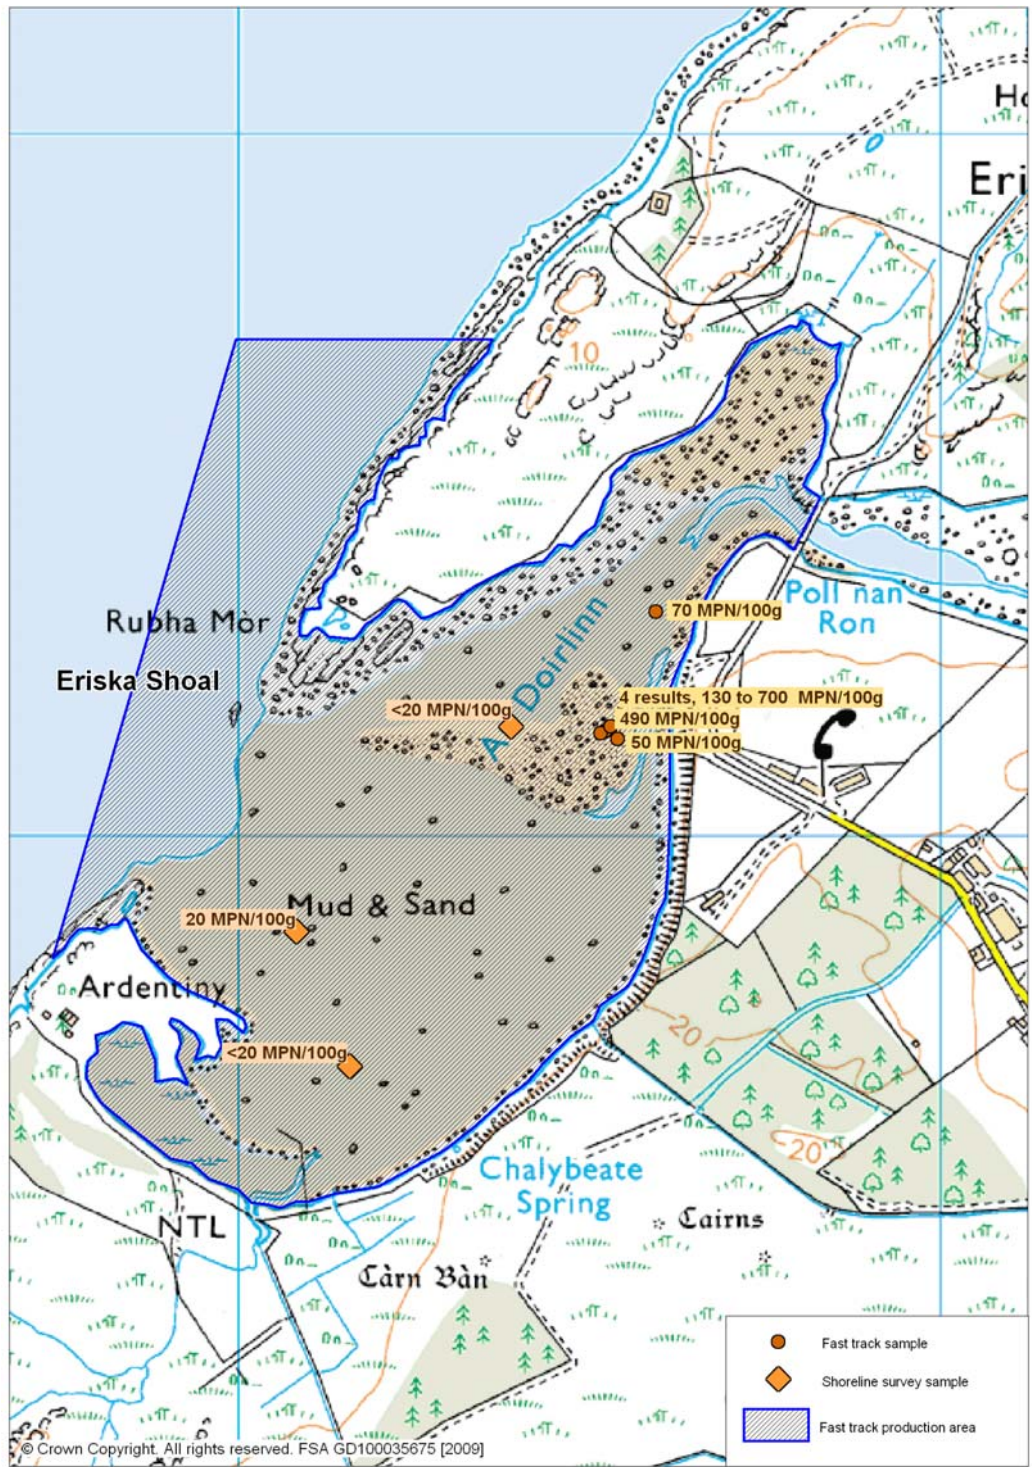
Figure 7.1 Results of shellfish sampling at Eriska Shoal

There is limited historical *E. coli* monitoring data available for Eriska Shoal, all of it gathered since April 2009. No samples appear to have been submitted in support of the fast track classification application which was dated 26/03/2009. The *E. coli* results for samples submitted in 2009 are listed in Table 7.1 below and are represented spatially on the map in Figure 7.1 overleaf. For reference, the results and locations of shellfish sampled during the shoreline survey are also represented on this map. All but one of the samples collected in support of the monitoring program came from within a 20 meters of one another. Results varied from a low of 50 MPN/100g to a high of 700 MPN/100g. Of these, 4 out of 7 (57%) exceeded 230 *E. coli*/100g.

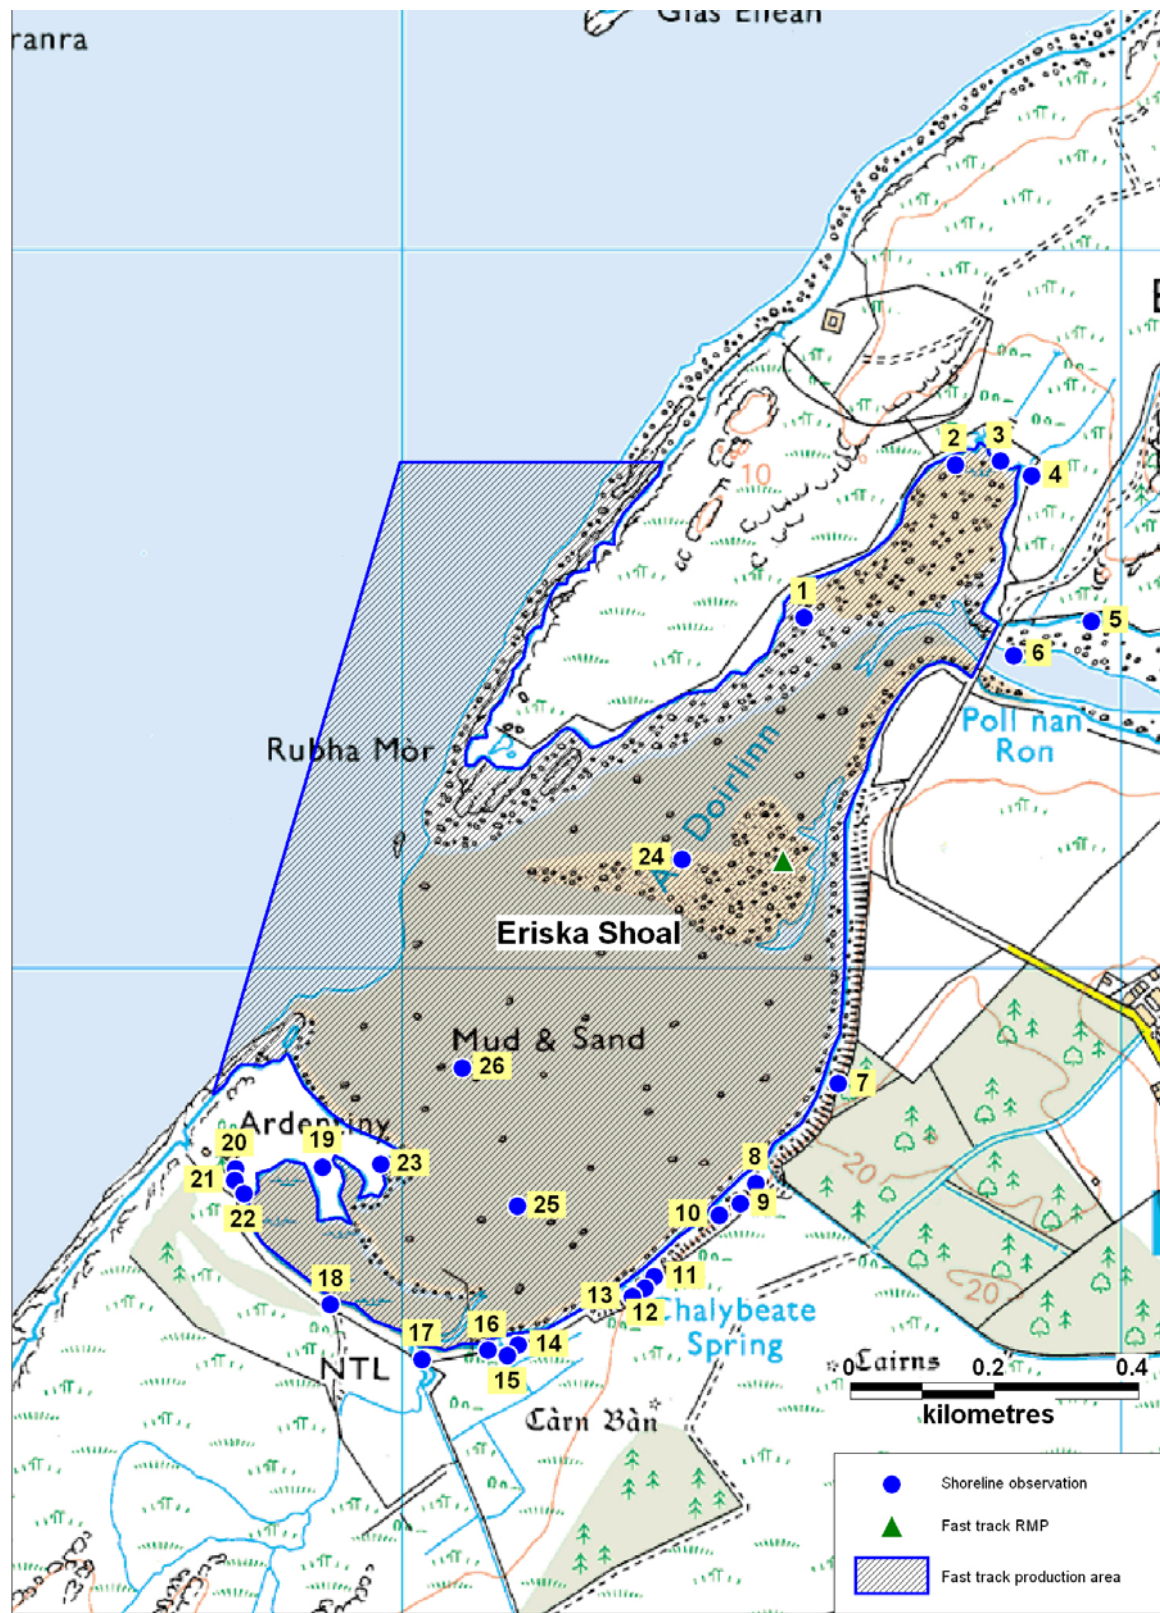
Figure 1. Shoreline Observations

No.	Date	Time	NGR	East	North	Associated photograph	Description
1	04/06/2009	08:50	NM 89559 42491	189559	742491		Survey start point. Geese droppings.
2	04/06/2009	08:56	NM 89769 42703	189769	742703		Small stream, not flowing.
3	04/06/2009	08:58	NM 89832 42709	189832	742709	Figure 4	Small stream, flowing but not enough to measure. Eriska fresh water sample 1.
4	04/06/2009	09:04	NM 89875 42688	189875	742688	Figure 5	Small stream, barely flowing, not measurable. Eriska fresh water sample 2.
5	04/06/2009	09:15	NM 89959 42485	189959	742485	Figure 6	Small stream, drainage pipe under road, not flowing.
6	04/06/2009	09:21	NM 89850 42438	189850	742438	Figure 7	Tidal channel at bridge approx 40 m wide at time of survey. Flows both East and West on ebb. Salinity = 35 ppt. Eriska sea water sample 3. Cockles shells and small clam shells.
7	04/06/2009	09:50	NM 89607 41842	189607	741842		Ground water running from bank. Deer hoof prints in sand.
