Scottish Sanitary Survey Review

Seil Sound

AB-247

Report Title	Seil Sound Sanitary Survey Review
Project Name	Scottish Sanitary Survey
Client/Customer	Food Standards Agency Scotland
Cefas Project Reference	C6316B
Document Number	C6316B_2014_21
Revision	V1.0
Date	10/04/2015

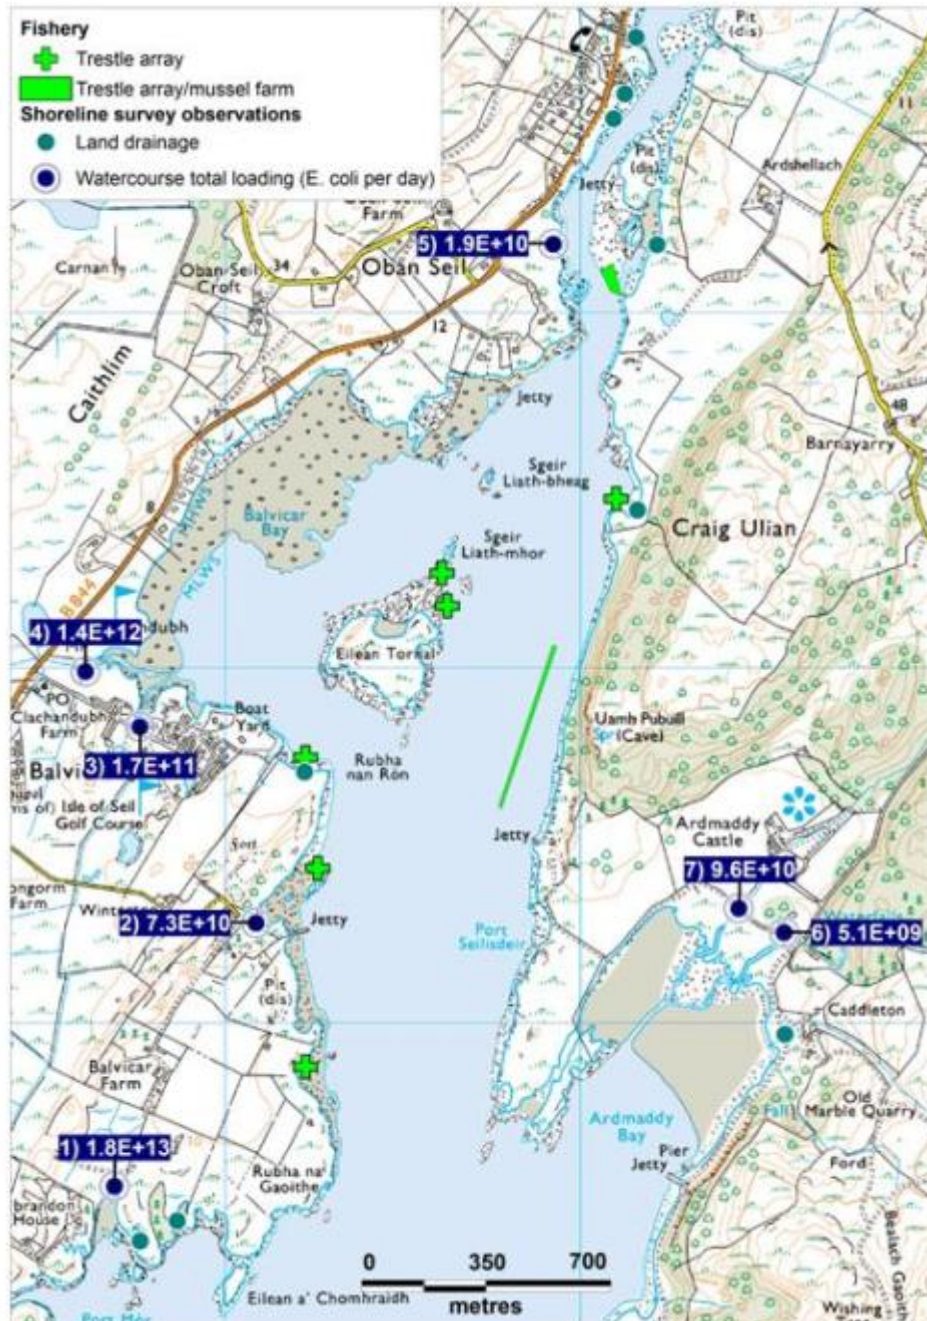
Figure 5.1 Watercourse loadings at Seil Sound estimated from the 2014 shoreline survey measurements

Watercourses continue to be a significant source of faecal contamination to Seil Sound. Highest impacts are anticipated to remain at the Balvicar, Rubha nan Ron South and Ardshellach sites, with other watercourses in the sound contributing to background levels of contamination.

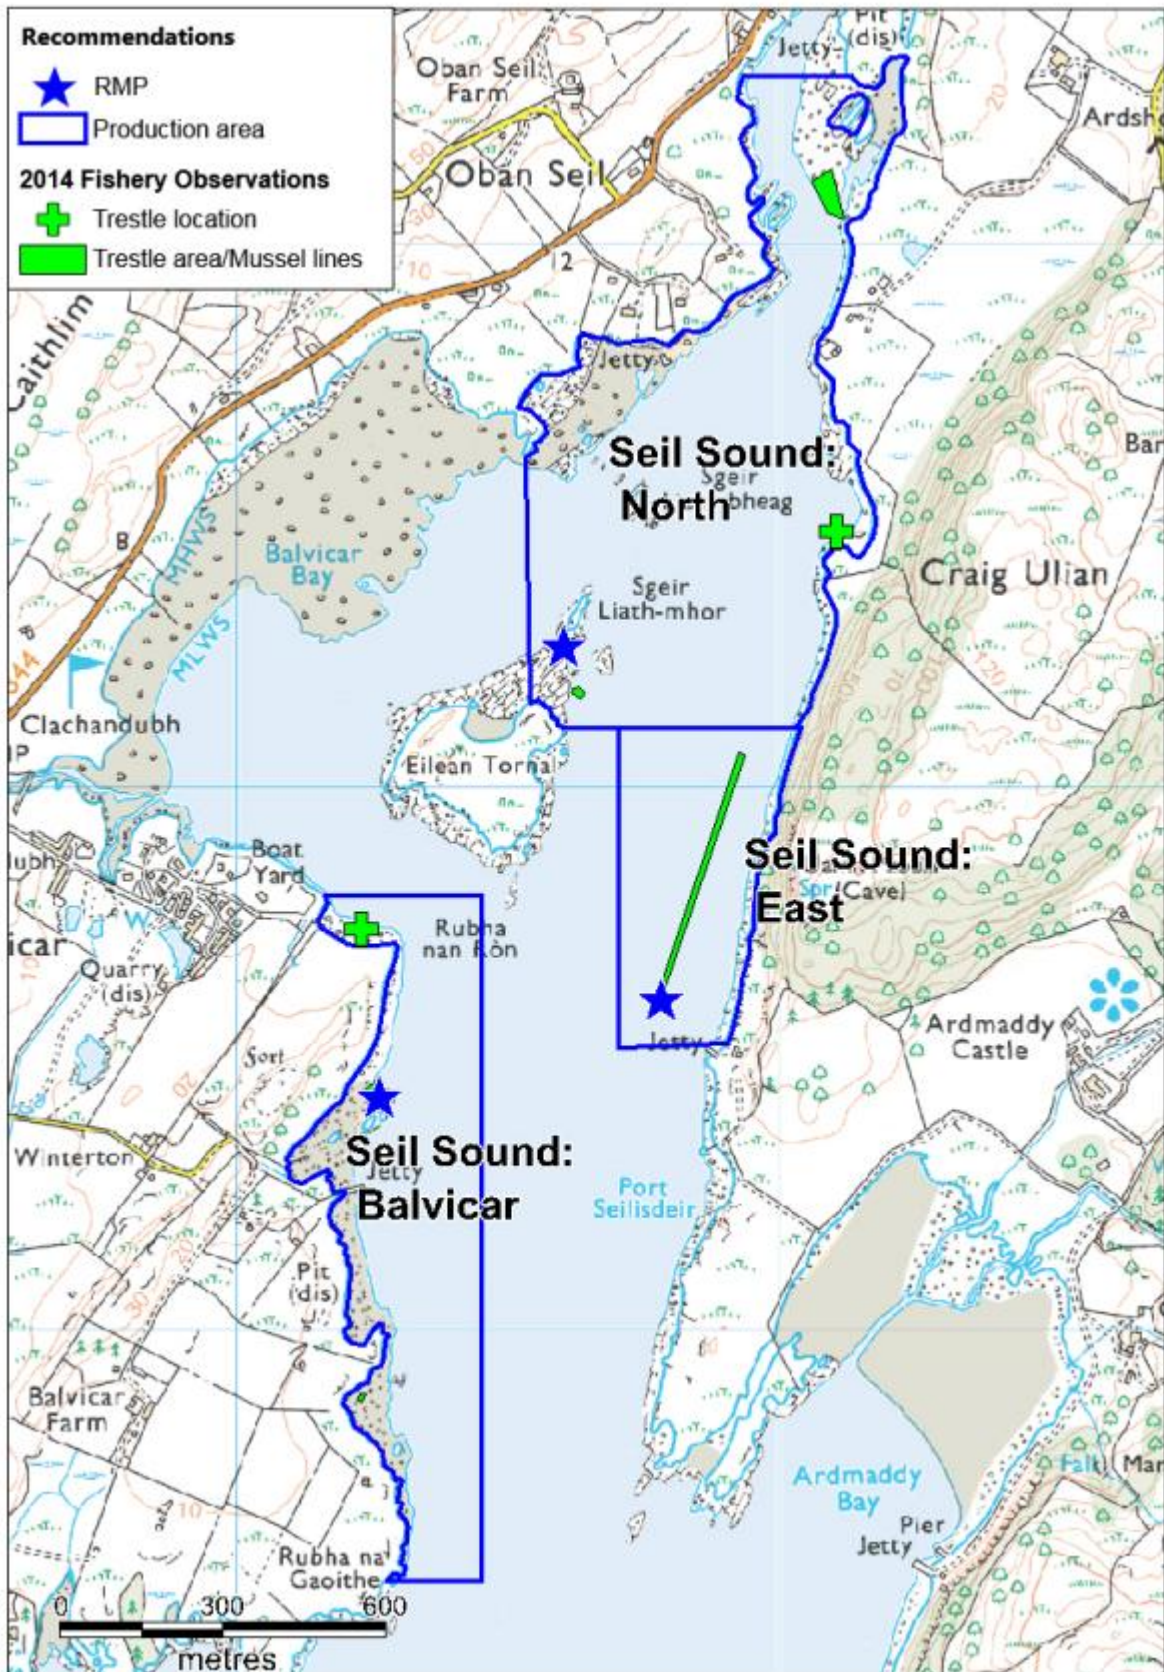
The conclusions of this review indicate that the three production areas are exposed to differing localised sources of contamination. It is therefore appropriate to maintain the three separate areas. The recommendations are shown in Figure 10.1.

© Crown Copyright and Database 2015. All rights reserved. Ordnance Survey Licence number GD100035675
Figure 10.1 Seil Sound recommendations

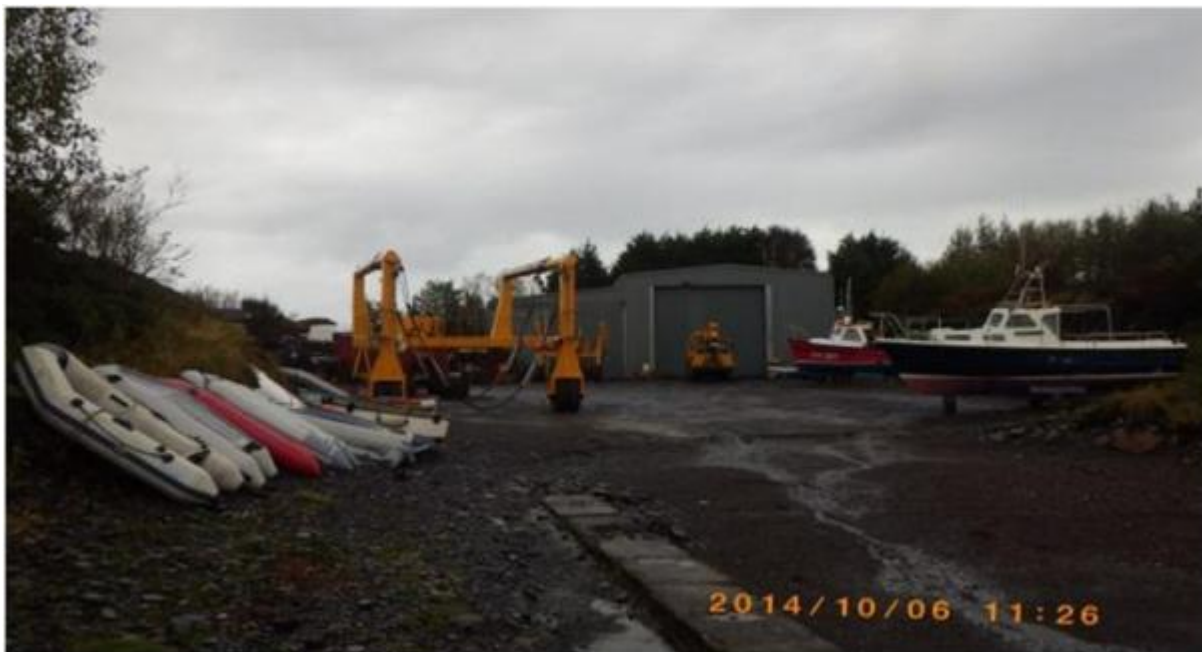
Balvicar Bay has numerous moorings of which the team counted forty two, with thirty occupied by vessels ranging from fishing work boats to yachts and small leisure craft. At Balvicar there is a commercial boatyard with slipway (Fig. 7, Waypoint 21) and a commercial fishing base with shed and pier (Fig. 8, Waypoint 22).

Figure 7. Balvicar boatyard, Balvicar village. Seil Sound south. Waypoint 21.

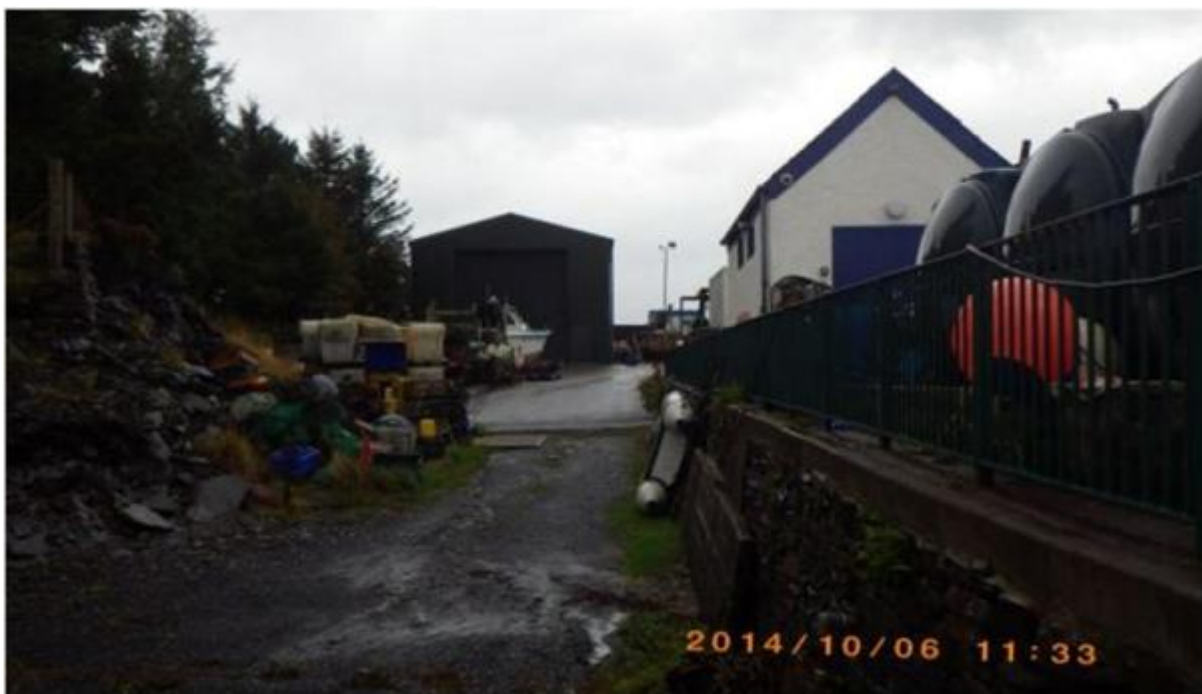
Figure 8. Fishing base pier and slipway at Balvicar village. Waypoint 22.

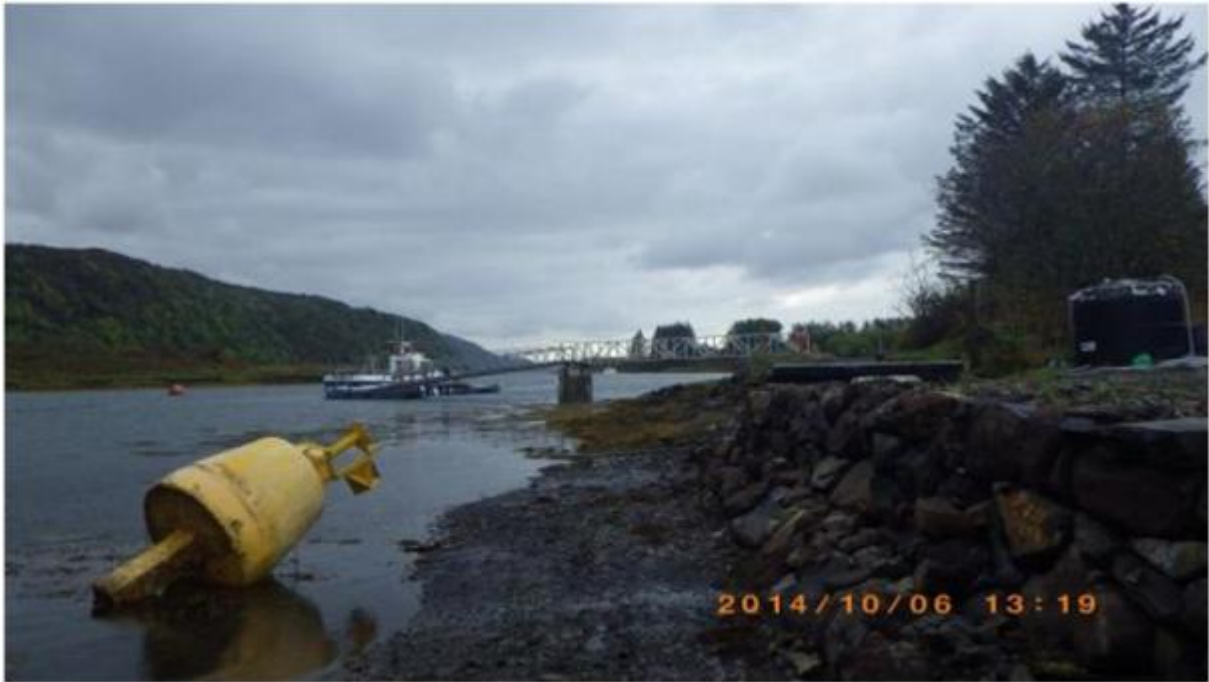
In the channel on the west side leading to the Atlantic Bridge are three private pontoons, one of which is commercial, operating wildlife watching and diving charters (Fig. 9, Waypoint 41, Sealife Adventures). The southernmost pontoon, Waypoint 43, had four leisure boats ashore (Figs. 10 and 11). The channel is narrow and restricted for moorings so there were six moored boats in the channel north to the Atlantic Bridge, which is outwith of the survey area. The team counted an additional two boats in the surveyed area. A slipway with leisure boats stored ashore is incorporated in a new build of four houses on the east side of the channel at the road end, past Ardshellach Farm (Fig. 20, Waypoint 102).

Figure 9. Sealife Adventures pontoon with charter vessel. Diesel tank on the right and car park (out of frame) above. Waypoint 41.

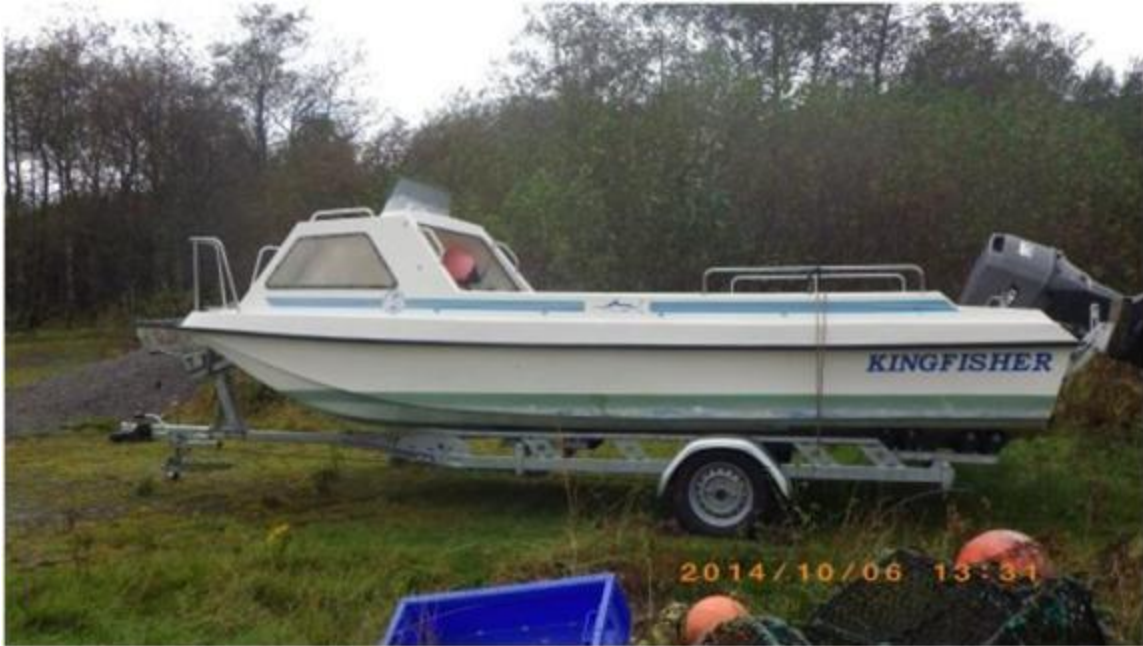
Figure 11. One of four leisure craft ashore by pontoon with small, newly established woodland beyond. Waypoint 43.

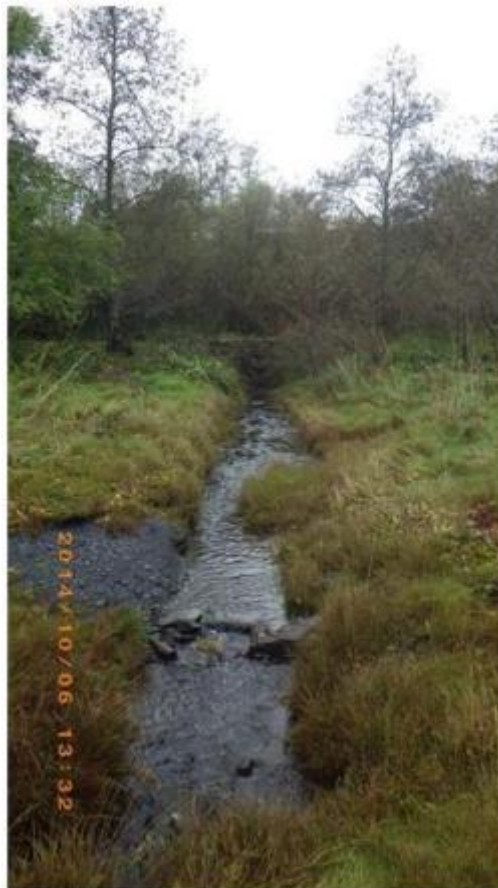
Two small rivers enter Ardmaddy Bay, the Allt Dallermaig and the Eas nan Ceardach. The latter has been harnessed for small scale hydropower (Fig. 17, Waypoint 88). All other water courses entering the survey area are much smaller. Figure 12 (Waypoint 45) is an example.

Figure 12. Watercourse Seil Sound North, west side, flowing past Oban Seil Farm. Site of unplanned freshwater sample SSFW7. Waypoint 45.

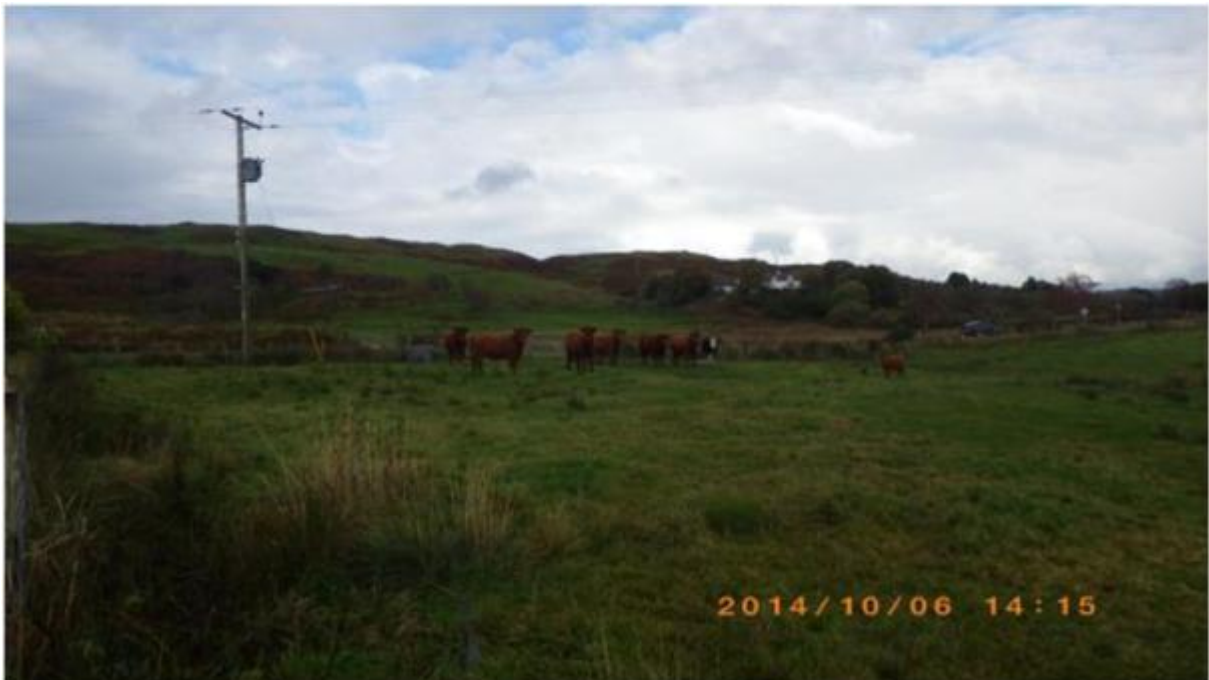
On the west side of the sound, south of Balvicar Bay, both cattle and sheep were seen in fields with open access to the shore. North of the bay a small group of nine young Luing cattle were encountered in a field without shore access after the end of the shore survey while exiting to the B844 road between waypoints 50 and 51 (Fig. 15).

Figure 15. Luing beef cattle in B844 roadside field with no direct shore access. Between waypoints 50 and 51.

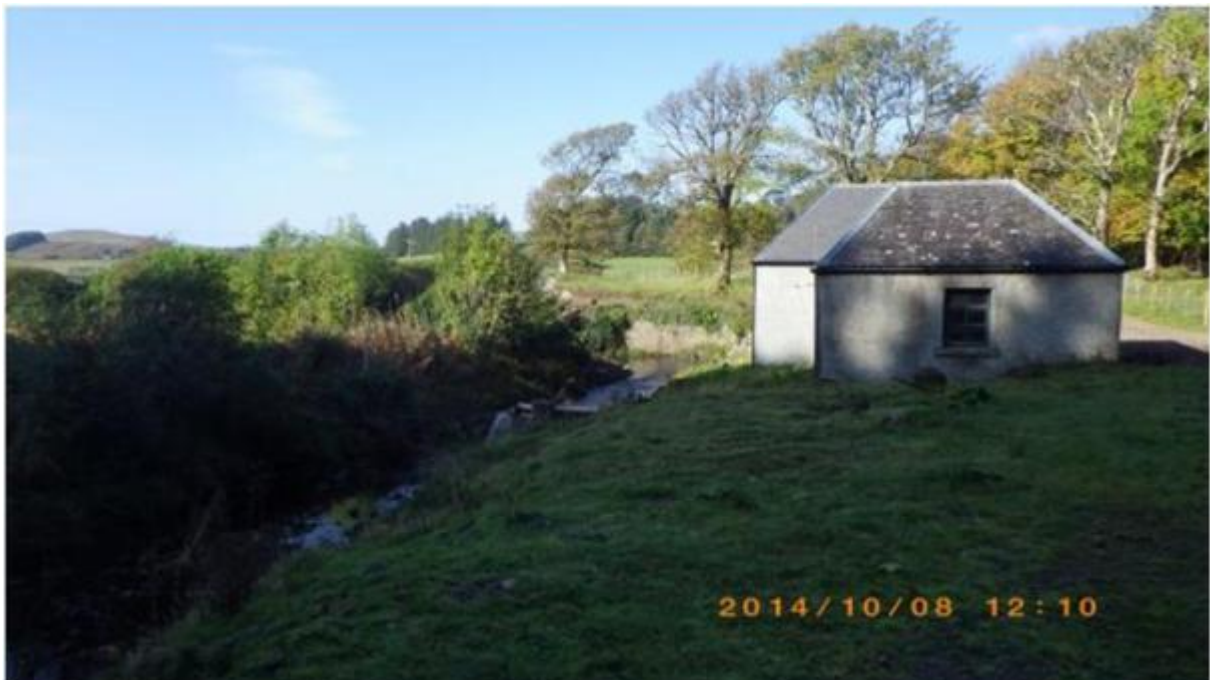
Figure 17. Housing for old (small) and new (larger) small scale hydroelectric plant at Ardmaddy Bay on the Eas nan Ceardach watercourse Waypoint 88. Site of planned freshwater sample SSFW10, Waypoint 89, is three metres downstream of the second (larger) building.

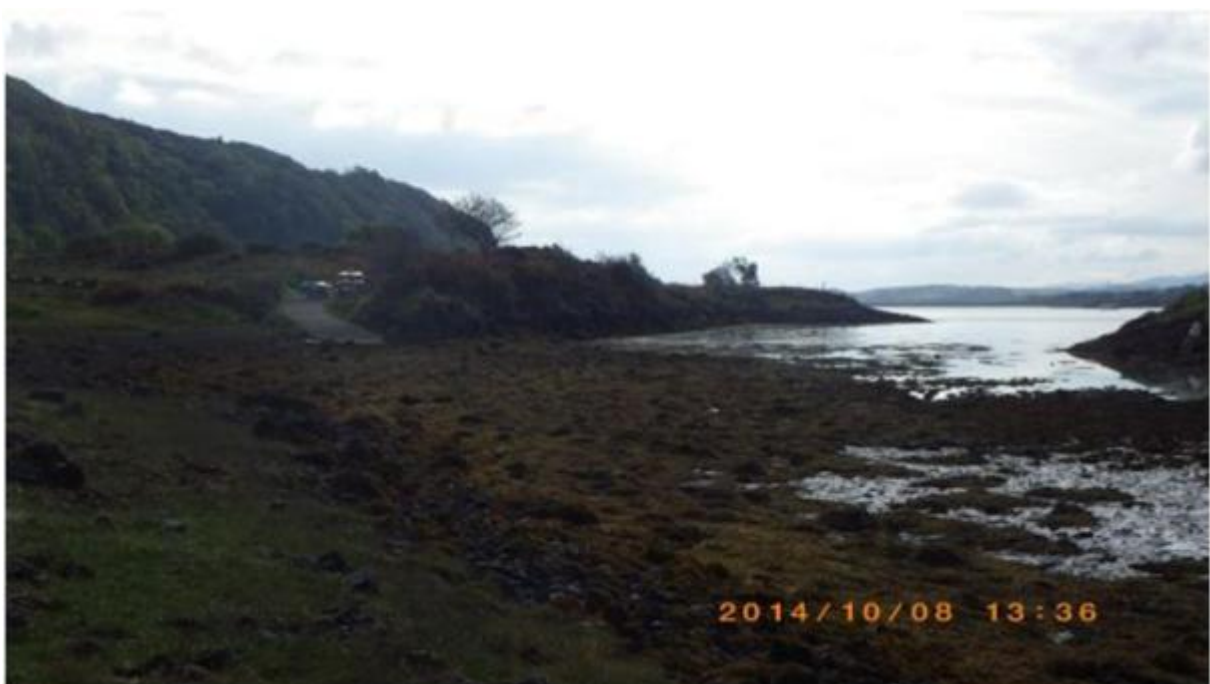
Figure 20. View south from the north of Seil Sound looking south, showing slipway and associated boats for one of four new houses at the north east of Seil Sound. Waypoint 102.

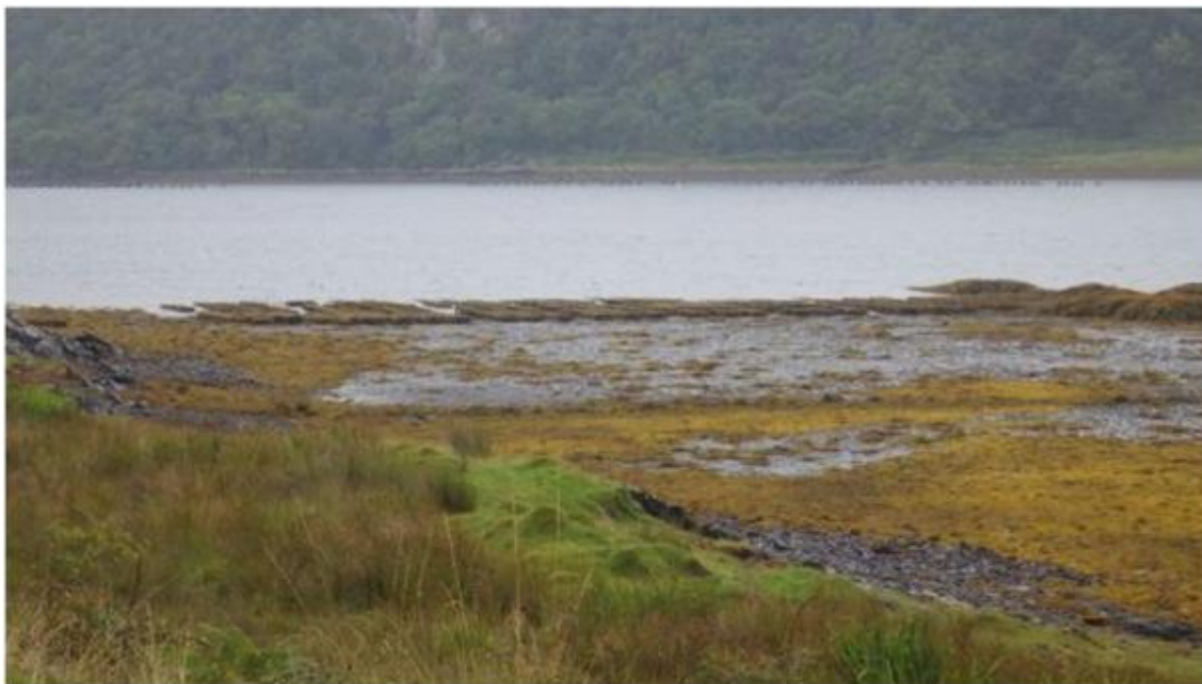
Figure 23. Seil Sound Balvicar (south), Rubha nan Ron south, oyster trestles photographed on 12th August 2014. Waypoints 106 to 109.

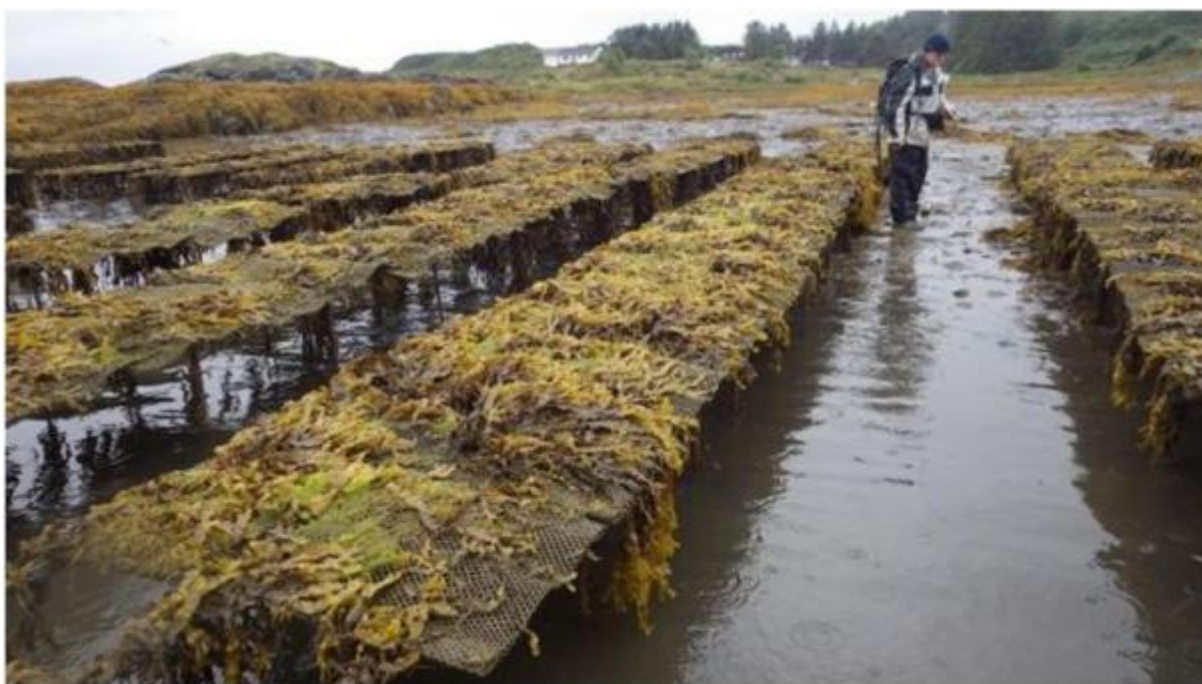
Figure 24. Seil Sound Balvicar (south), Rubha nan Ron south, oyster trestles by Balvicar Chalets photographed on 12th August 2014. Chalets with modern bungalow on the left (south) at the head of the bay in the background. Waypoints 106 to 109.
