Scottish Sanitary Survey Review

Vaila Sound

SI-288 and SI-289

Report Title	Vaila Sound Sanitary Survey Review
Project Name	Scottish Sanitary Survey
Client/Customer	Food Standards Agency Scotland
Cefas Project Reference	C6316D
Document Number	C6316D_2014_18
Revision	V1.0
Date	27/02/2015

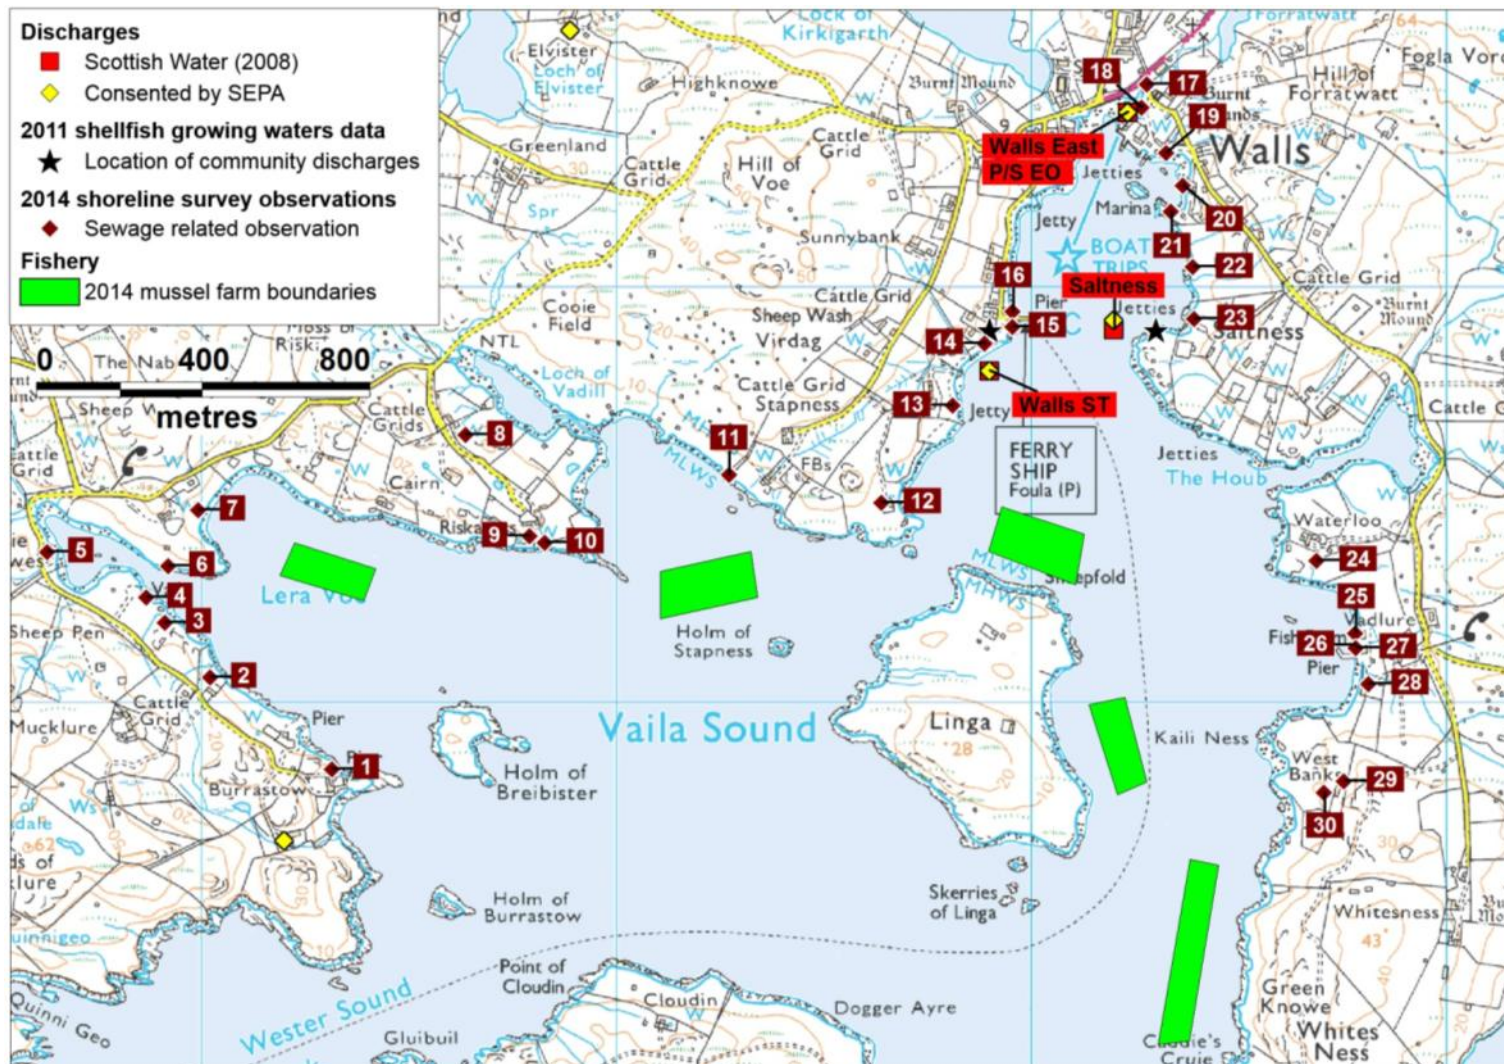
Figure 2.2 Map of sewage discharges in the vicinity of Vaile Sound

The 2009 sanitary survey report included information on three community discharges and four domestic STs to soakaway. A summary of these discharges can be found in the sanitary survey report: the locations are displayed in Figure 2.2. The 2008 shoreline survey also identified a large number of additional private sewage inputs. These were mostly located around Walls, with several also recorded adjacent to the Lera Voe, Riskaness and East of Linga sites. One overflowing sewage discharge pipe was noted approximately 290 m northwest of the Riskaness site, with a dripping discharge pipe also noted to the north in Walls. Overall, the highest contamination impacts from sewage were expected at the Linga site, though Lera Voe and Riskaness sites would also experience low levels from private discharges on nearby shorelines.

roads at several points around the sound, and some of these are located near to mussel farms. Sewage contamination is expected to be greatest in the vicinity of Walls and this will principally affect the Linga site. Contamination from private septic tanks will affect other locations around the sound with impacts anticipated to be greatest at the Lera Voe and Riskaness sites. Additional input of human sewage may come from the overboard discharge of marine toilets from boats. Habitation of the isle of Linga may cause additional localised inputs to the area.

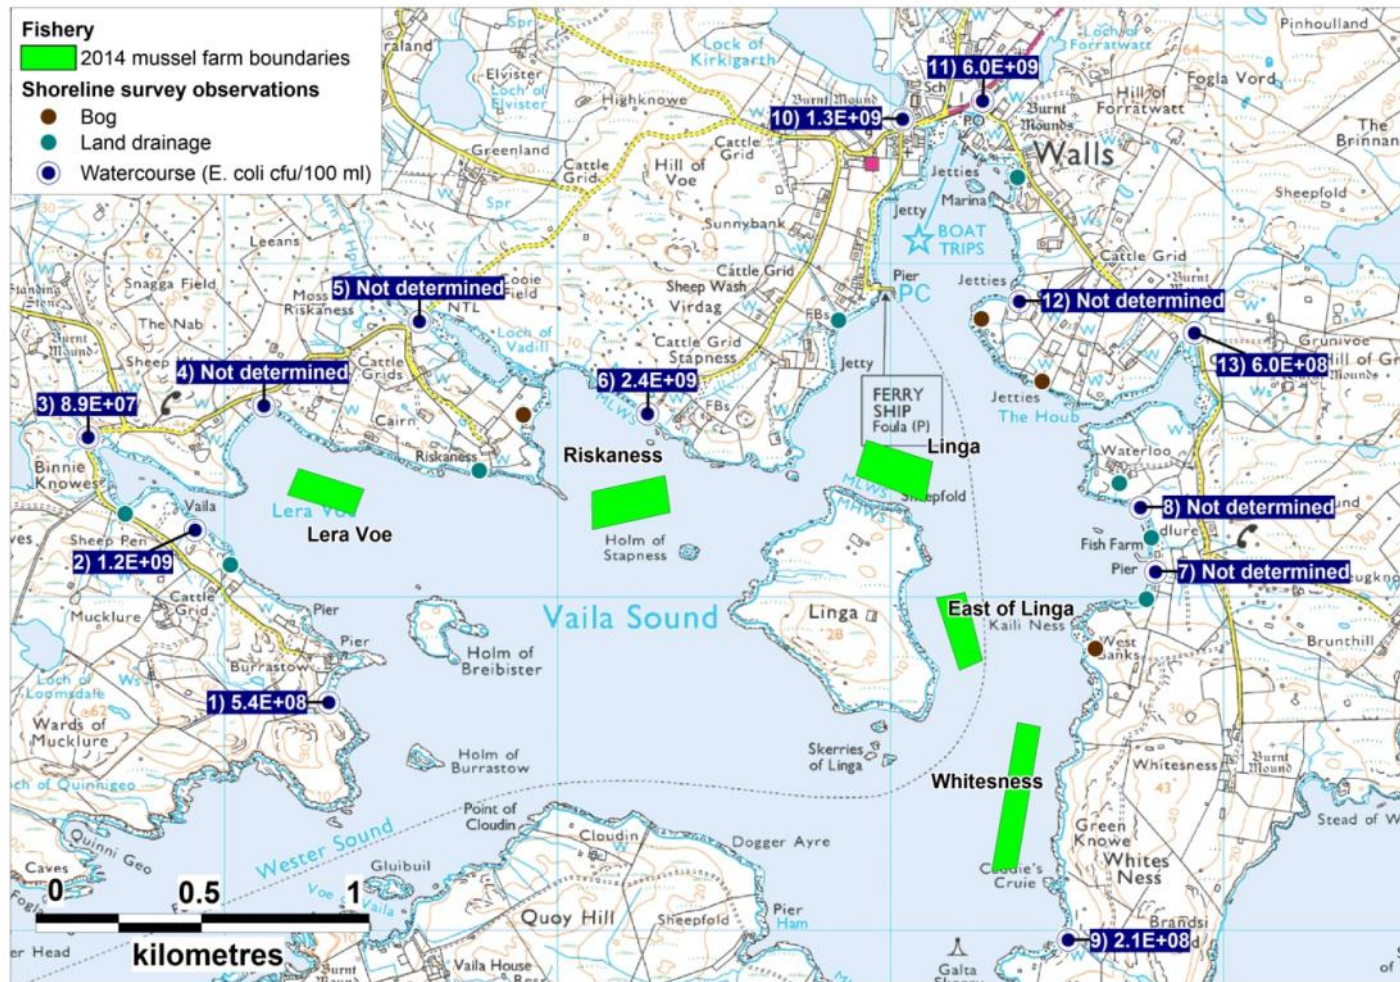
Figure 5.1 Watercourse loadings at Vaile Sound during the 2014 shoreline survey

Freshwater contamination loading to Vaila Sound remains low to moderate. Impacts remain highest at the Lera Voe and Riskaness sites. There is also expected to be impact to the eastern extent of the East of Linga site and the southern extent of the Whitesness site.

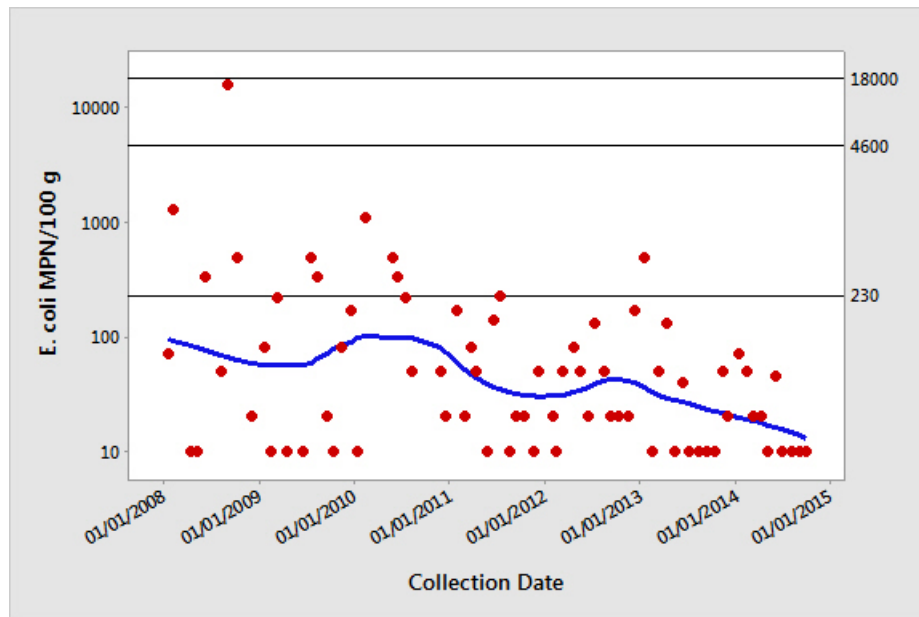
Figure 7.5 Scatterplot of Linga *E. coli* results by date (2011-2014)

A decrease in results at Linga is noted in the trend-line. This is related to an absence of samples with results >230 *E. coli* MPN/100 g since mid 2010, excluding one sample taken in 2013.

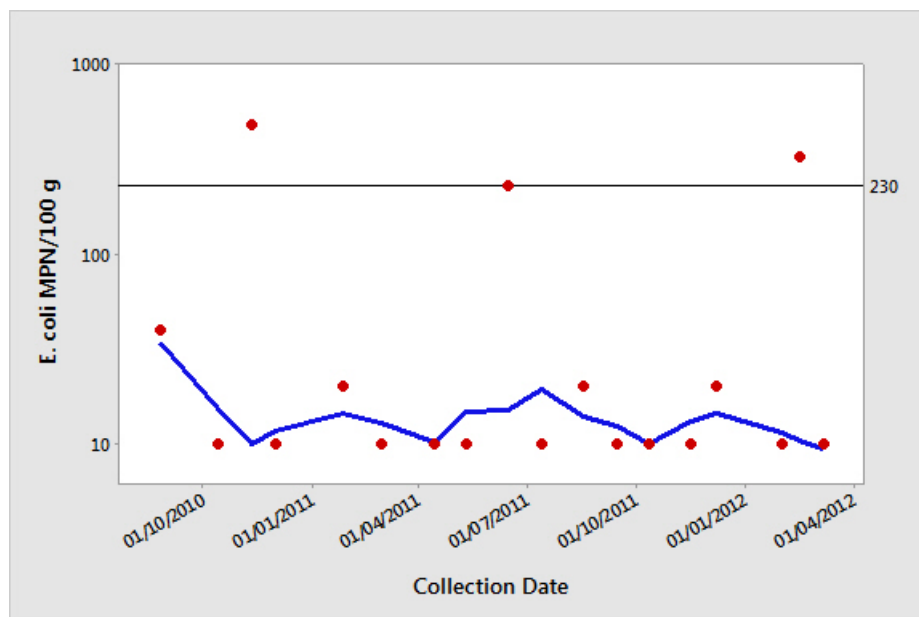
Figure 7.6 Scatterplot of Lera Voe *E. coli* results by date (2009-2011)

Results at Lera Voe were largely stable. All but four results were at or below the limit of detection. Of the four results above 20 *E. coli* MPN/100 g, three were at or above 230 *E. coli* MPN/100 g

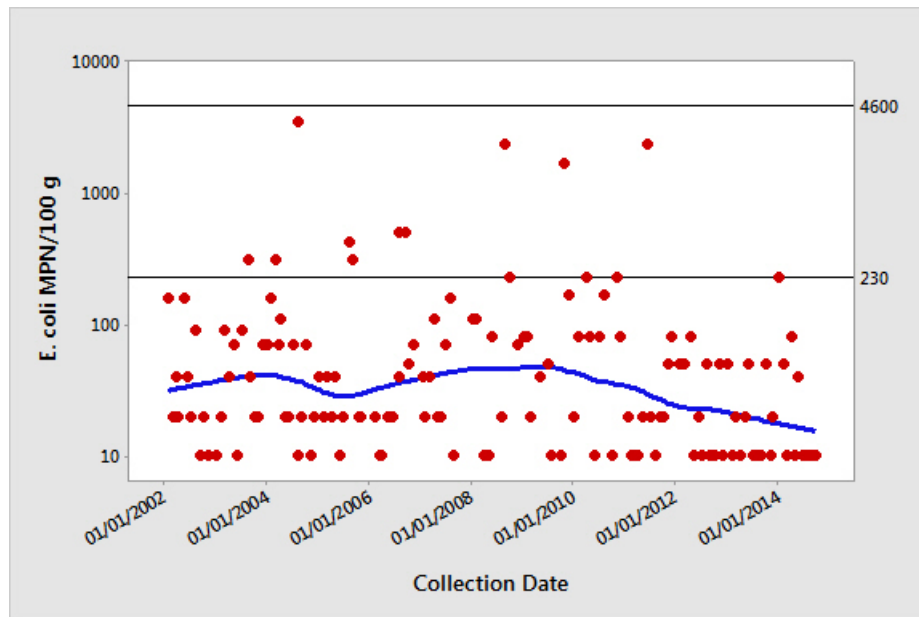
Figure 7.7 Scatterplot of Riskaness *E. coli* results by date (2002-2014)

Results have been generally constant at the Riskaness site. A gradual decrease is noted in the trend-line, related to the increase in <20 *E. coli* MPN/100 g sample results since 2012.

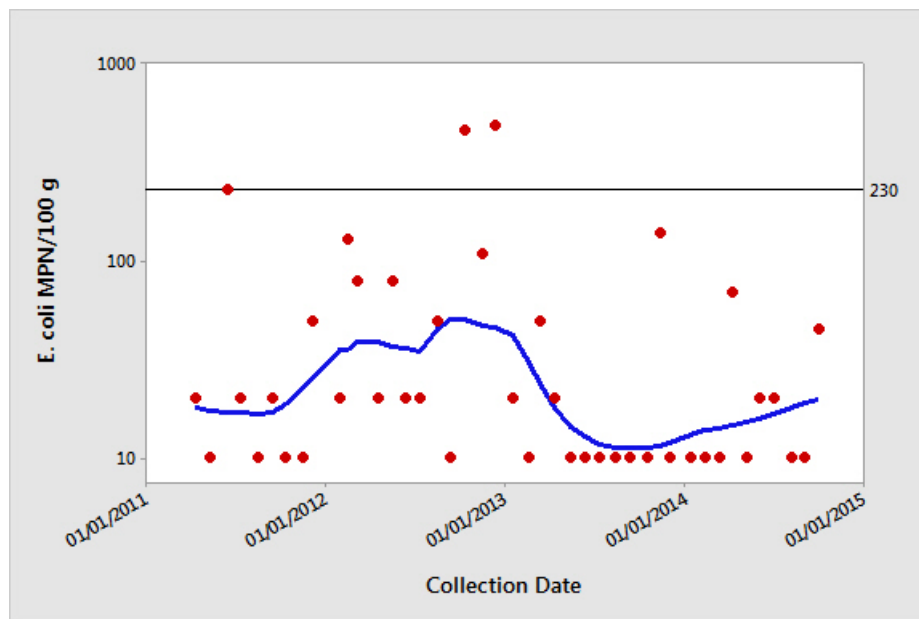
Figure 7.8 Scatterplot of Whitesness *E. coli* results by date (2011-2014)

The trend in results at the Whitesness site shows a sharp decrease in 2013, owing to an increase in the number of samples with results of <20 *E. coli* MPN/100 g.

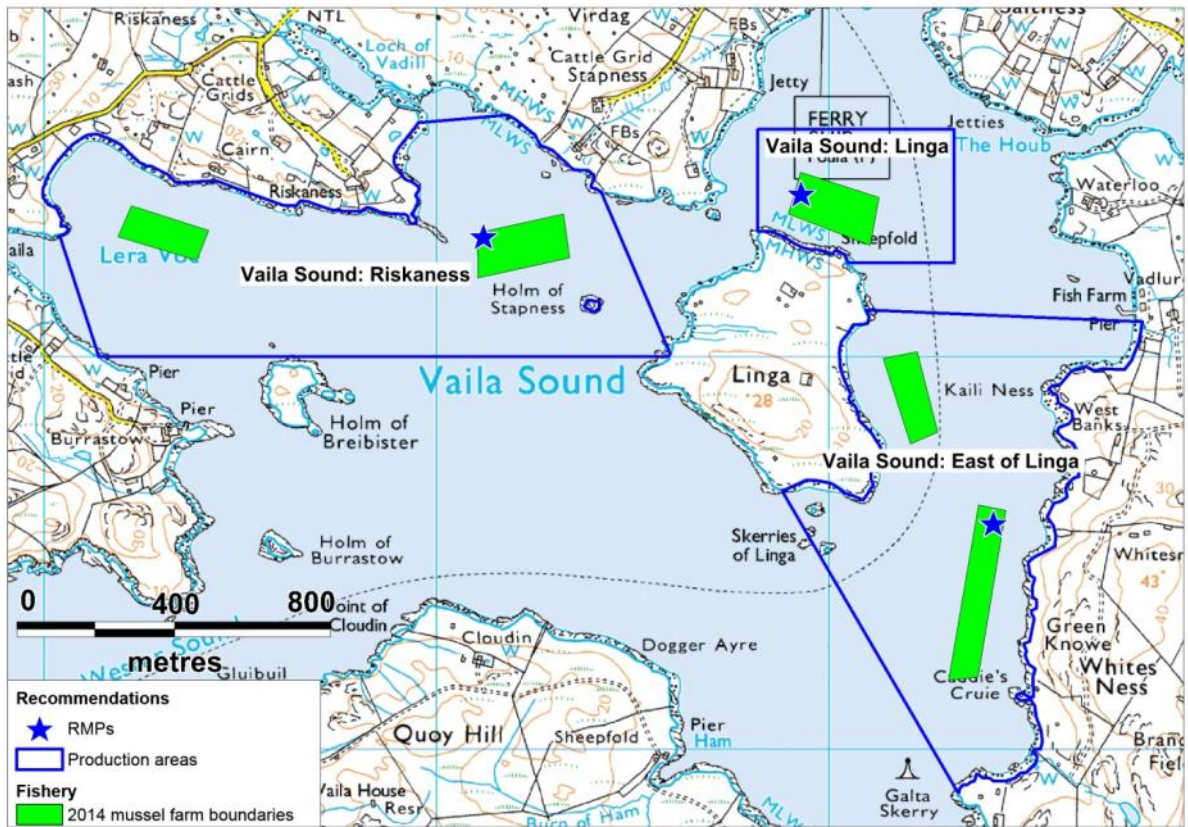
© Crown Copyright and Database 2014. All rights reserved. Ordnance Survey Licence number GD100035675
Figure 10.1 Recommended production area boundaries and RMPs – Vaia Sound

Production area: Area bounded by lines drawn between HU 2290 4848 and HU 2317 4862 and between HU 2342 4842 and HU 2360 4800 and between HU 2360 4800 and HU 2214 4800 and between HU 2214 4800 and HU 2204 4831 extending to MHWS.

RMP: HU 2312 4831

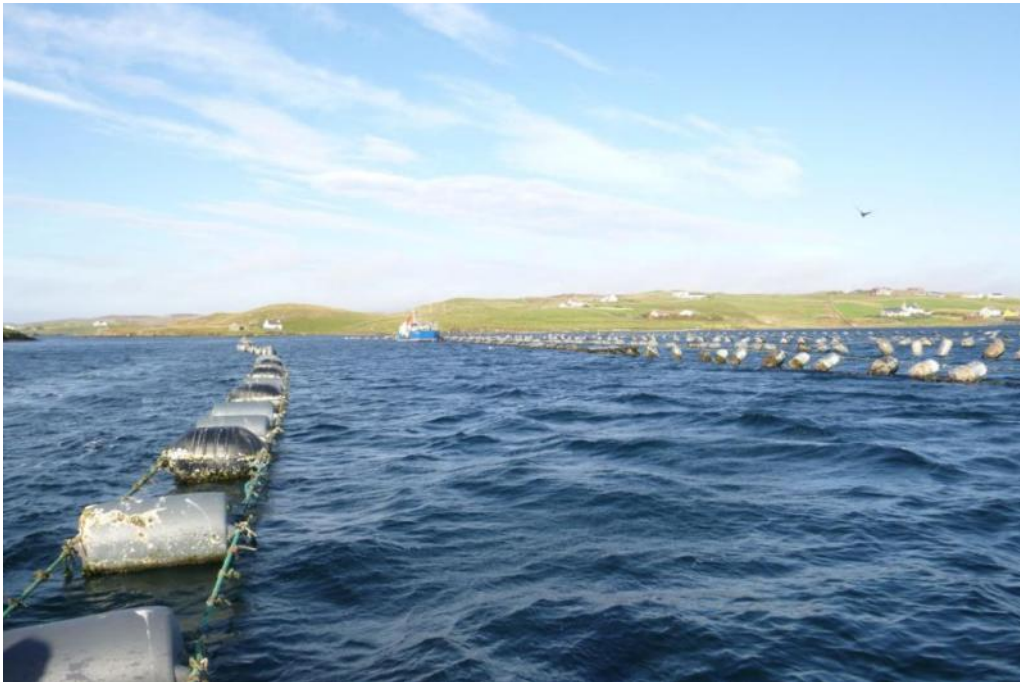
69	30/09/14 09:08:21	HU 23340 48253	423340	1148253			SE corner of Riskaness fishery.
70	30/09/14 09:10:35	HU 23897 48364	423897	1148364			SW corner of Blueshell Mussels' Linga fishery. Fishery consists of 8 x 200m lines with 8m droppers, running adjacent to NE side of the island of Linga. Some bird faeces on buoys at the fishery. Workboat onsite, currently harvesting.
71	30/09/14 09:12:02	HU 24106 48284	424106	1148284	Figure 4		SE corner of Linga fishery. 5 cormorants in flight. Photo looking NW.
72	30/09/14 09:13:26	HU 24128 48406	424128	1148406			NE corner of Linga fishery.

Figure 4 – Mussel lines at the Linga fishery looking northwest.

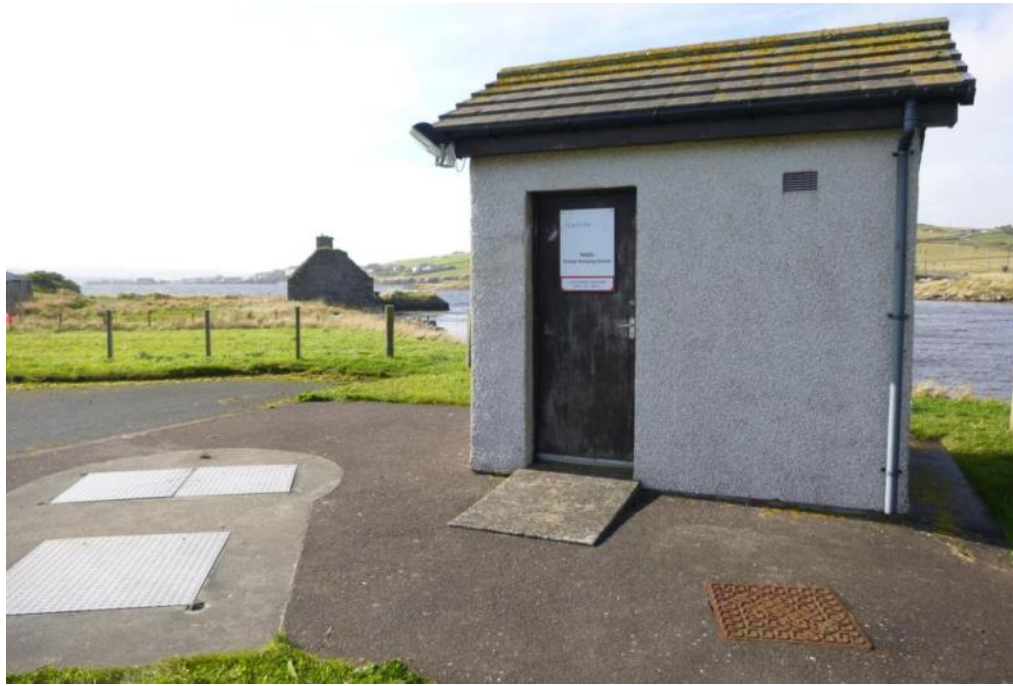
88	30/09/14 11:09:55	HU 24267 49434	424267	1149434	Figure 26		Walls Sewage Pumping Station (Point 2 in Table 5 of plan). No outfall observed.
89	30/09/14 11:12:03	HU 24225 49369	424225	1149369			2 small jetties with 2 dwelling houses above shoreline.
90	30/09/14 11:16:15	HU 24285 49322	424285	1149322			Walls Regatta Clubhouse with associated jetty and pontoon. 2 sailing boats on site.

Figure 26 – Walls East Pumping Station.
